# Independent Monitor **COMMUNITY REPORT**

**McARTHUR RIVER MINE**

December 2017

# Environmental Performance 2016

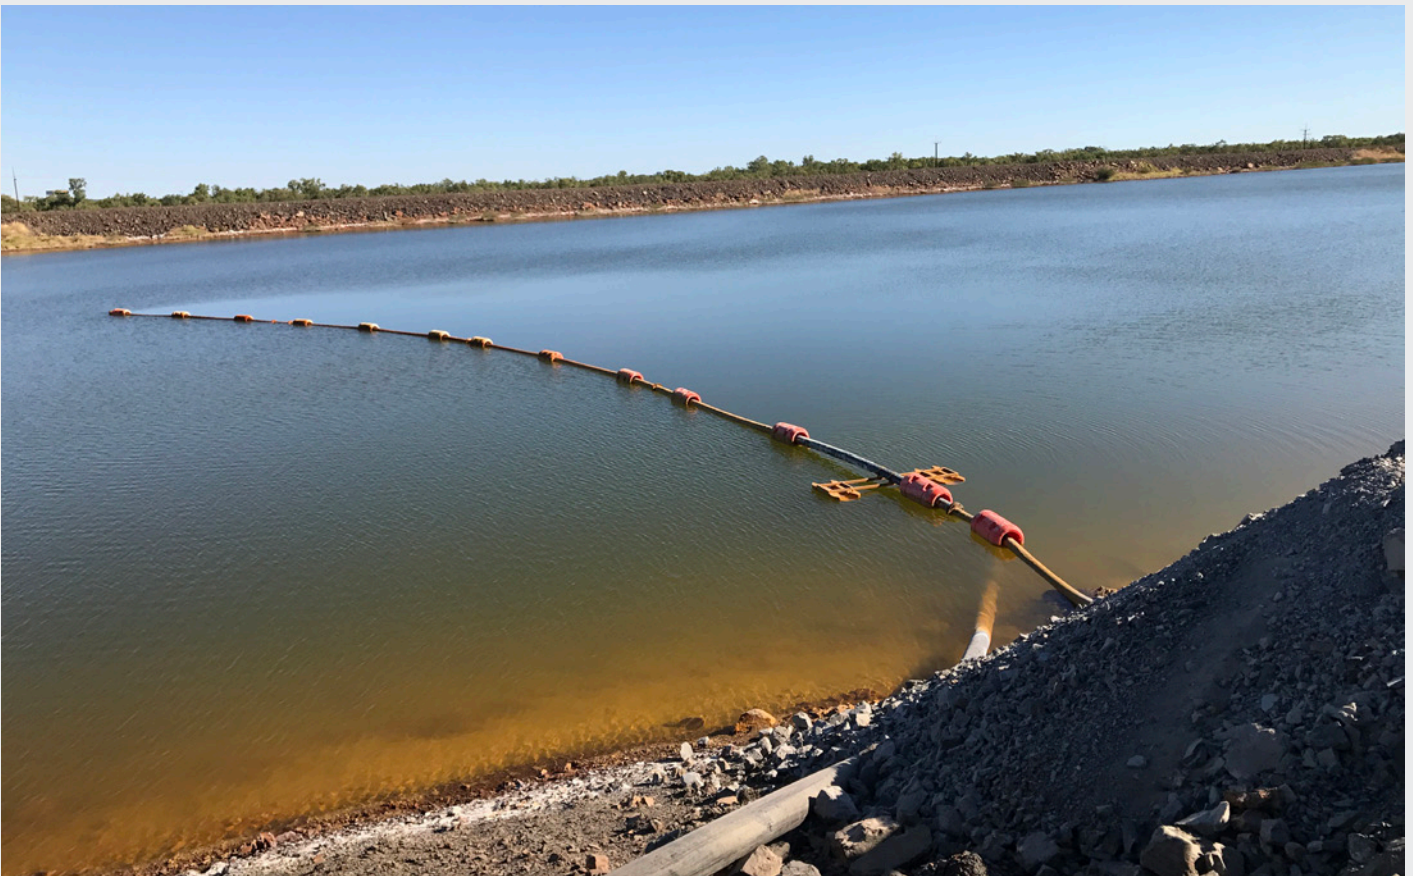
Seepage collected in the SPROD

- Carry out further investigations to determine the direct seepage contribution from the NOEF to the groundwater system and to confirm the effectiveness of the advection covers.
- Proceed with trial cover designs.
- Complete treatment of acid water in NOEF SPSPD/SPROD before the next wet season to avoid uncontrolled release.
- Prepare a tailings kinetic test report for the next IM reporting period.

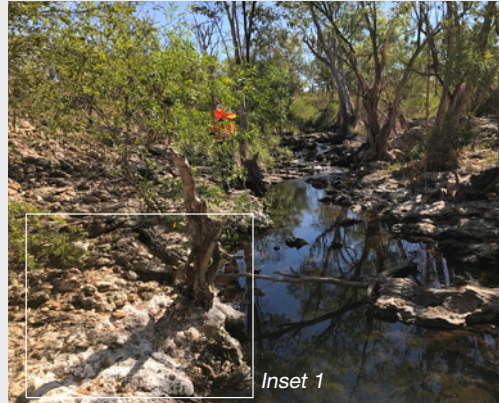
Seepage at Surprise Creek

Poor quality leachate from the TSF is present in groundwater and surface drainage due to inadequate management of seepage during operations. Process water appears to be the key source of contamination rather than oxidising pyrite in the tailings.

- Undertake further investigations of the causes of continued seepage through the TSF Cell 2 embankment and provide options for limiting further seepage and reducing water levels within the embankment.
- Assesses the impact on the mine site water balance should TSF Cell 2 spill to the water management dam thereby contaminating water in the dam and making it unsuitable for off-site release.
- Undertake inspection of the entire tailings pipeline including checking flange bolts to confirm correct assembly.

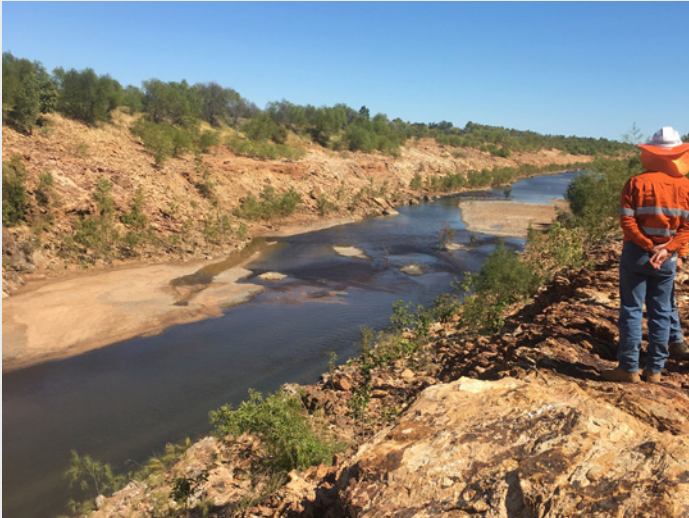
The rehabilitation of the diversion channel remains a concern, with very little change observed since the previous IM visit despite the planting of a significant number of seedlings in recent years.

The upstream end of the diversion channel has areas of good coverage; however, despite planting in other locations along the diversion channel, much of the tubestock has been washed out during the wet season, although some tubestock survival has been seen next to LWD piles where sediment has collected and is shielded from high flows.

*Revegetation in the middle to upper part of the McArthur River diversion channel*

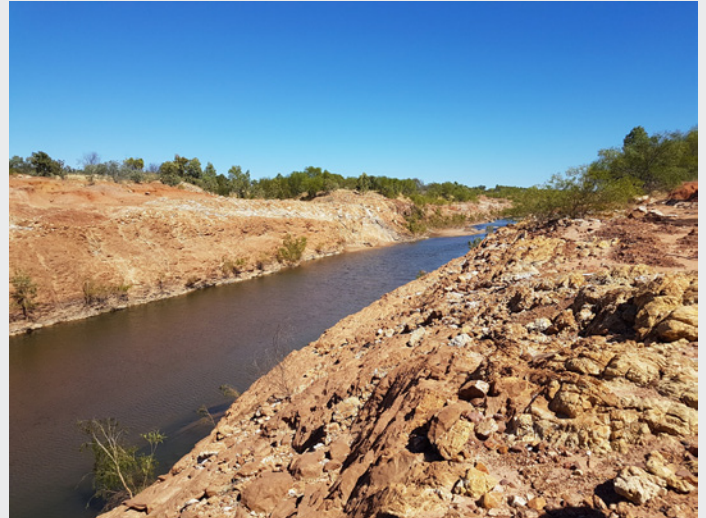
Due to lack of revegetation and flooding/high flow rates during the wet season, erosion of the banks of the diversion channel (as well as immediately upstream) continues to be an issue.

*Middle to downstream section of the diversion channel showing extensive erosion of banks*

Monitoring of diversion channel and bank erosion should continue on an annual basis using ALS complemented by photograph monitoring and visual inspection. An annual report on observed erosion should then be completed.

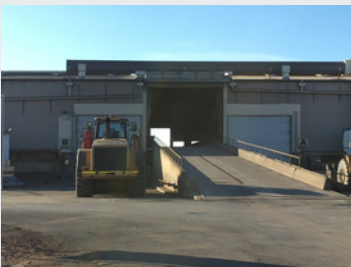
New smaller roller doors of the concentrate storage shed

- The bitumen surface surrounding the loading facility needs to be repaired to avoid future contaminated soil, water and/or dust management issues. MRM plan to do this during 2018.
- The two large roller doors of the concentrate storage shed have not been replaced and are a likely cause of dust issues in the local area. The IM recommends they be repaired as soon as possible.
