Independent Monitor Community Report

2010 Operational Period

Community Report by the Independent Monitor of the
McArthur River Mine, November 2011

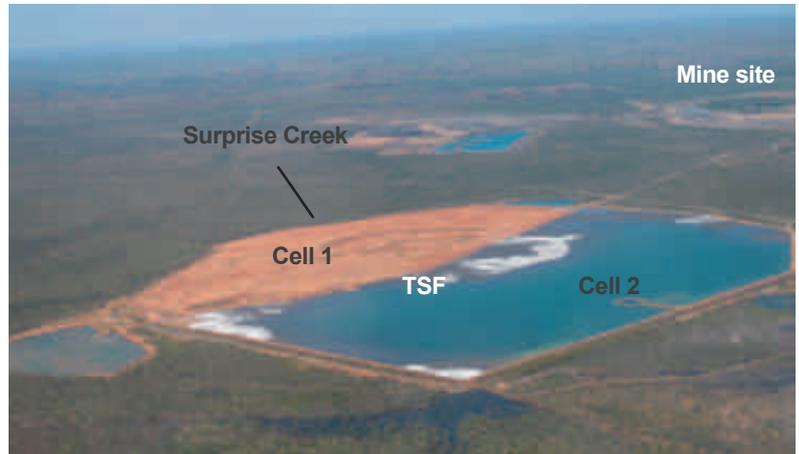
Aerial view of the Tailings Storage Facility (TSF) Cells 1 and 2. Cell 1 has now been covered with a clay to suppress tailings dust. Cell 2 is receiving tailings waste from the Mine, but was also storing more water than it should in May 2011

Tailings dust blown from surface of TSF Cell 1 has been an issue during previous audits, and has been contaminating stream sediments in Surprise Creek. However, further dust generation has now been mitigated by the completion of a clay cap which covers the dried tailings in TSF Cell 1 (see photo top of Page 1).

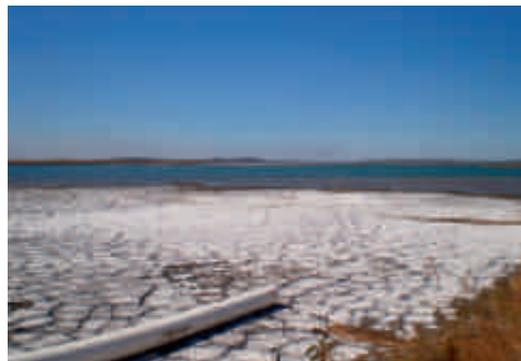
The volume of water held within TSF Cell 2 is again of concern this audit period. At the water levels we observed in May this year, the TSF would not be able to contain additional rainfall water if a 1 in 200 year rainfall event were to occur, which could lead to the instability of the TSF walls or contaminated water overtopping spillways.

Tailings 'beach' recently deposited at the edge of TSF Cell 2, with excess water in the background - Photo taken in May, 2011.

MRM have since reduced the water level in the TSF through evaporation on tailings beaches (see photo left), through evaporative fans, and water recycling at the Mine site. We will continue to monitor this issue closely over the next monitoring period.

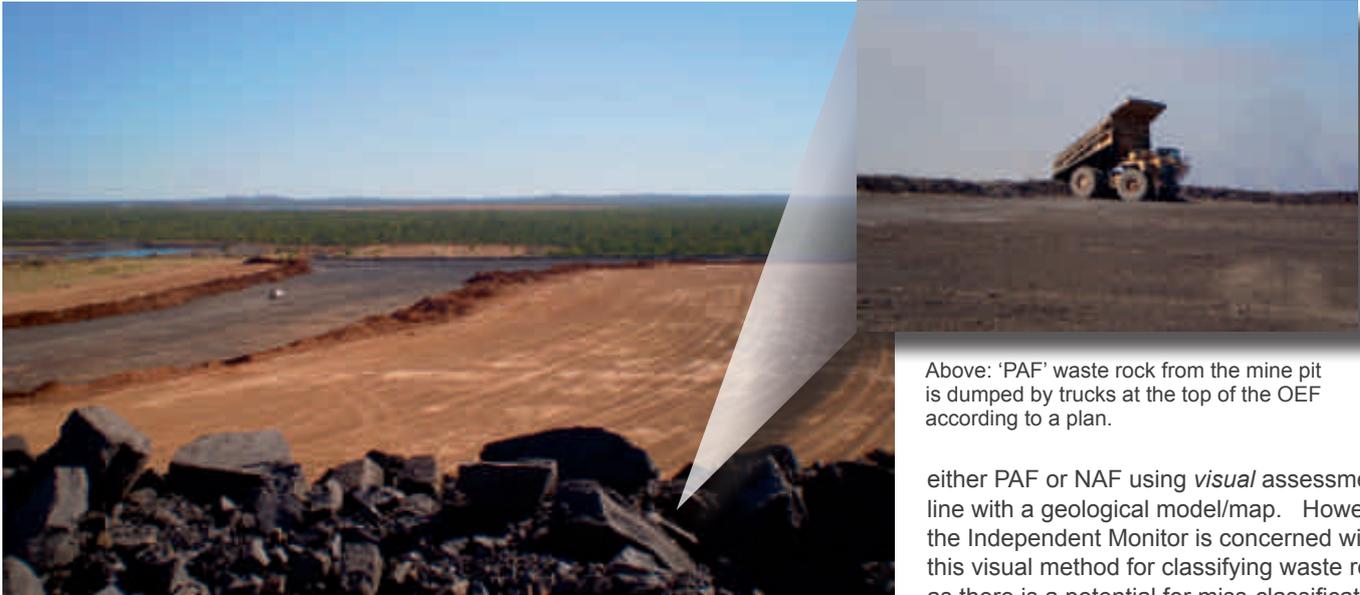
View from the top of the OEF looking at the clay base, with waste rock piled in the foreground.

Waste rock from the mine pit is placed in the '**Overburden Emplacement Facility**' (OEF). This facility will be a permanent structure that can produce acid leachate or become unstable in future if not managed appropriately.

The OEF design must minimise acid generation by stopping rainwater infiltrating through the PAF rock. It does this by placing a clay layer over the top of the PAF material and at the base of the OEF (see photo top left). Only part of the clay cover was completed at the time of our inspection, and we have recommend that it be completed and armoured prior to the heavy rainfalls of the wet season. A careful watch of the clay placement also needs to be maintained so that the correct thickness is achieved.

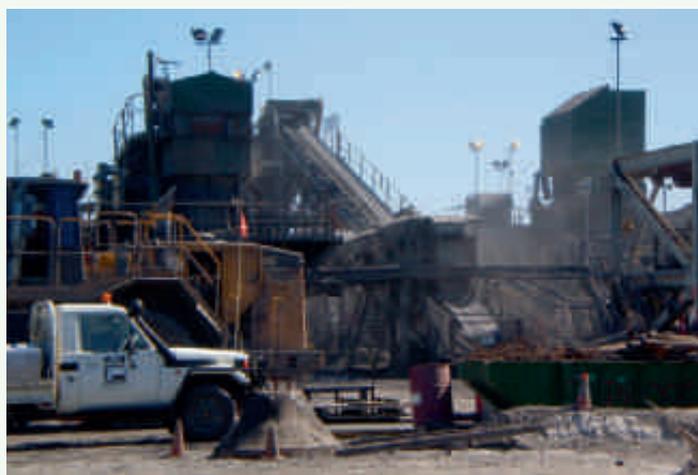
The 'PACRIM' ore crushing plant is the primary source of contaminated dust generated at the Mine site. Dust needs to be further reduced here.

The ore crushing machinery at the Mine site known as the 'PACRIM' (see photo left) is the primary source of contaminated dust at the Mine. Water sprays are being used throughout the crushing system, however, lead and zinc dust is still escaping from this area and settling over the nearby landscape. The laboratory results from nearby dust monitoring gauges on the Barney Creek floodplain indicate that the amount of contaminated dust has not improved.

Further efforts to control fugitive dust emissions are needed at the Mine site, particularly in the PACRIM area to avoid further unnecessary contamination. However we do note that zero dust emissions may not be possible at this facility.

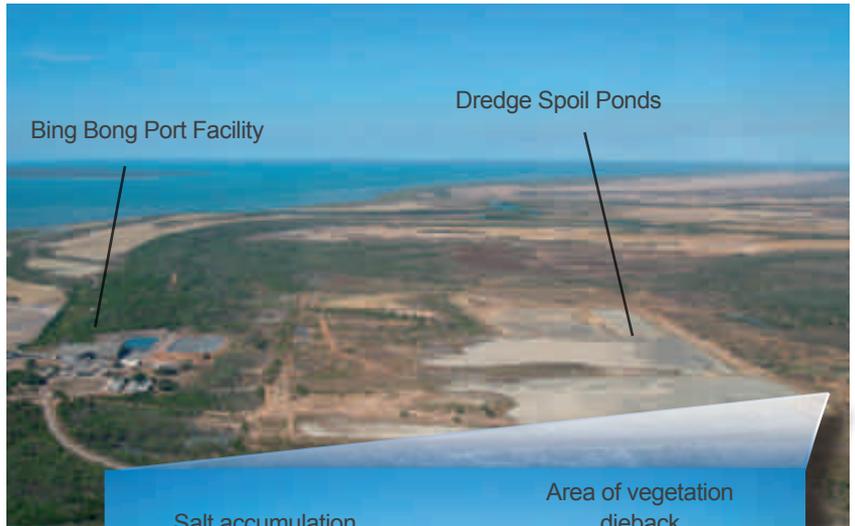
Vegetation affected by dredge spoil seepage

Vegetation dieback surrounding the dredge spoil has been caused by saline seepage from the spoil ponds. This has been an issue raised by the Independent Monitor in previous audits. In 2009, it was flagged as an urgent issue requiring immediate attention. In response, MRM constructed a spoon drain outside the dredge spoil walls to redirect saline seepage back out to sea and reduce the effects on the surrounding vegetation. The Independent Monitor has inspected the spoon drain in 2010 and 2011, and it appears to be effective (see photos right).

MRM continue to monitor salt levels in soil, and have been monitoring the areas of vegetation dieback through aerial survey photos of the dredge pond area. However, MRM has not provided any interpretation or discussion of the photos. We recommend that MRM compare yearly photographs to identify any quantitative changes in vegetation cover in salt-affected areas. Judging from our photographs and site inspections, there has been no significant visible increases in the vegetation coverage at this stage, but this is likely to be a slow process. We will continue to monitor this issue.

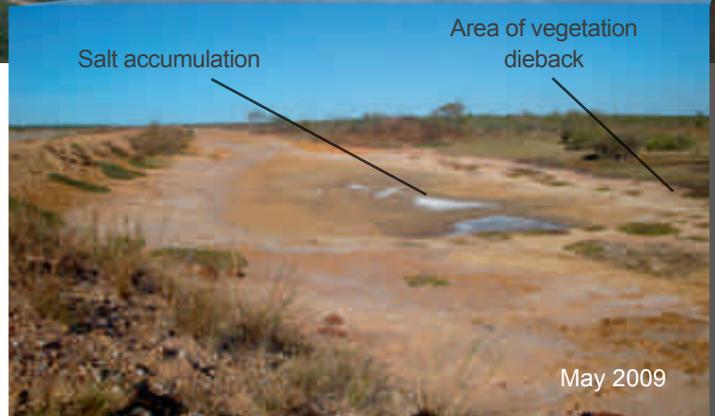
Dredge spoil wall stability

At the time of our site inspection in May 2011, the Bing Bong dredge spoil was dry, appeared to be stable and not likely to fail. However, there is still no information available regarding the geotechnical stability of the pond walls. We have recommend that MRM consider conducting a complete geotechnical review of the walls prior to the 2011/2012 wet season to determine their level of stability.

MRM have advised that further earthworks have recently been undertaken to clean out the spoon drain and repair the dredge pond walls prior to the 2011/2012 wet season.

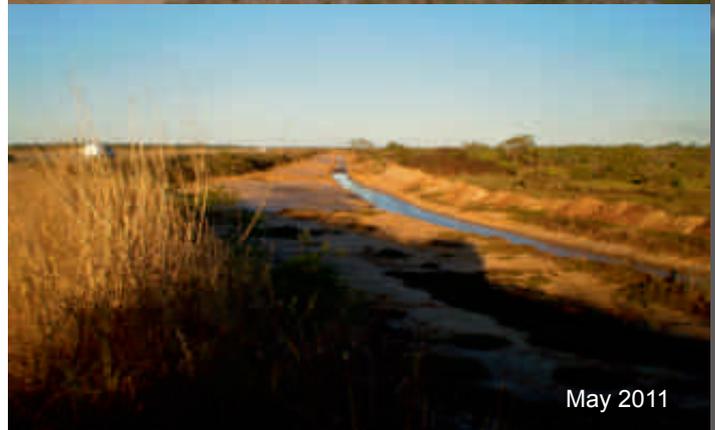
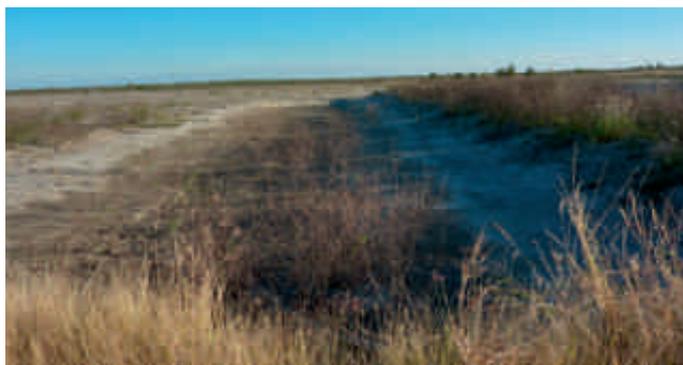
Above: Series of photographs taken in 2009, 2010 and 2011, showing the outer toe of the spoil ponds, with the spoon drain subsequently installed in late 2009 to redirect saline seepage out to sea.

Left: Dredge spoil revegetation plot trial area constructed on the dredge spoil by MRM in preparation for a PhD student study, which has not yet eventuated.

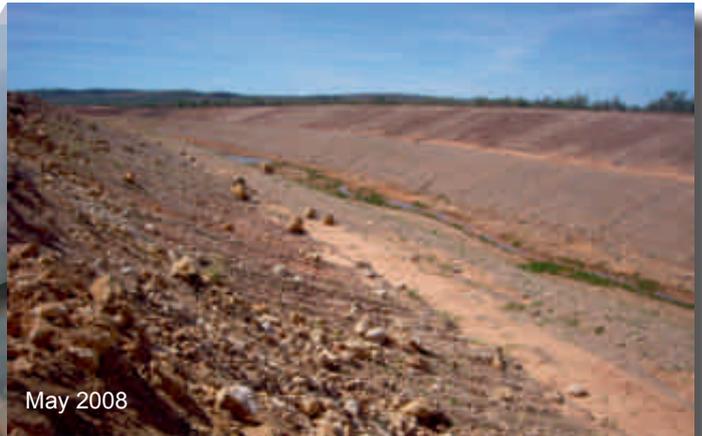
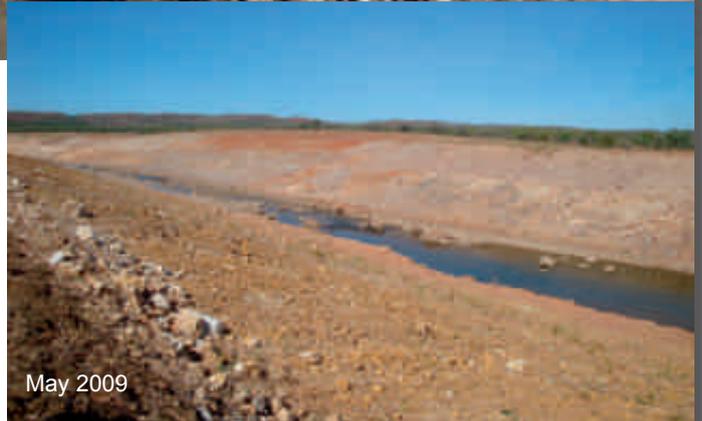
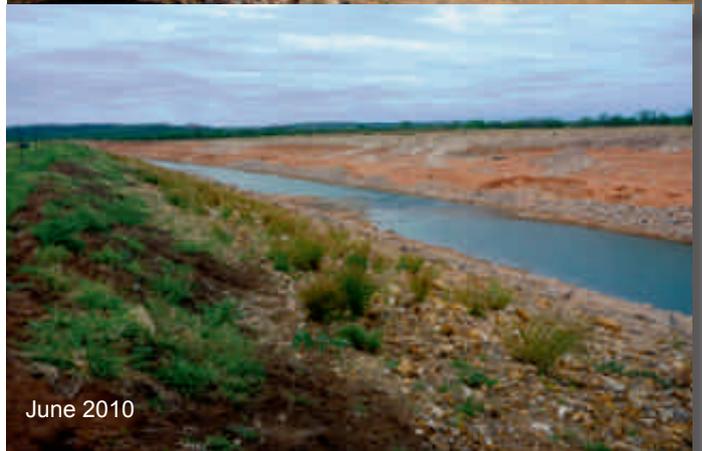
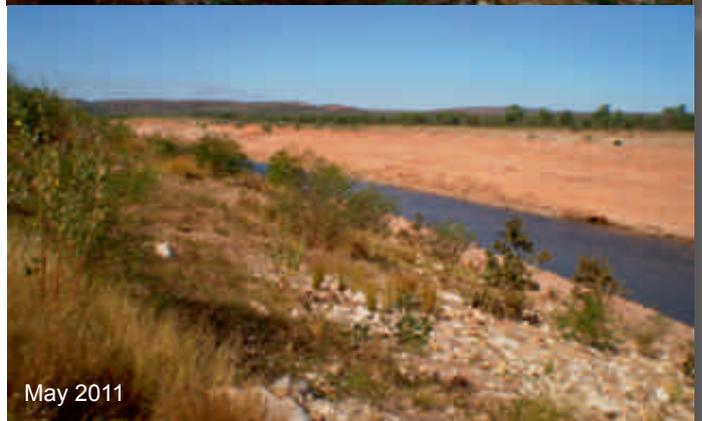
Above: Progressive establishment of vegetation on the mine side of the McArthur River Diversion from 2008-2011. Revegetation is improving, however further works downstream and on the opposite bank are required in coming years.

Revegetation has only been undertaken on the mine-side bank of the diversion at this stage, and the opposite bank still remains un-vegetated. Furthermore, most of the revegetation efforts have been undertaken on the upstream section of the McArthur River Diversion. Due to access restraints caused by the recent wet season, the downstream section of the Diversion could not be inspected by the Independent Monitor this year.

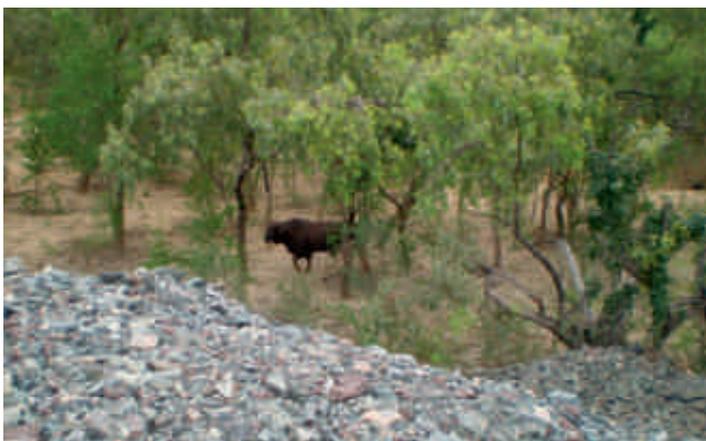
Cattle still remain to be a problem, as they trample revegetation efforts and cause river bank erosion when they enter the site through broken fences after the wet season. Sections of the perimeter fence have now been re-located away from flood waters, however, fence damage is still likely to occur seasonally. Any damage needs to be fixed rapidly after each wet season.

Left: Cattle also need to be kept away from areas undergoing revegetation.

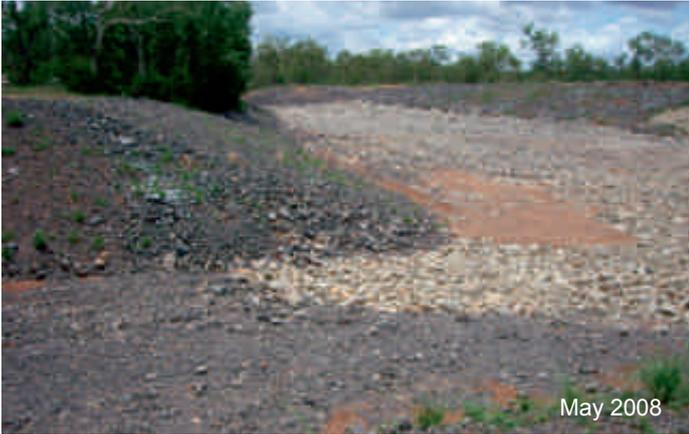
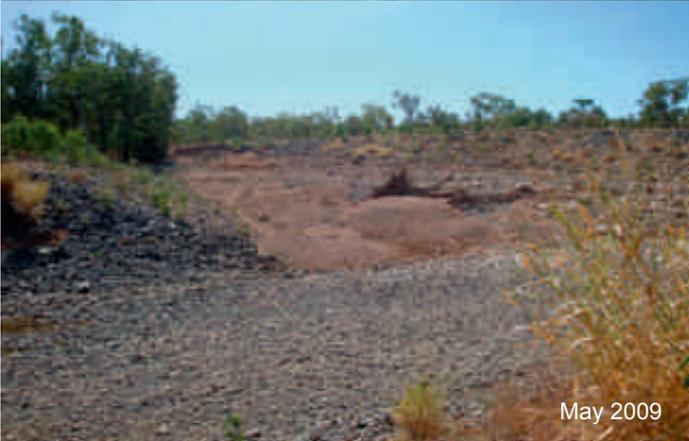
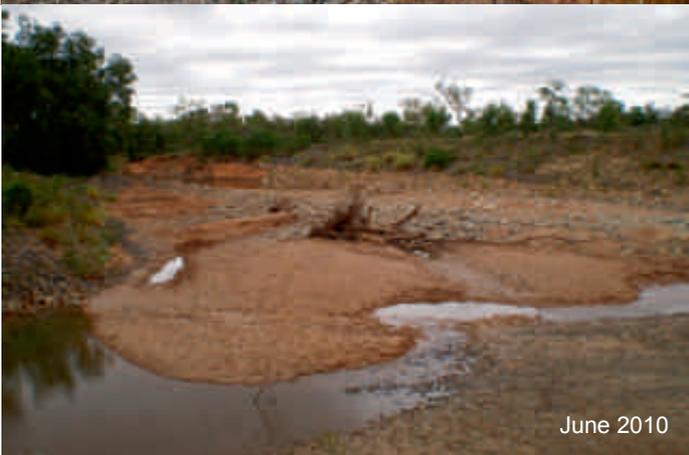
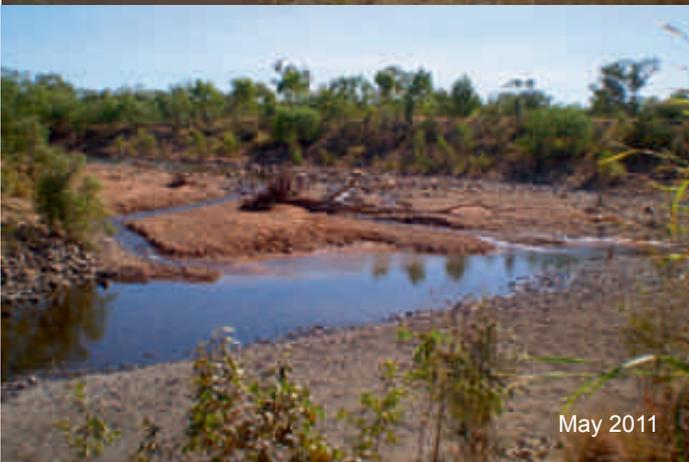
Re-vegetation of the Barney Creek Diversion is progressing well, as we have observed over the past four years of monitoring.

Barney Creek Diversion vegetation growth has continued to improve since the Independent Monitor's last inspection. We note that flood velocities are not as high along this part of Barney Creek, which have allowed for successful revegetation in this area. Also, this area was planted one year prior to revegetation at the McArthur River Diversion, so it exhibits additional growth.

Further revegetation efforts downstream in the Barney Creek Diversion are still required in coming years.

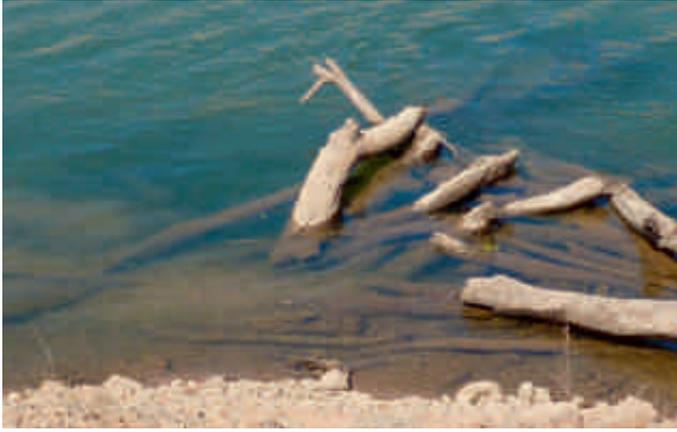
Woody debris placed in the river diversions provides essential shelter for fish.

Fish recaptures in the tagging program have begun to provide information on fish movements. The placement of woody debris also appears to be improving habitat for fish in the McArthur River Diversion. We observed approximately 10 fish species around one of these log jams during the May 2011 site inspection (see photo top left).

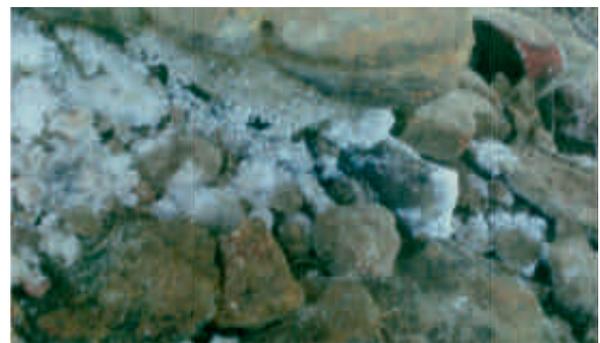
More white material was reported at the Surprise Creek Bridge in December 2010 by the Environment Centre NT (see photo right). The area of impact was inspected by the DoR on 13 December 2010, yet the DoR officers inspecting the area observed only minor amounts of white material (likely to be salt) on rocks along the bank of the Creek. The DoR advised MRM that this area should be added to the MRM monitoring program.

Photograph of white material in Surprise Creek taken by a member of the Environment Centre NT. The photograph was sent to the Department of Resources, and was investigated by MRM and the DoR in December 2010.

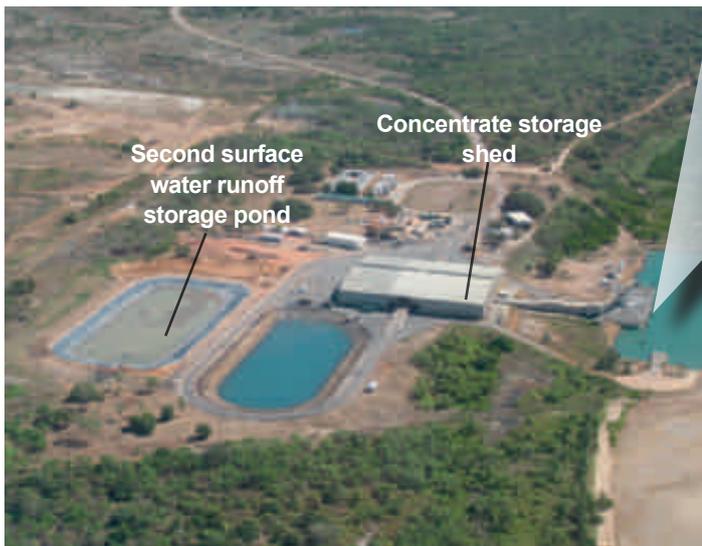
The main source of contaminated dust at Bing Bong Port comes from the concentrate storage shed. This year we observed that the doors to the shed still remain open, which is necessary to avoid gas-build-up in the shed. We have previously recommended that the doors to the shed remain shut to stop lead/zinc dust being carried by wind and contaminating the surrounding soil and marine sediments.

Aerial photograph of the Bing Bong Port Facility. Ore concentrate is stored in the large shed on site until it is loaded onto the Aburri Barge (photo right). As show above, a second surface runoff pond was constructed at Bing Bong in 2010 to store the large volume of runoff water from the site during the wet season. This runoff water is potentially contaminated with concentrate dust which escapes from the storage shed.

MRM have indicated that updates to the shed have now been approved, including an venting system, which will allow the shed doors to remain shut - these updates will begin in 2011.

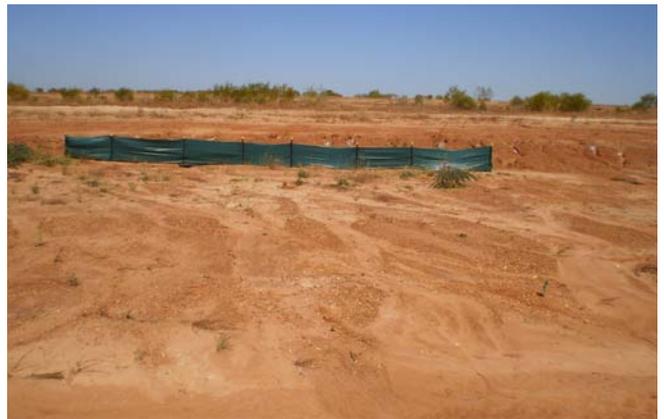
TSF Cell 1 Cap with mesh fence to stop erosion. The cap needs to be shaped next audit.

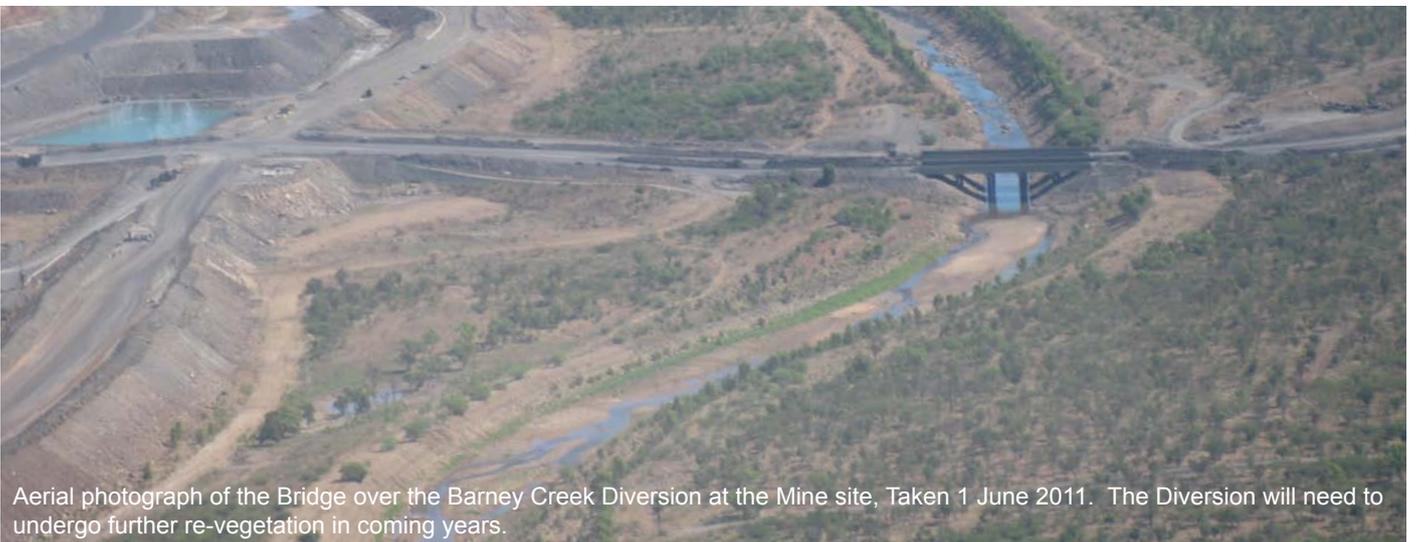
Aerial photograph of the Bridge over the Barney Creek Diversion at the Mine site, Taken 1 June 2011. The Diversion will need to undergo further re-vegetation in coming years.
