**Exploration Mining Management Plan and
Public Report**

MOLYHIL MINING PTY LTD

ML 23825, EL 22349 &
EL31443

2018 Update Report

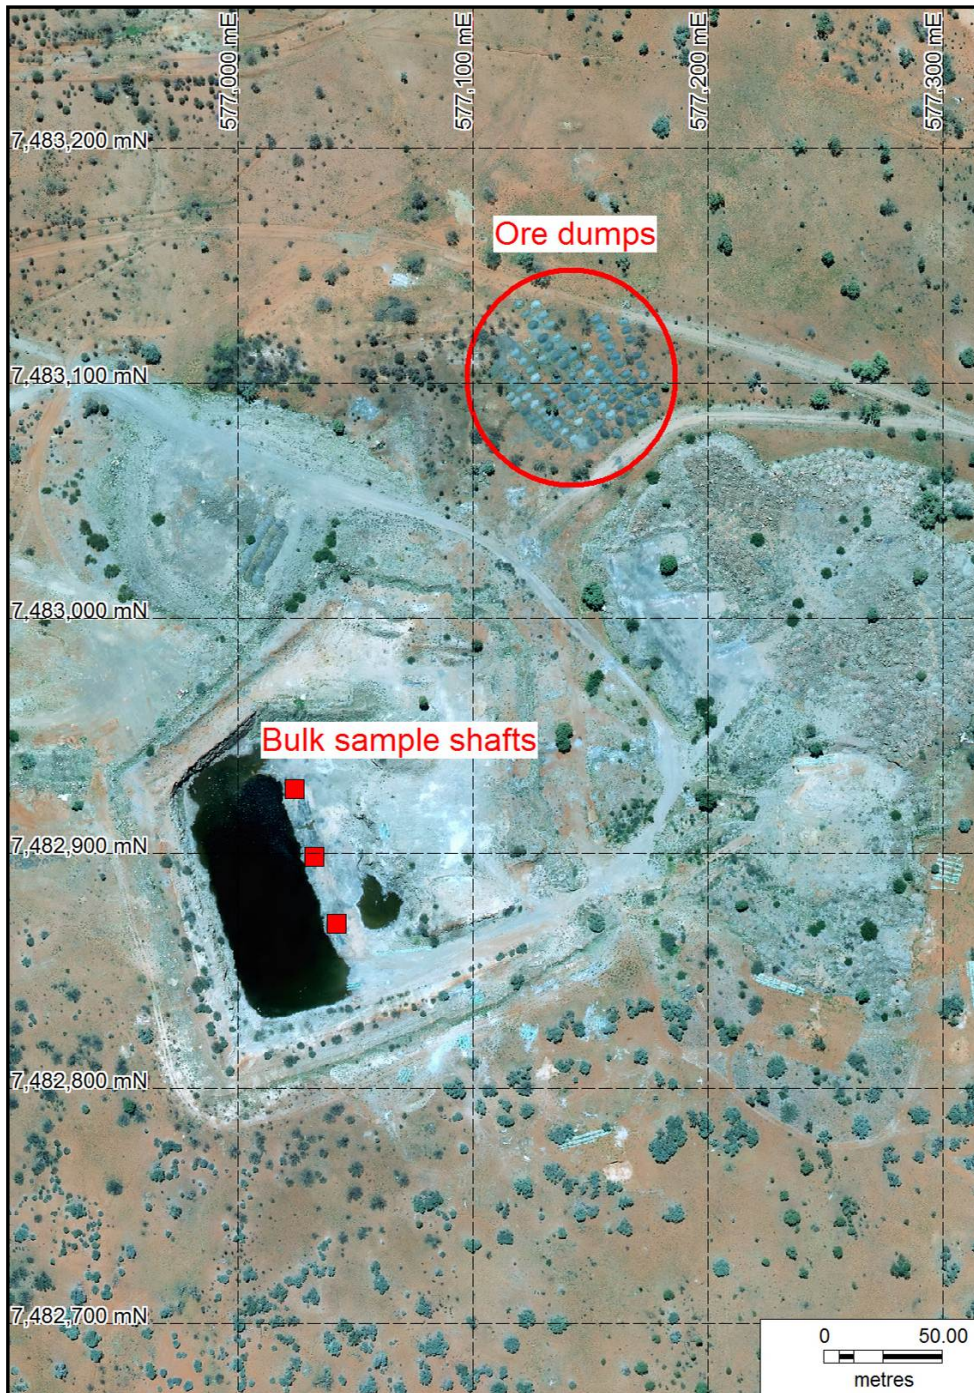
Figure 3: Bulk sample shafts and ore dumps at Molyhil

Material mined from the three shafts in the existing Molyhil pit remains stockpiled to the north east of the pit (Figure 3). Removal of this material to back fill the shafts has been allowed for in the current rehabilitation bond.

The shafts were sunk with a cross sectional dimension of 2.0x1.5 metres to depths of 24, 33 and 39 metres giving a combined volume of 294m³. The 100 dumps situated to the north east of the current pit have a total combined volume of approximately 250 m³ thus; there is sufficient room for all of the waste to be tipped into the shafts.

The 100 dumps comprise approximately 30 dumps of unmineralised waste, 40 dumps of weakly mineralised waste and only 30 dumps of ore. Backfilling the shafts will be undertaken such that the ore is tipped first followed by the weakly mineralised waste and topped off by the unmineralised waste. There should be several metres of unmineralised waste covering the weakly mineralised ore.

In the event that the Molyhil mine project does not go ahead, and the three shafts require rehabilitation, the method to backfill the shafts would comprise removing the steel covers and tipping the stockpiled material down the shafts.

If there is insufficient room in the shafts for all of the dump material, the surplus material will be tipped into the bottom of the pit. If there is insufficient material in the dumps to fill the shafts completely then unmineralised waste from within the pit will be used to ensure the shafts are filled and compacted.

The fill will be mounded above the ground surface to allow safe compaction by wheel rolling. The final profile will be mounded in the event of any subsequent additional settling of the fill. Water displaced from the shafts during filling will flow into the bottom of the pit and be contained within the pit.

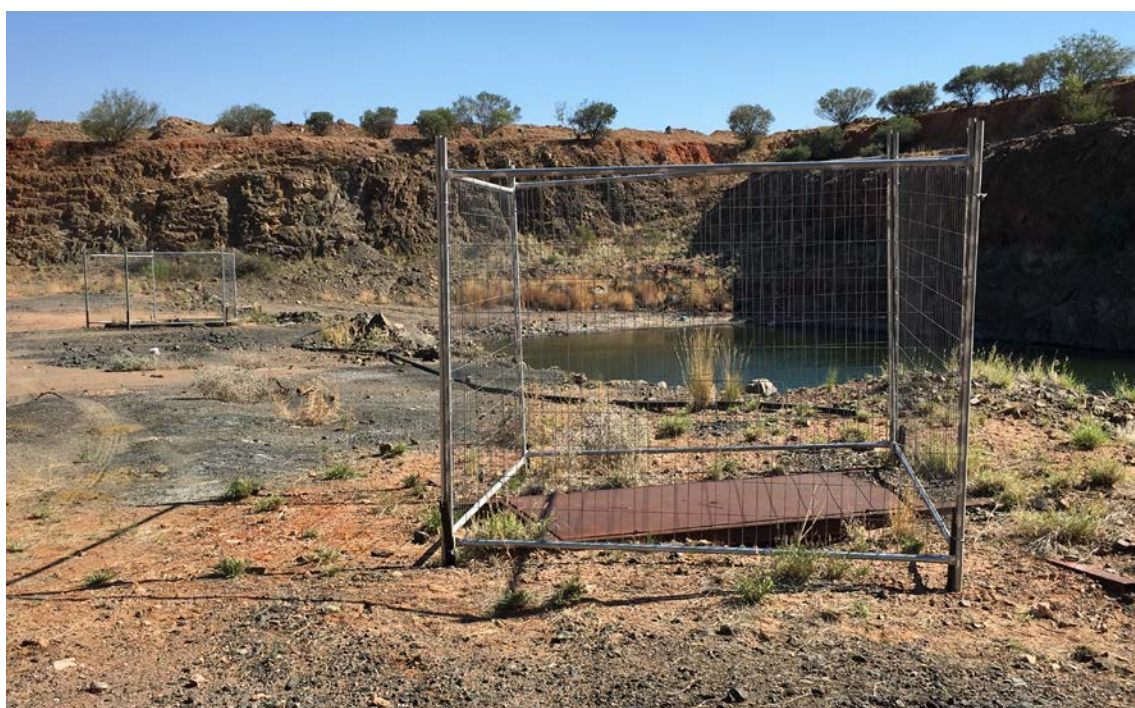
Figure 4: Barricading erected on two northern most bulk sample shafts in Molyhil pit.

In December 2017, barricades were erected around the two of the three bulk sample shafts which were collapsing resulting in a safety hazard. The third, southern most shaft remains in good condition and required no further barricading (Figure 4).

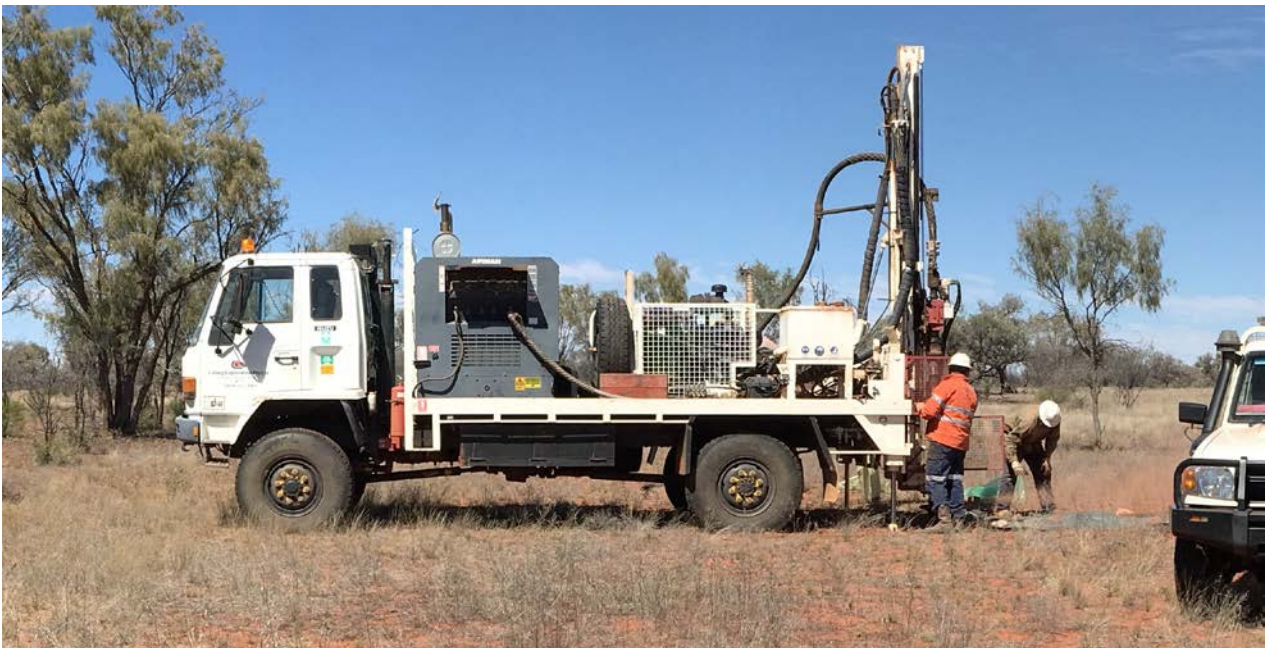
Plate 1: Light weight drill rig from 2016 bedrock geochemistry program

- Holes will be in the order of 5 to 15 metres deep – No casing or collars will be left in any holes.
- Drilling, sampling and backfilling of each hole will take in the order of an hour using small 4WD drilling equipment similar to the 2016 drill program (Plate 1).
