# TODD RIVER RESOURCES

## MINING MANAGEMENT PLAN (MMP)

## MOUNT HARDY PROJECT

December 2018

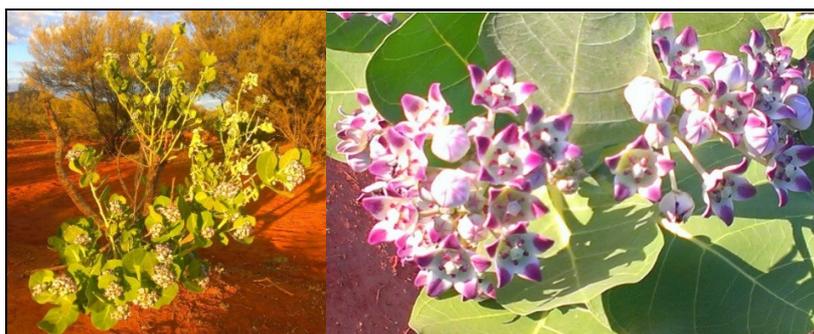
Rubber Bush (*Calotropis procera*) has been located along Gap Creek. It is declared a weed (Class B & C) and its presence has been reported. An eradication programme was undertaken in April/May 2017 with limited further work being undertaken during the mid-year drilling programme. The best time to treat rubber bush is October to March and communication with the Landholder has resulted in the request to cut, burn and treat with diesel in order to avoid chemical use. A programme to control the spread and eradicate the population along Gap Creek will be undertaken at the beginning of the 2019 field season.

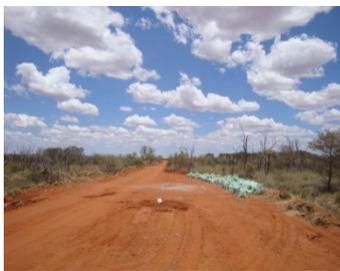
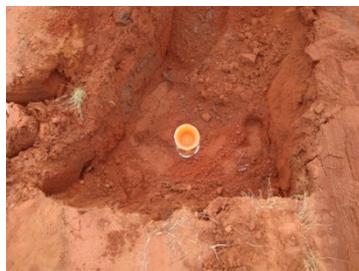
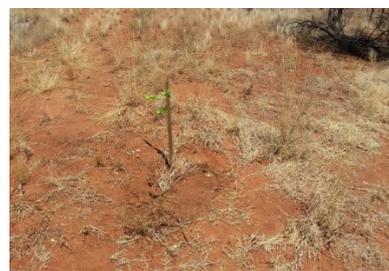
**Clarification of drill collar capping and plugging.**

Capped at completion of hole.    Dug out/cut/plugged during rehab.    After rehabilitation.

Disturbance	Rehabilitation Activities	Schedule (Timing)	Closure Objectives / Targets	Monitoring Techniques
<b>Drill holes</b>	Collars cut and plugged with plastic cone >40cm below ground level & mounded with topsoil (also see below).	Drill collars are temporarily capped with a plastic cone at the completion of the hole. The cone is then used to plug the drill collar during rehab.  Holes to be rehabbed within 6 months.	All holes safe prior to end of programme and site returned to pre-disturbance condition based on surrounding conditions.	Monitoring stations set up at specified sites and photographs and inspections undertaken annually. Currently three drillsites are monitoring stations.  Inspection will specifically target drill hole erosion and subsidence.  Remediation will be undertaken if drillhole subsidence or erosion is noted during site monitoring and inspections.
<b>Drill pads</b>	Rubbish collected and removed.  Recontoured and respread windrows. Pre-disturbance topography restored. Previously cleared vegetation is spread across the site.	On completion of drill hole.  In conjunction with drill hole rehabilitation – within 6 months of programme completion.	Site to return to pre-disturbance condition based on surrounding conditions.	Monitoring stations set up at a number of sites, photographs and inspections undertaken annually. Currently three drillsites are monitoring stations.  This will include inspection for weeds, erosion and native vegetation growth.  Remediation will be undertaken if erosion is taking place across the drill pad area or if surface water flow has results in gullies forming.
