Independent Monitor **COMMUNITY REPORT**

McARTHUR RIVER MINE

November 2018

Environmental Performance 2017-2018

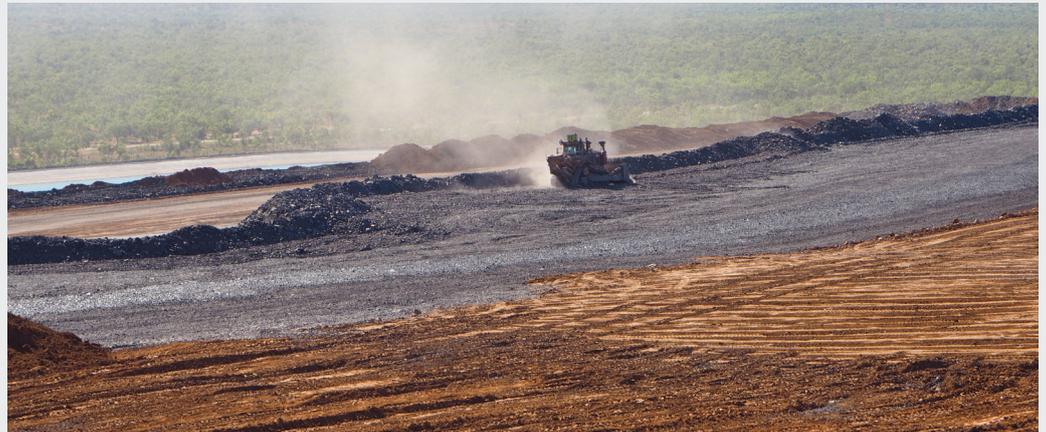
Bulldozing PAF Cell - NOEF

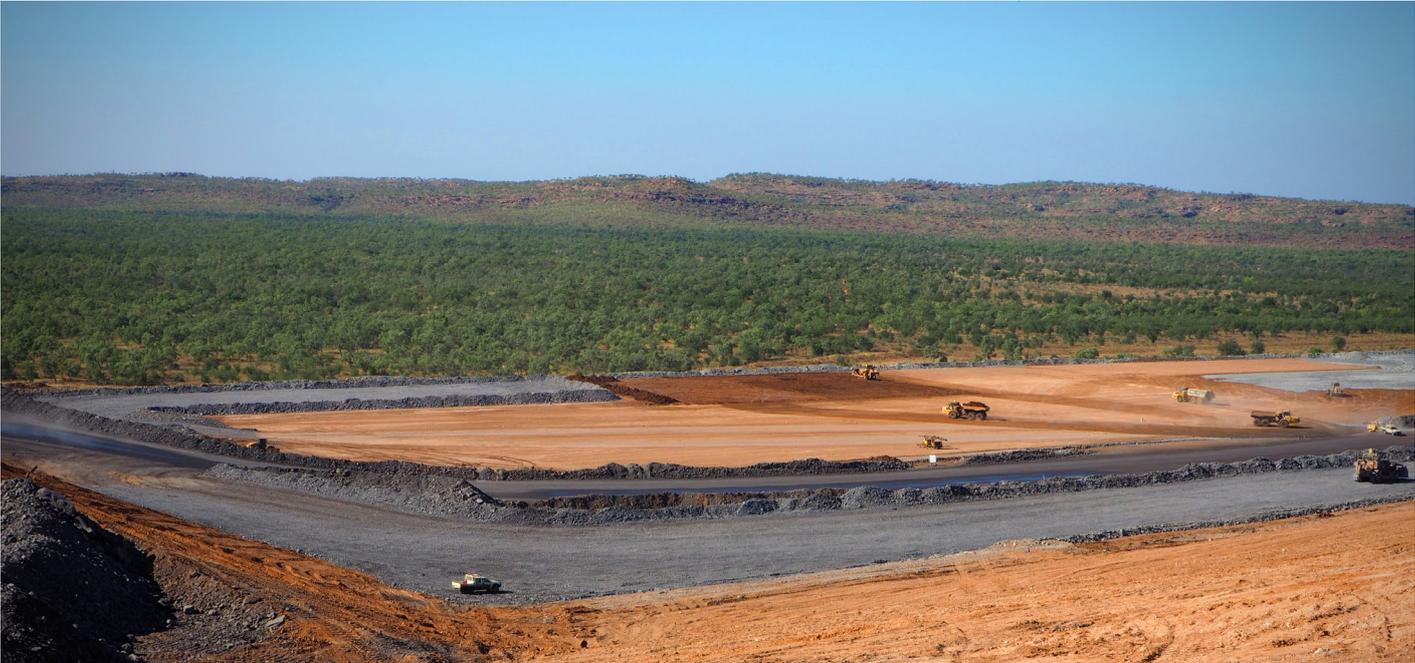
Construction Activities on Central West Stage of the NOEF

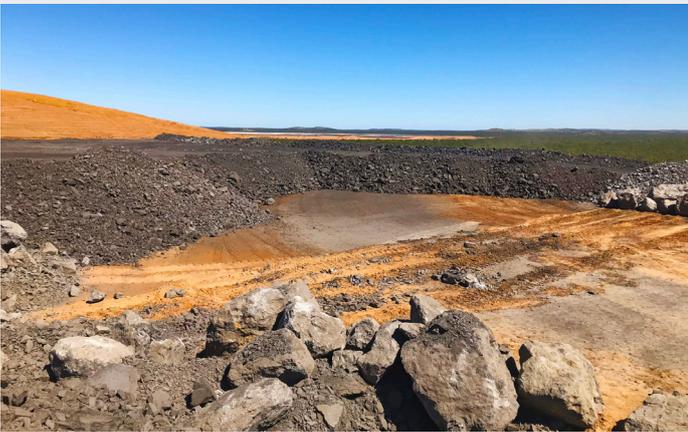
2-m Dumped PAF Rock Ready for Compaction

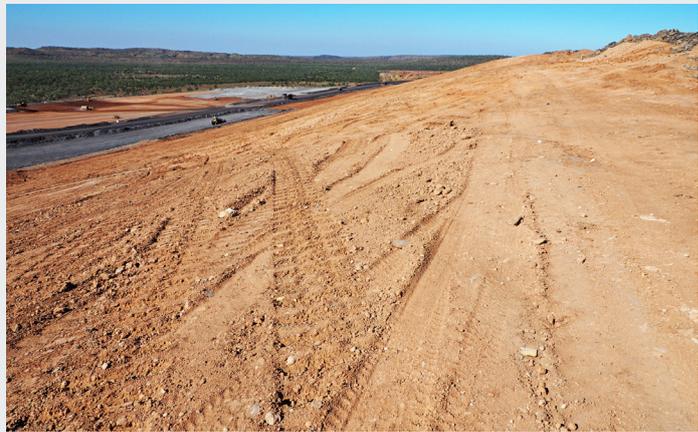
Interim Barrier to Help Prevent Transfer of Heat Between Older Dump Area and New Central West Stage

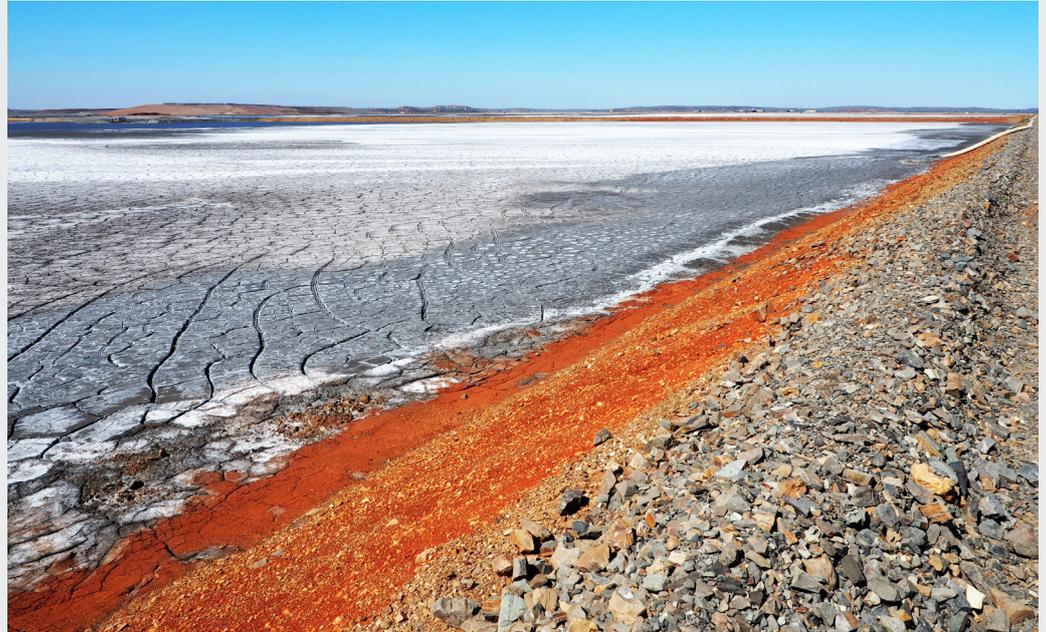
Salt Crusting on the Surface of TSF Cell 2

Management of Cell 1 and Cell 2 has not changed from the last IM report. Management of seepage from Cell 1 relies primarily on repair of a temporary and eroded 500-mm clay cover over the tailings before each wet season, with various drains and sumps in place to direct and handle the runoff.

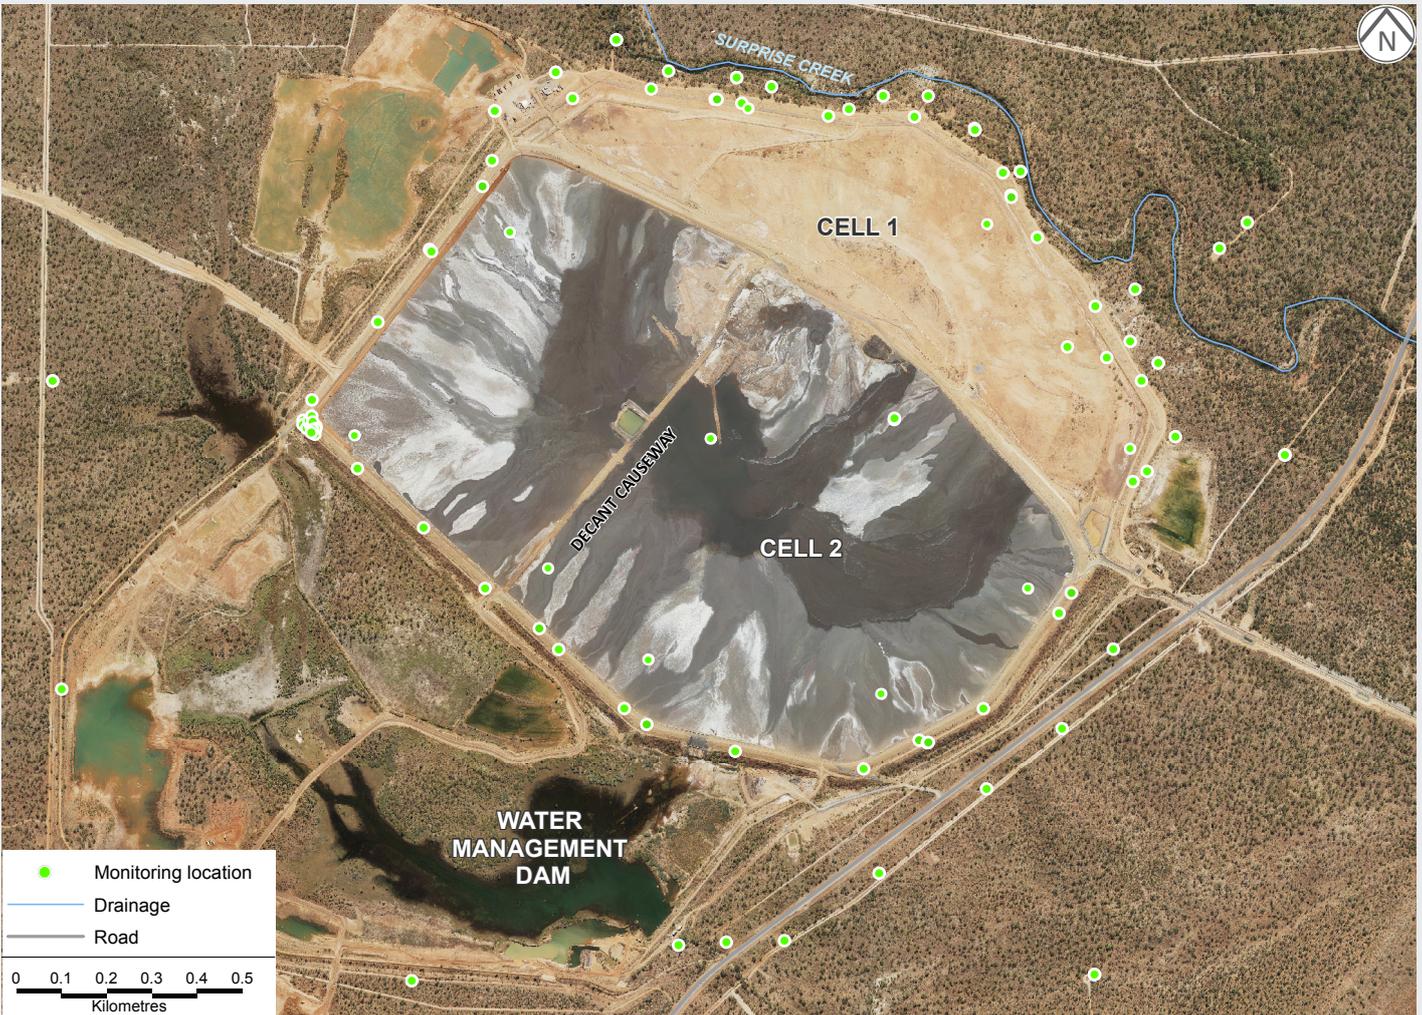
Overview of TSF Showing Locations of Monitoring Sites

- Undertake further field investigations to better identify groundwater pathways around the TSF.
- Use an updated conceptual model to revise the TSF groundwater model and then estimate current and future seepage impacts and suitable mitigation options.

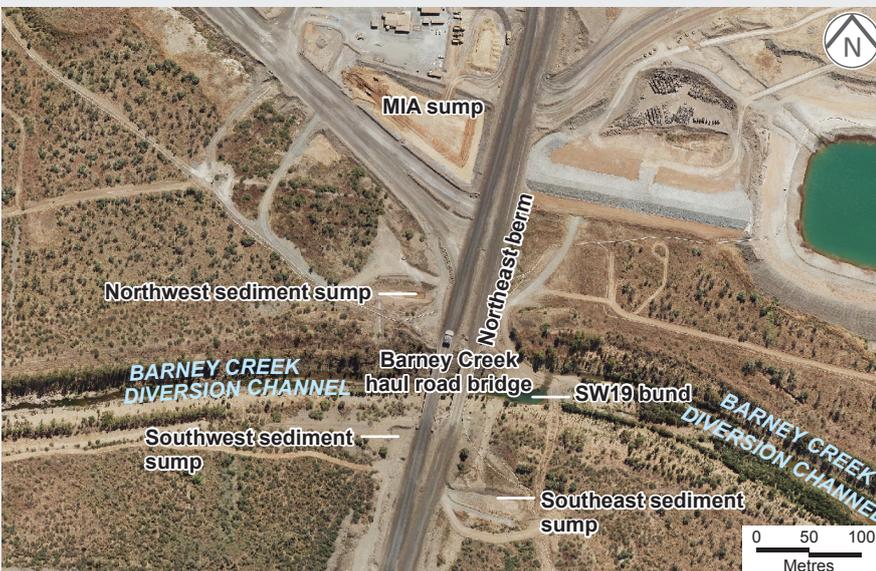
Sediment Control Structures Near Barney Creek Haul Road Bridge

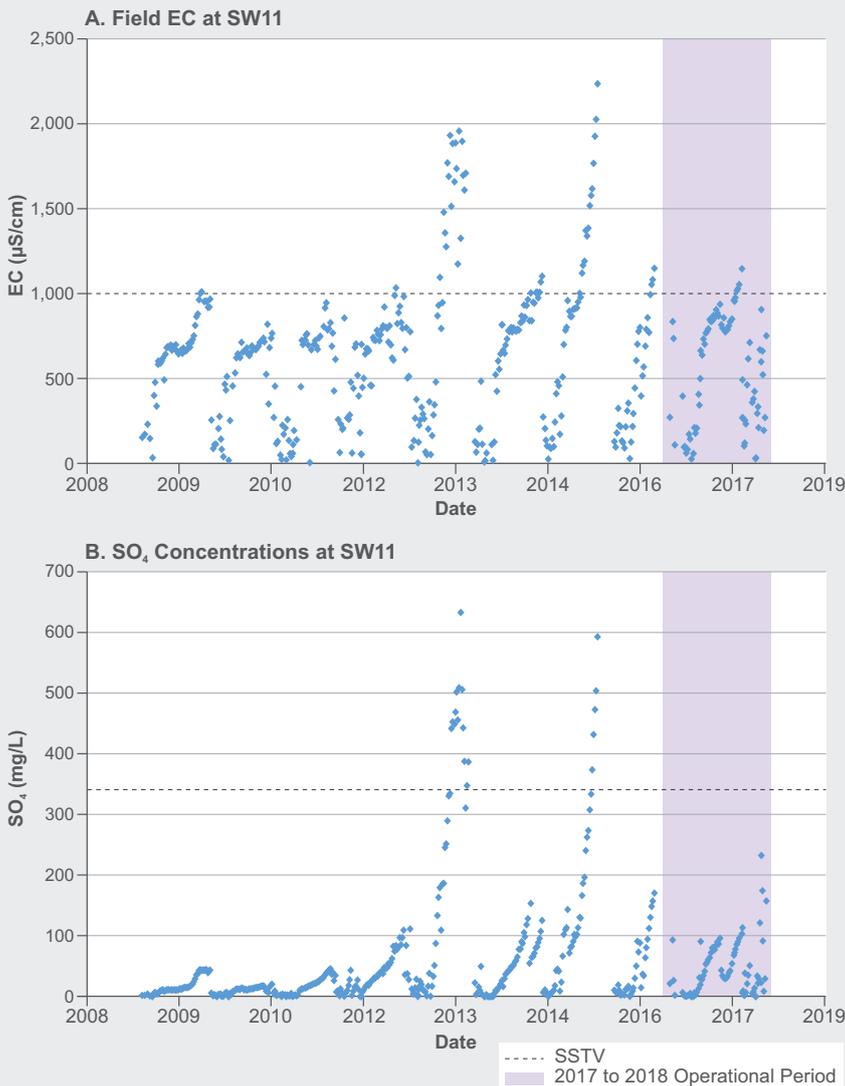
- Compliance with trigger values at SW11 has improved, particularly in relation to electrical conductivity (EC) and sulfate (SO₄).
- McArthur River diversion channel water quality in the 2016 and 2017 dry seasons improved compared with that in the previous dry season.
- The monitoring program provided a suitable basis for MRM's water management decisions.

EC Levels and SO₄ Concentrations at SW11 Over Time

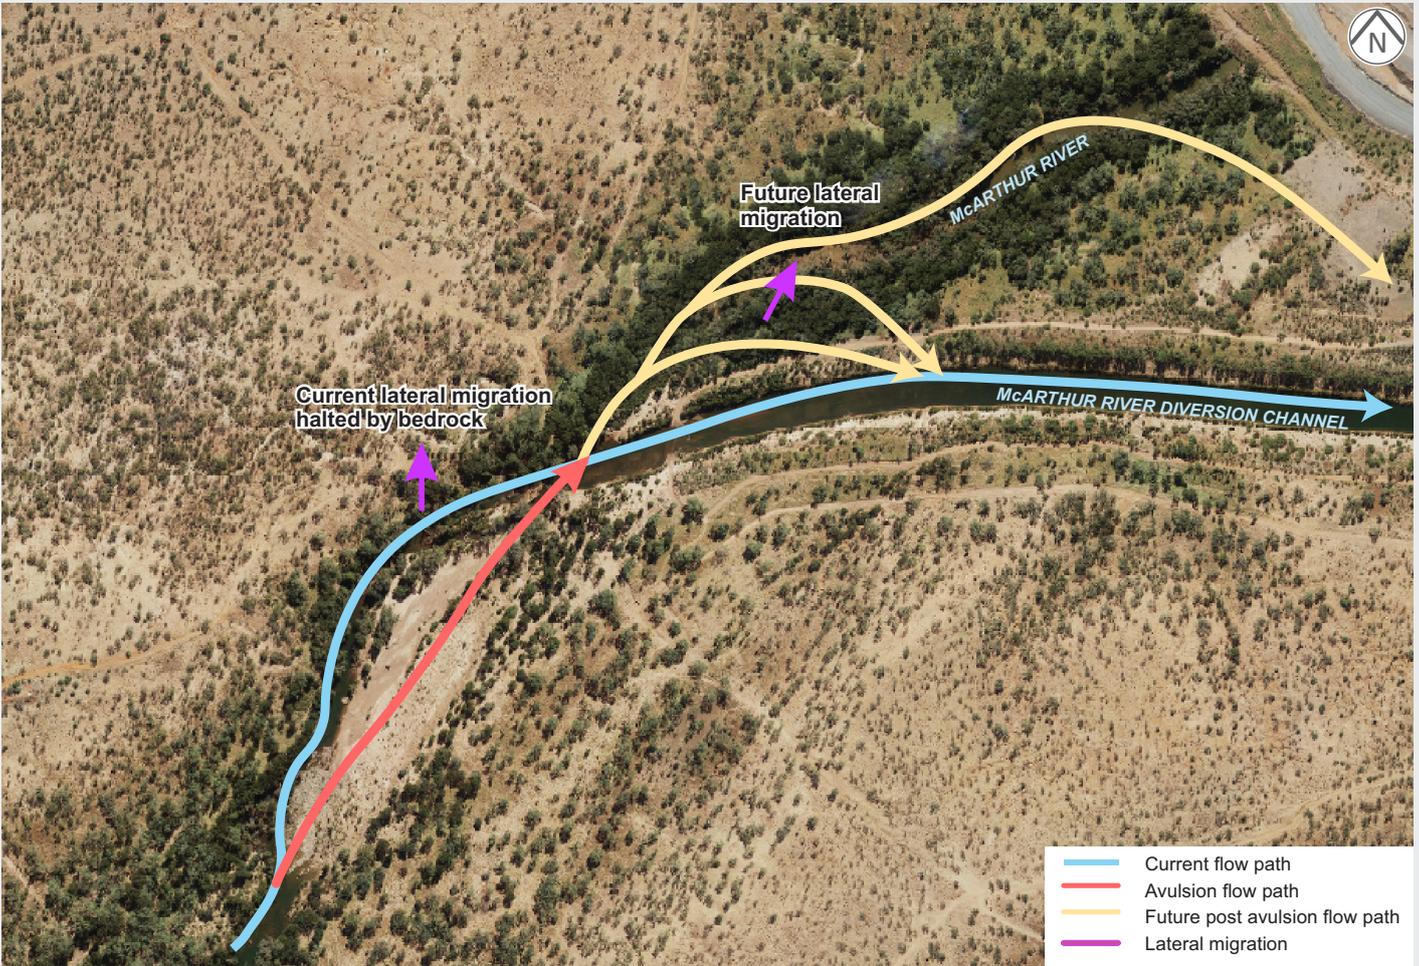
McArthur River Diversion Channel Offtake – Potential Future Flow Paths
Source: WRM, 2018a.

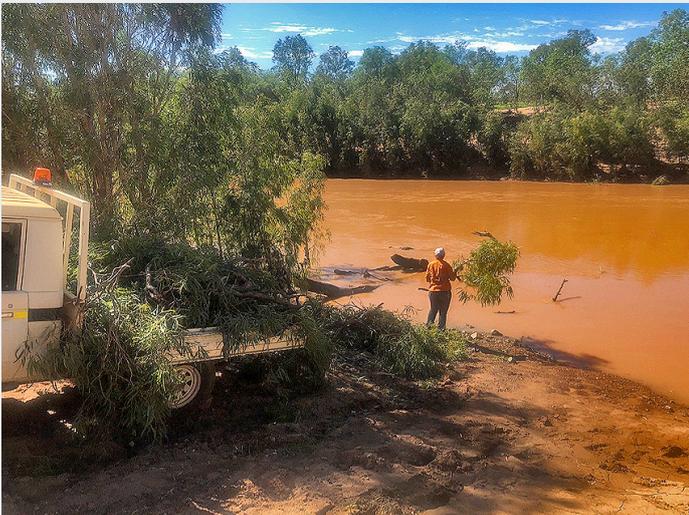
During 2017, 12 truckloads of large woody debris (LWD) were added to the diversion channel, and MRM started documenting the persistence of LWD as part of annual monitoring. A new program of adding small and medium-sized woody debris was also initiated in 2018. It is intended that smaller debris will contribute organic matter, and that the combination of sizes will create more complex habitats.

Small Woody Debris Being Placed into the McArthur River Diversion Channel

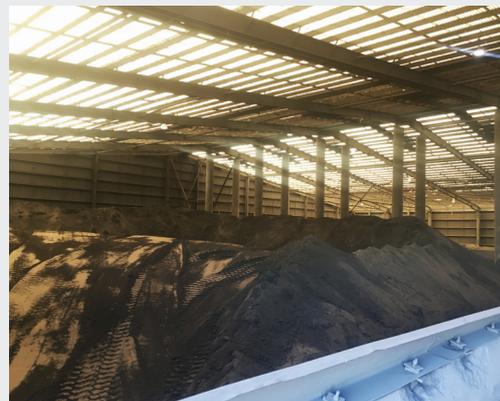
Concentrate (Mine Product) in the Bing Bong Loading Facility Storage Shed

- The main doors of the concentrate shed have not been able to be closed for at least the past five years. This is a likely cause of dust issues in the local area, and the IM recommends they be replaced as soon as possible. Related to this, the shed's dust extraction system requires repairs and cannot function effectively until the doors are functional.
- The bitumen surface surrounding the loading facility has been in need of repair for several years, and should be repaired to avoid dust and potential for contamination of underlying soils – MRM plan to do this during 2018.
- Analysis of collected dust monitoring data is required to identify causes of data trends and address issues as they arise.
