Independent Monitor
ENVIRONMENTAL
PERFORMANCE
ANNUAL REPORT
2014

McARTHUR RIVER MINE

OCTOBER 2015
Report No. 01164A_3_v2

**Independent Monitor
Environmental Performance Annual Report
2014**

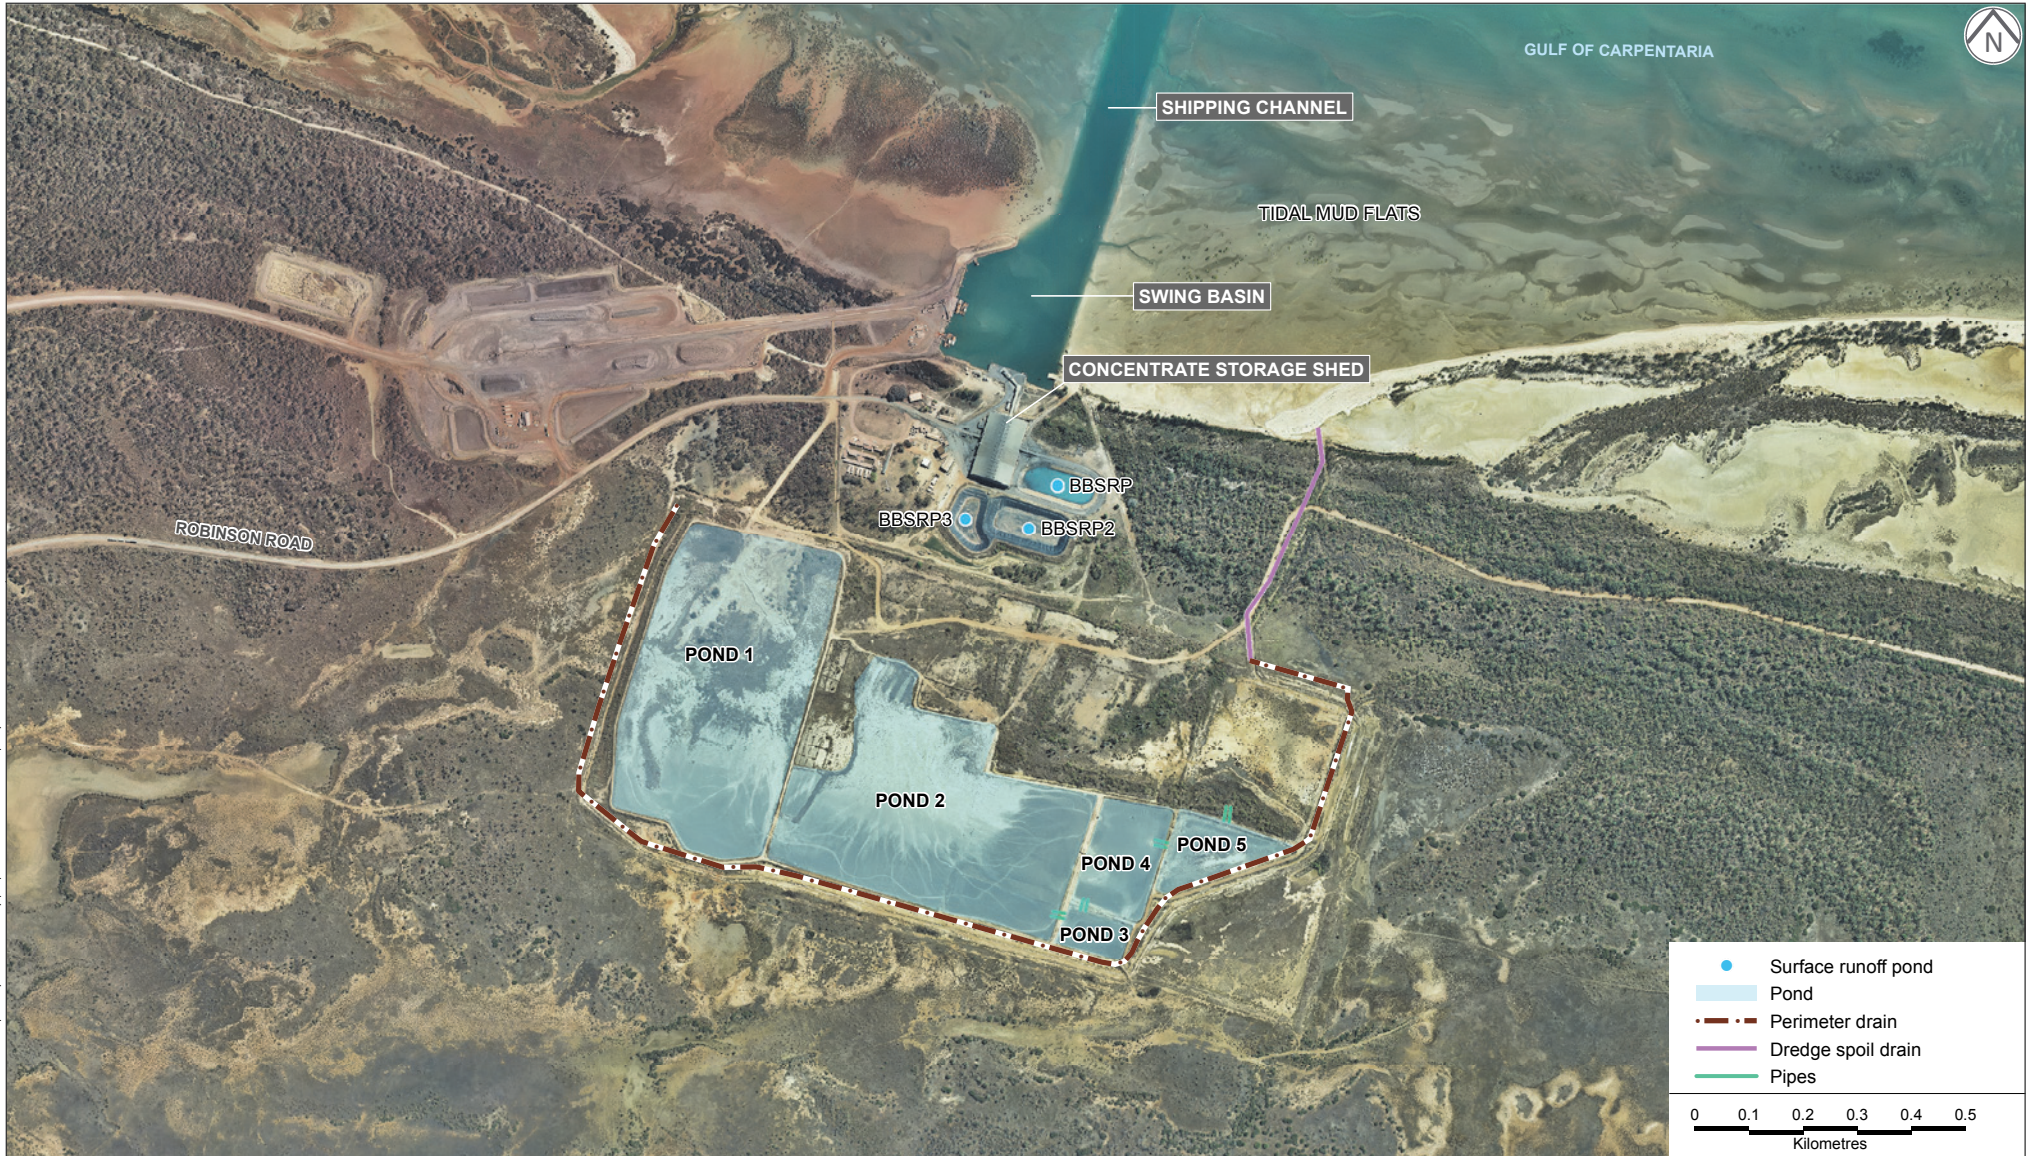
FIGURE 4.3

- ◆ Artificial surface waters – Sampling sites are shown in Figure 4.5 for the 2013-2014 monitoring period (one runoff pond and three sites along the dredge spoil perimeter drain¹³ (DSD)). Sampling is generally on a monthly basis, subject to dry season conditions. Both in situ (pH, temperature, DO, EC, turbidity) and laboratory (TDS, TSS, other ions and filtered (<0.45 µm) trace metals) analysis is undertaken. Figure 4.3 shows site BBDDP, which is the authorised discharge point specified in the WDL.

Although the WDL specifies application of ANZECC/ARMCANZ (2000) trigger values to BBDDP (see Figure 4.3) as a statutory compliance point, this effectively means that ambient water quality guideline values are applied to the discharge from the dredge settling ponds. Evaluation of data from the swing basin and navigation channel is more likely to provide an indication of environmental performance in terms of the protection of these beneficial uses. This approach has therefore been adopted in this report (which is consistent with the approach adopted by MRM and last year's IM report), as reflected in the second dot point above.

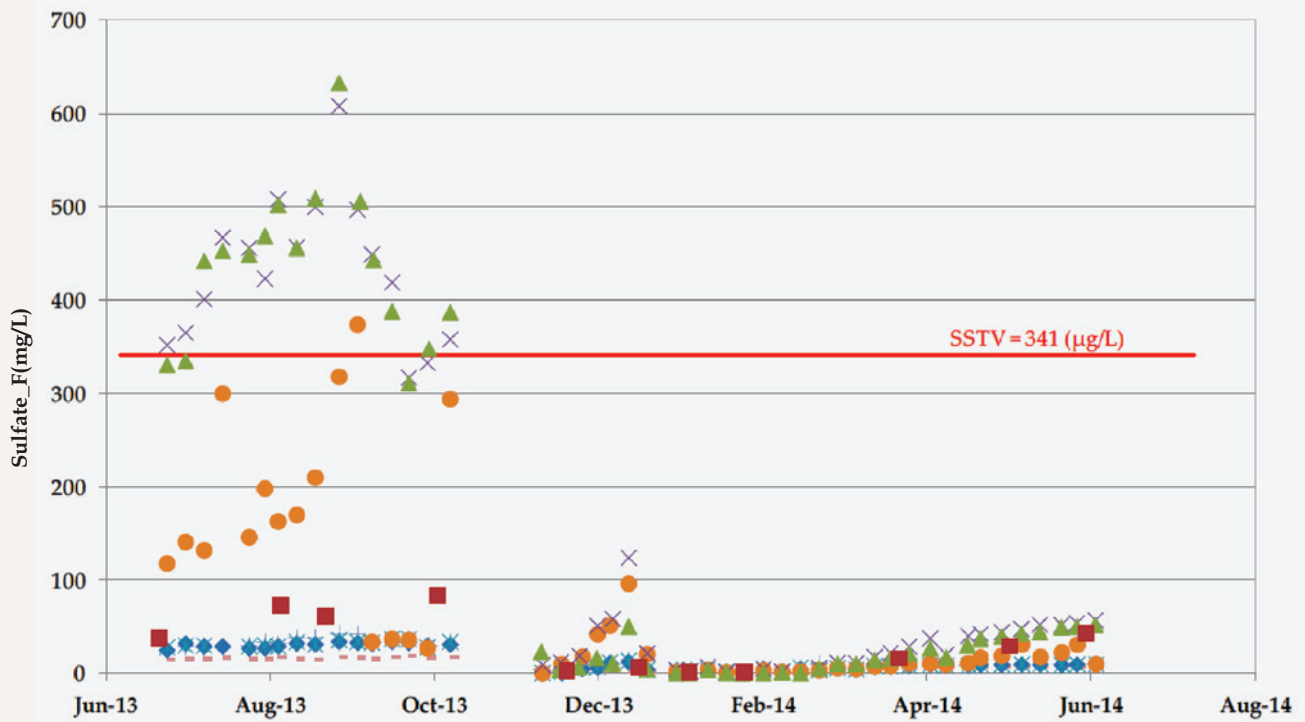
A. Laboratory electrical conductivity measured at upstream and downstream sites along the McArthur River

B. Concentration of sulfate in the McArthur River

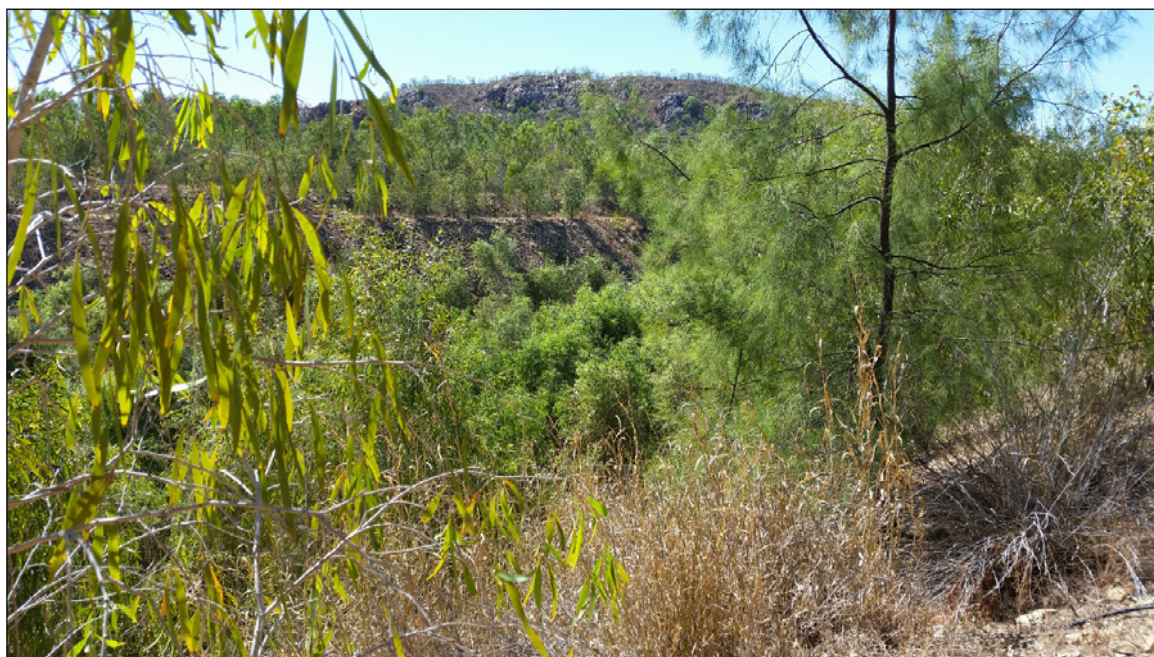
Plate 4.1 – Vegetation Along the Barney Creek Diversion Channel

- ◆ A plan in place to commission a full assessment of McArthur River diversion channel erosion is excellent and will contribute to establishing a plan for management.

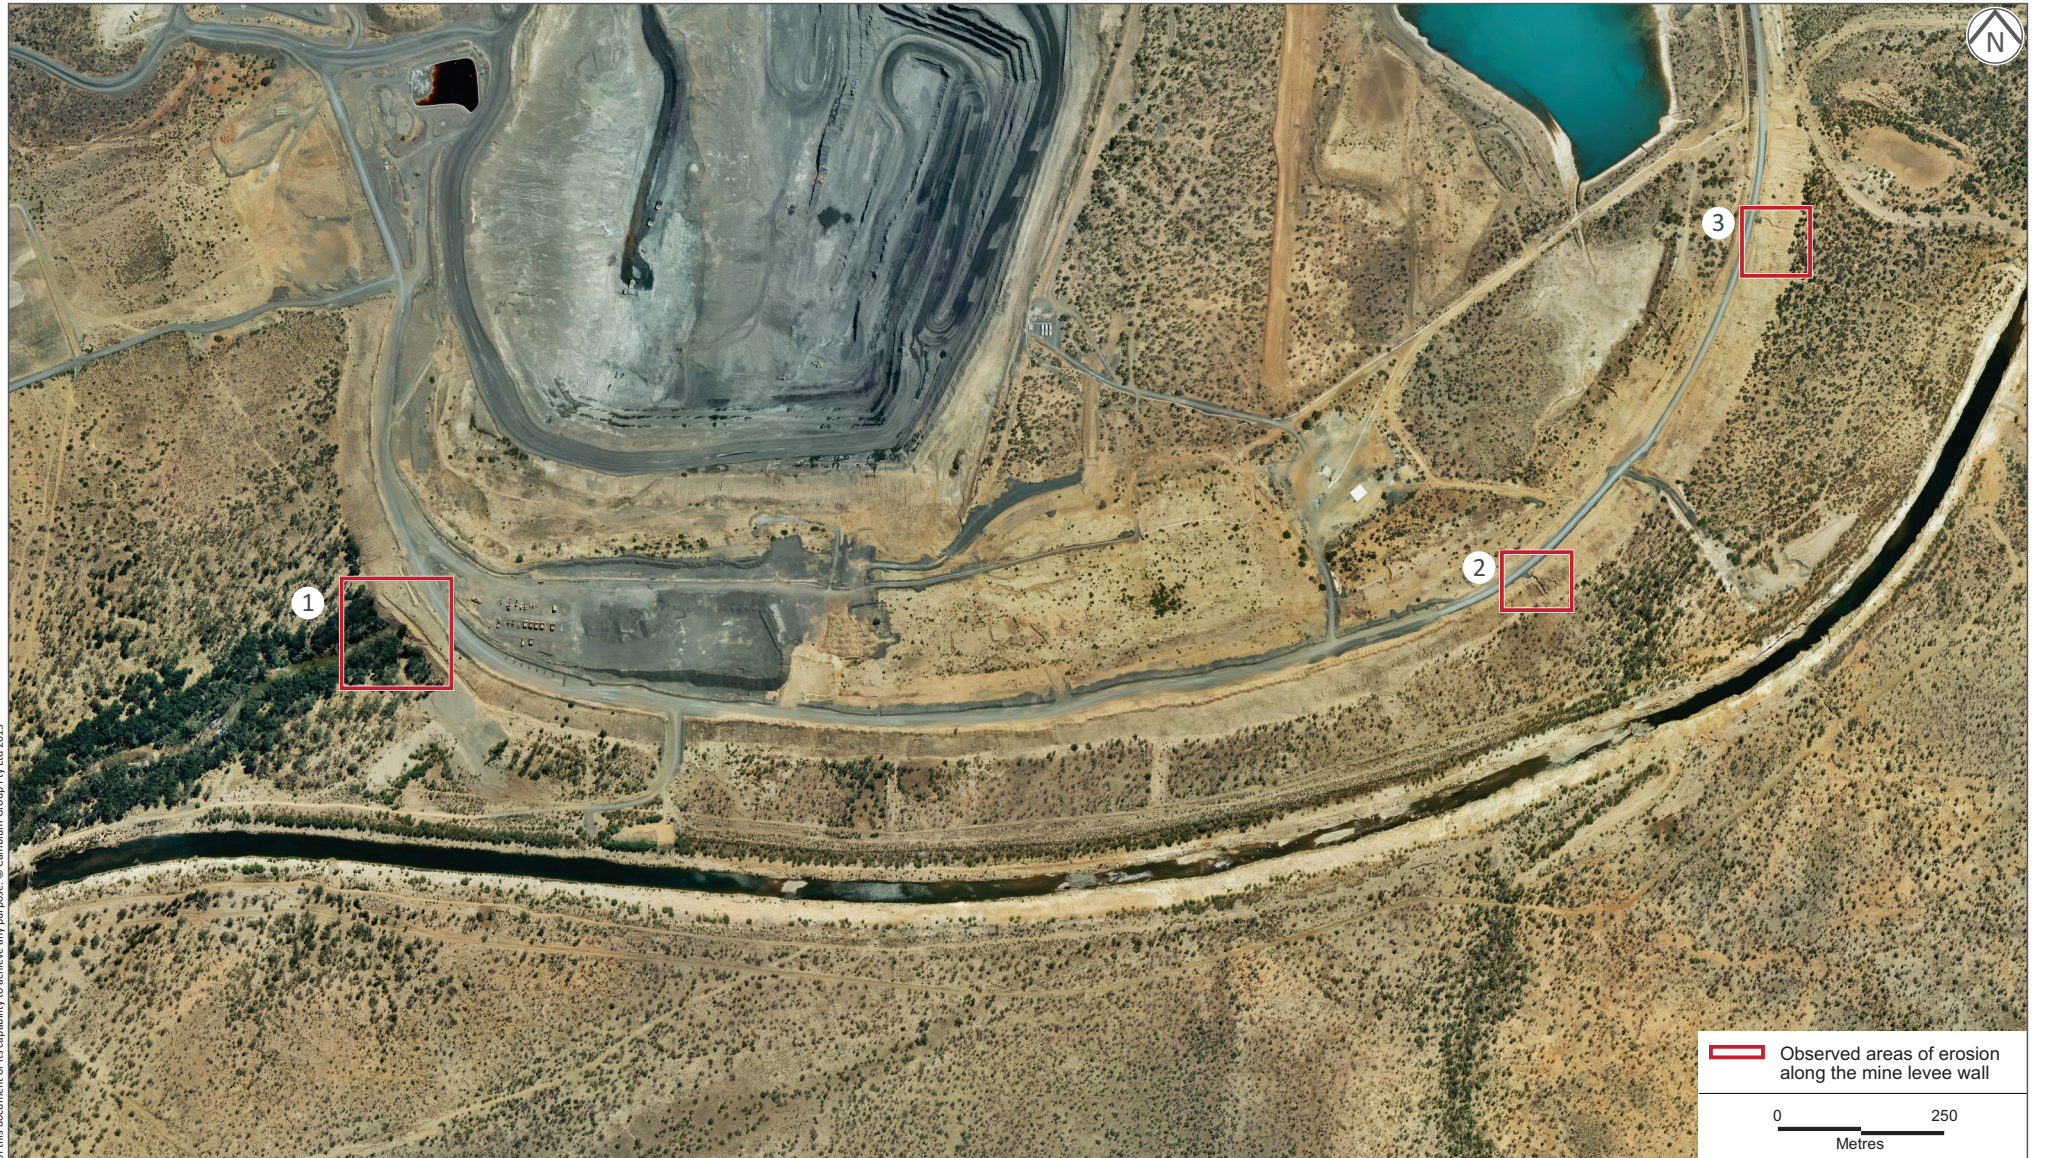
FIGURE 4.7

Erosion at the toe of the mine levee wall (Figure 4.7, Location 1) is occurring where the old McArthur River channel meets the levee. This appears to be due to local runoff rather than fluvial erosion from flood events, however, it may pose a threat to the long-term stability of the mine levee wall. This site should be assessed by a qualified geomorphologist (i.e., included in the scope of the planned (October 2015) assessment).

Erosion into the mine levee wall is occurring due to local runoff from within the bunded mine area at two locations (Figure 4.7, Locations 2 and 3). Location 2 appears to have initiated in 2010 and is ongoing (Plate 4.2). These sites were not inspected during the June 2015 site inspection and it is unclear whether mitigation measures have been put in place. This erosion may pose a threat to the long-term stability of the mine levee wall. It is recommended that these sites be assessed by a qualified geotechnical engineer. A secondary issue, is the probable runoff from the mine area to the creek. While this is predicted to be minor, it is recommended that the runoff be directed inwards of the mine levee wall.

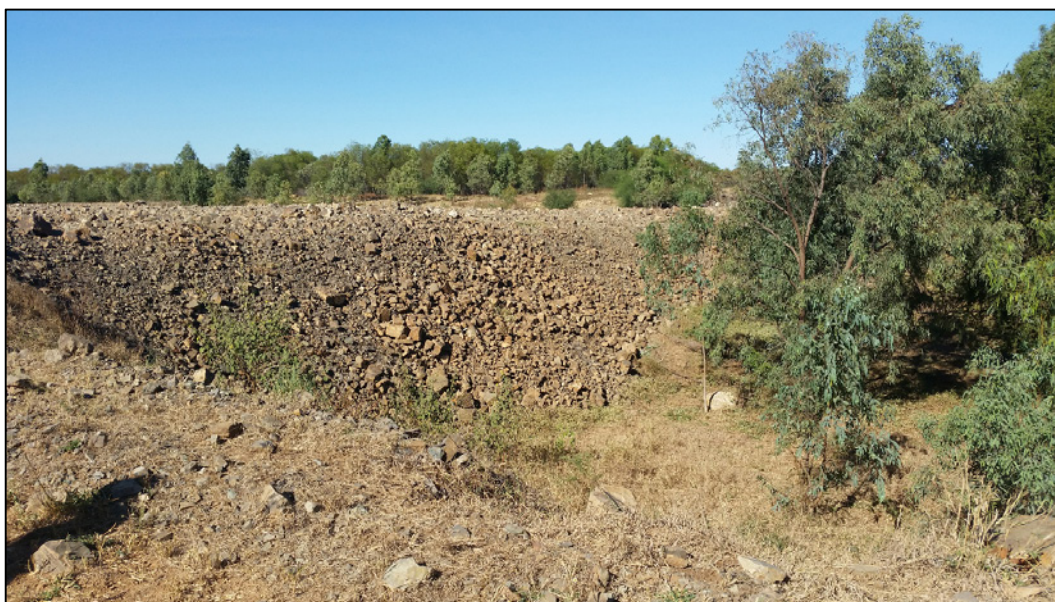
Ponding of Water between the Channel Diversion and Mine Bund

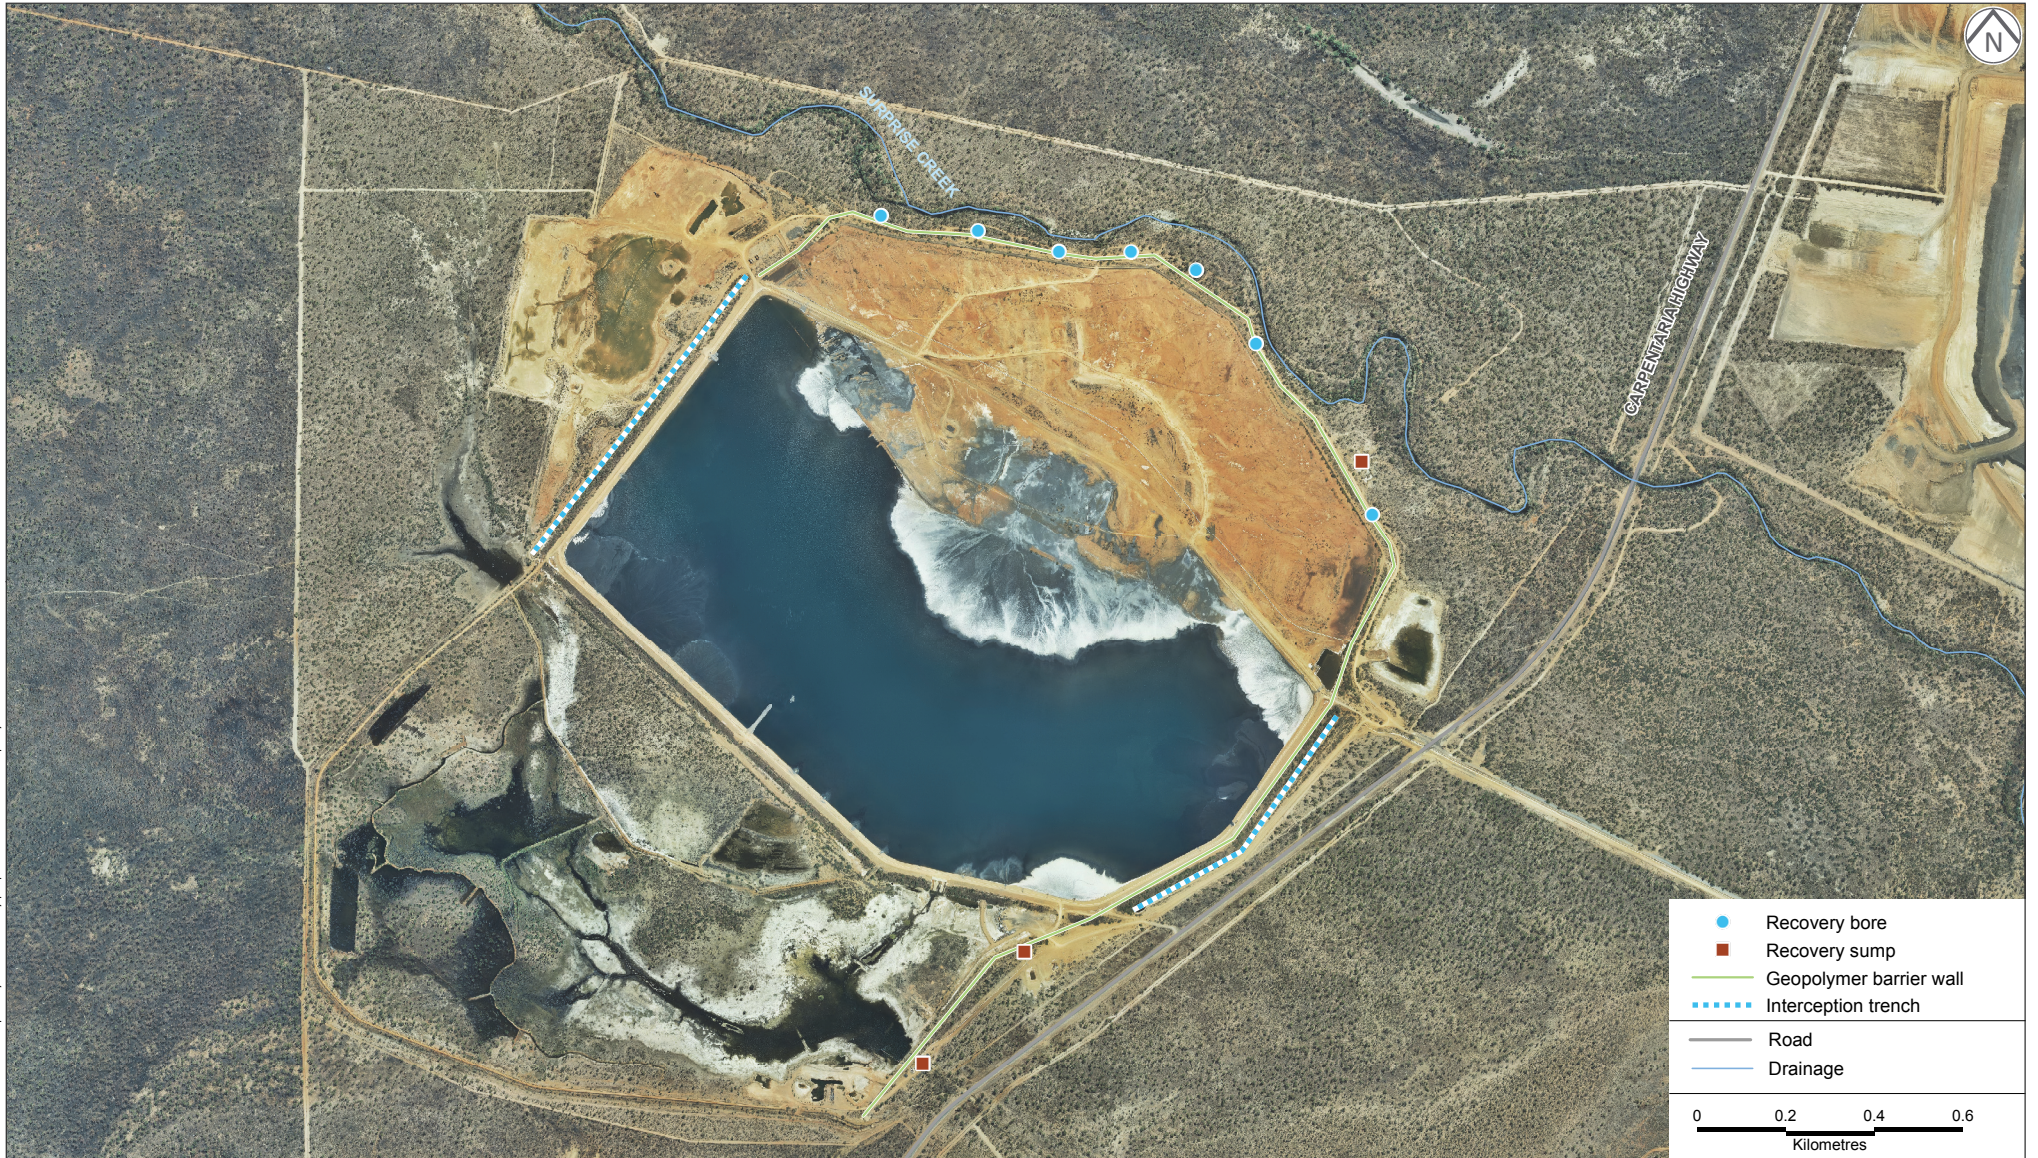
FIGURE 4.10

Locations of the geopolymer barriers are shown in Figure 4.10.

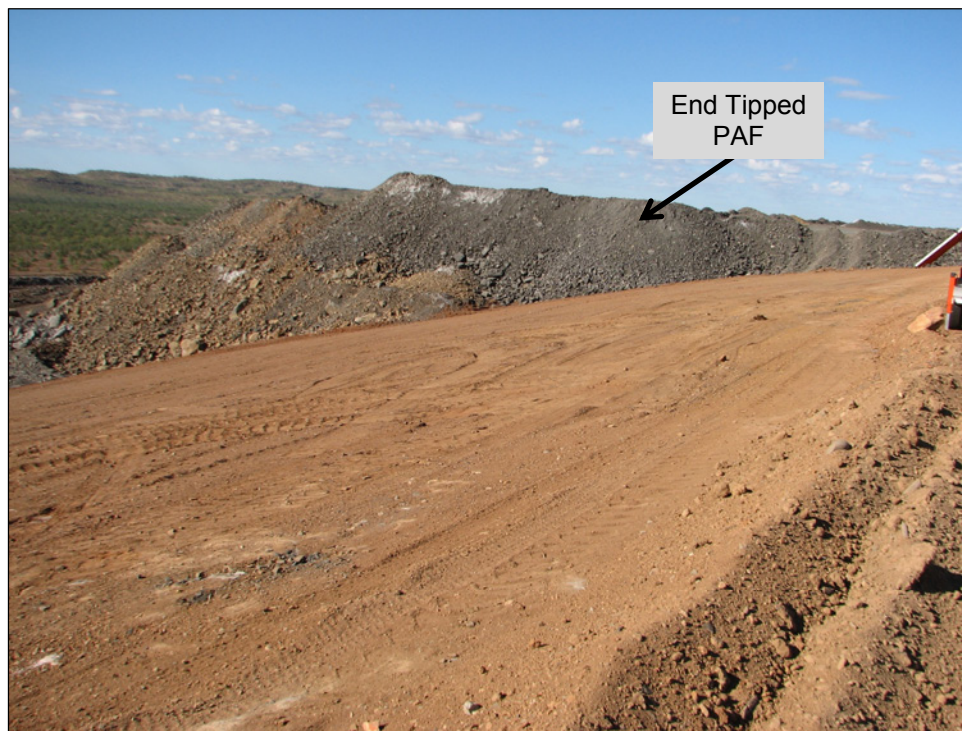
Note: dump batters at this location have not been dozed down due to restrictions in approved space.

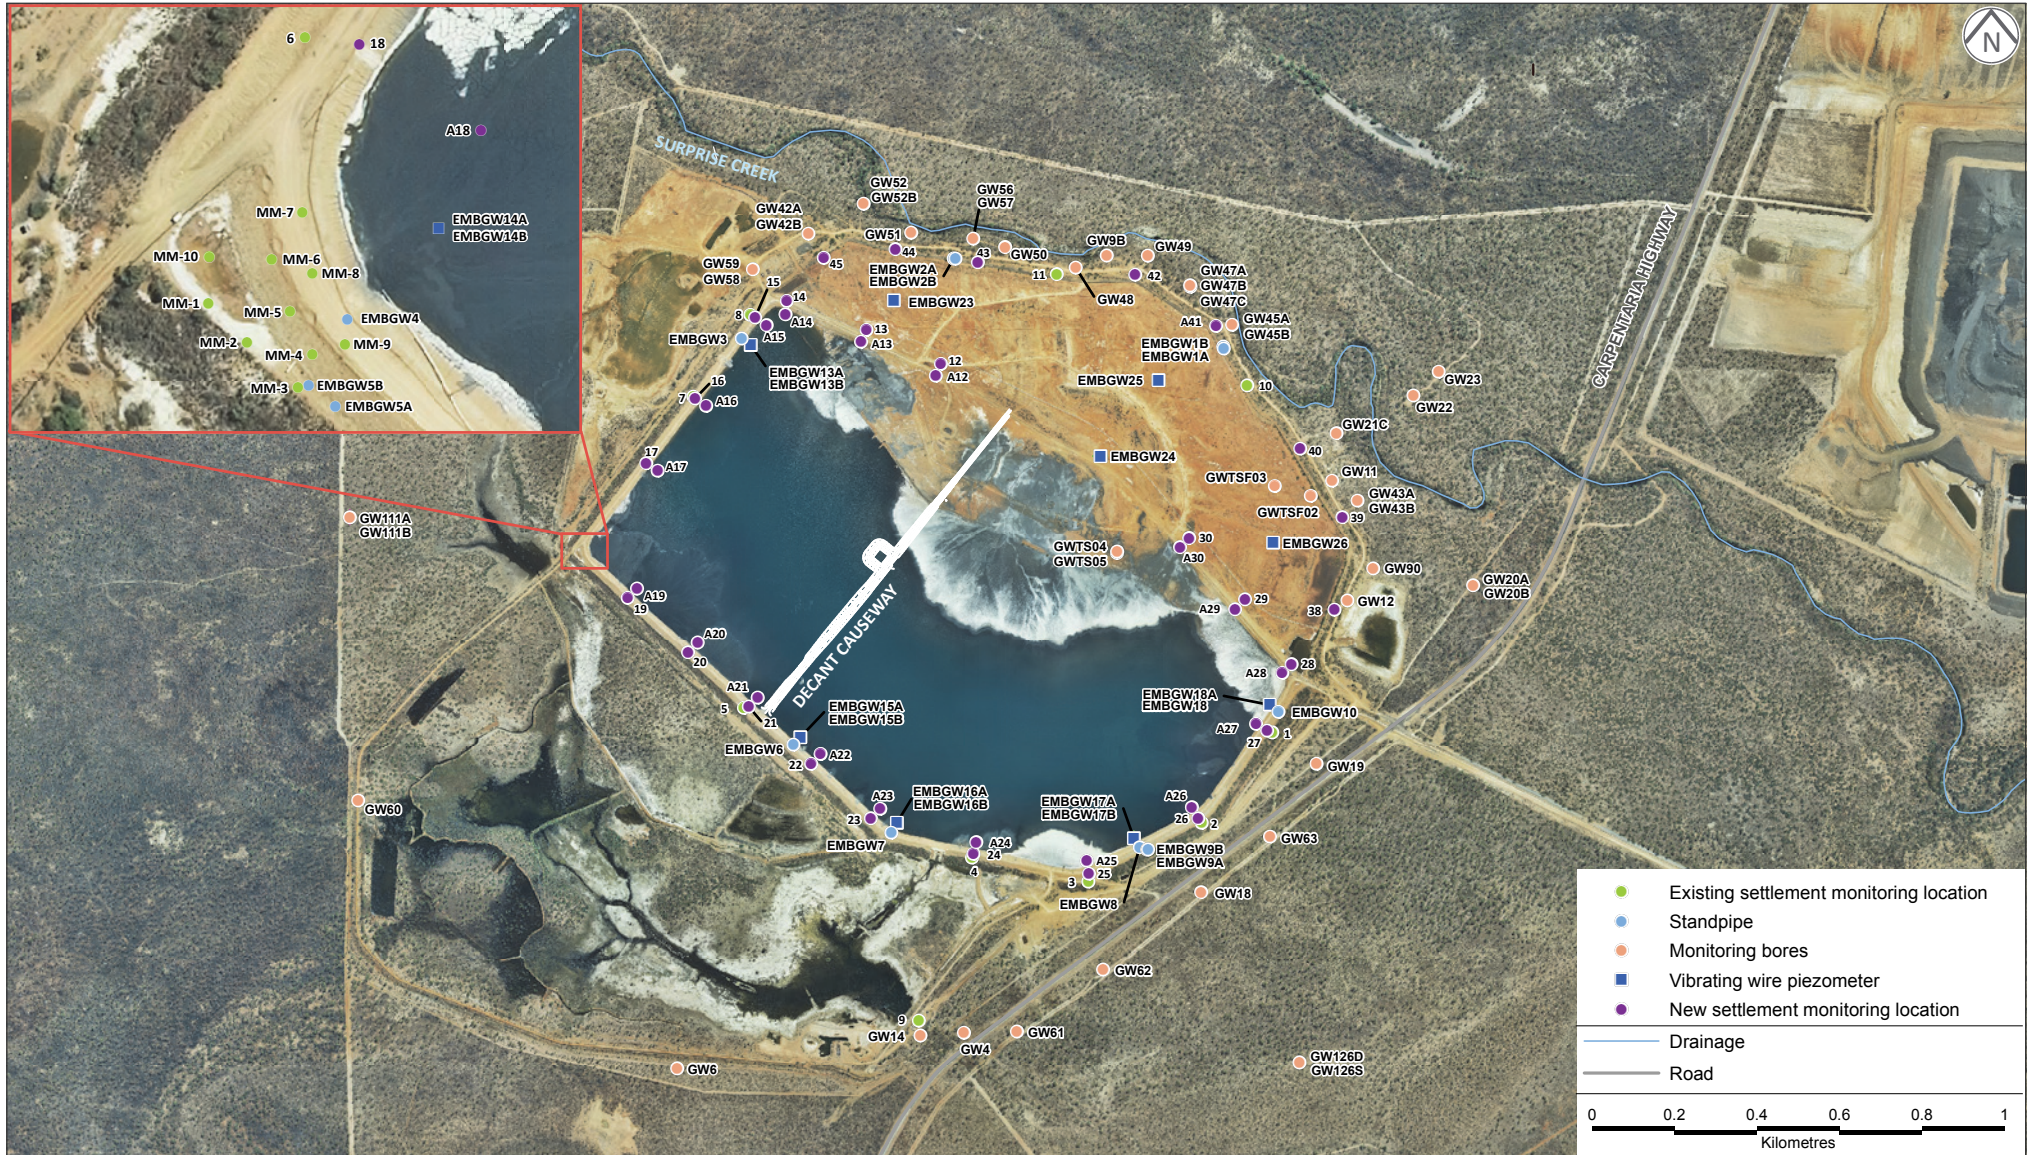
FIGURE 4.15

The new decant causeway (Figure 4.15) was constructed on the existing tailings surface from a relatively coarse and, therefore, permeable waste rock. The decant causeway construction was only partially constructed during the reporting period. However, it is understood that the central decant pond was relocated some time before November 2014 when the embankment was still under construction.

Under the previous configuration, tailings deposition had to be minimised along the southern embankment where the original decant was located. The new central decant allows discharge of tailings from the entire Cell 2 perimeter. This has now largely occurred which has promoted embankment stability, reduced seepage and shifted the decant pond to the new central collection sump.

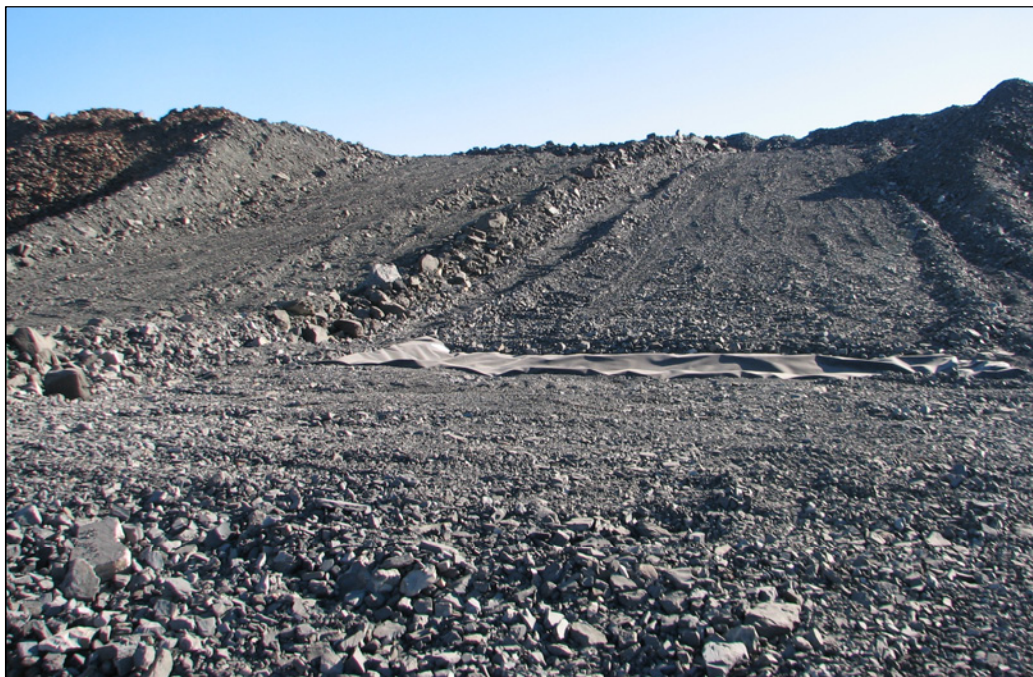
Note: plate shows two different materials placed in parallel down slope, with a berm between and a HDPE-lined collection sump below.

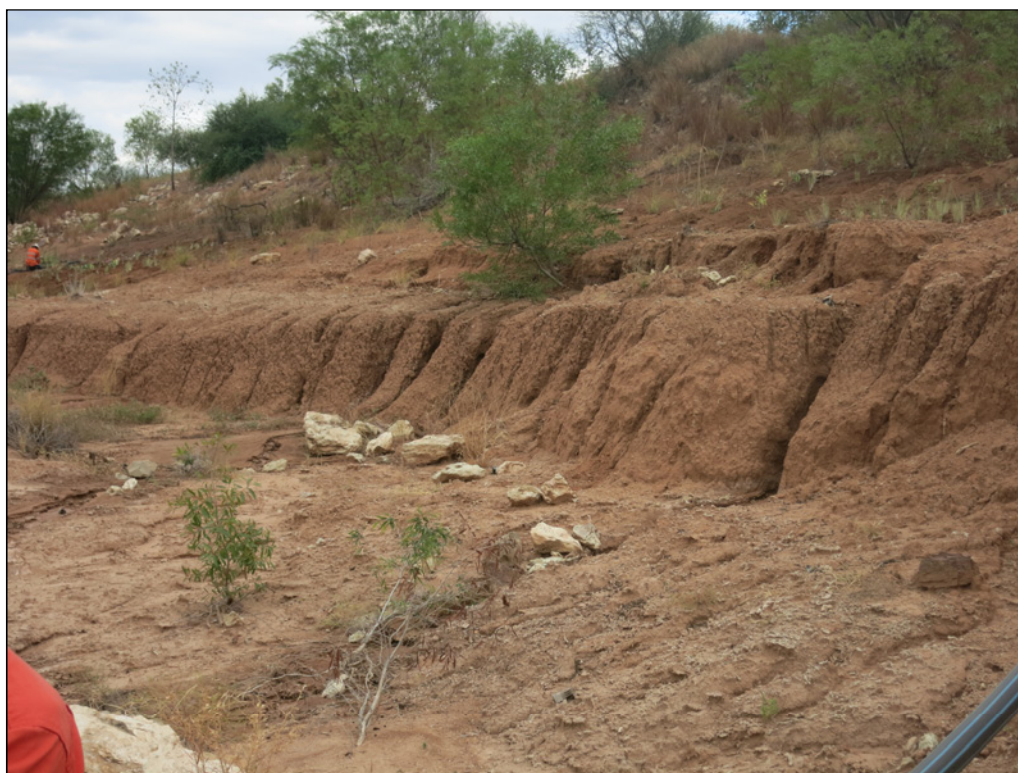
Plate 4.9 – Terracing (Soil Loss) Observed along the McArthur River Diversion Channel During the IM Visit, June 2015

Excluding one site (MRR4B), all sites along the McArthur River diversion channel recorded erosion. High rates of erosion activity (greater than 30 cm loss or deposition of soil across 50% or more of the plot) were recorded at the slope plot MRR3A and batter plots MRR6B, MRR7B and MRR8B. All of these sites are located on the bank opposite the mine and experience high velocity water flows. Significant terracing was observed along the McArthur River diversion channel by the IM in June 2015 (Plate 4.9).

Overall, the Barney Creek diversion channel is revegetating well and falling within completion criteria range in a number of areas. Taking into account the shorter timeframe since initial revegetation works began on the McArthur River diversion channel, the rehabilitation is occurring more slowly than initially planned. This is due to rocky banks being exposed as a result of erosion by floodwater flows, erosion of soil from the banks exposing subsoil that is not conducive to plant establishment, removal of plants by floodwater and damage caused by introduced herbivores. Overall revegetation at the McArthur River diversion channel has shown improvement each year since monitoring commenced in 2010, but progress is minimal.

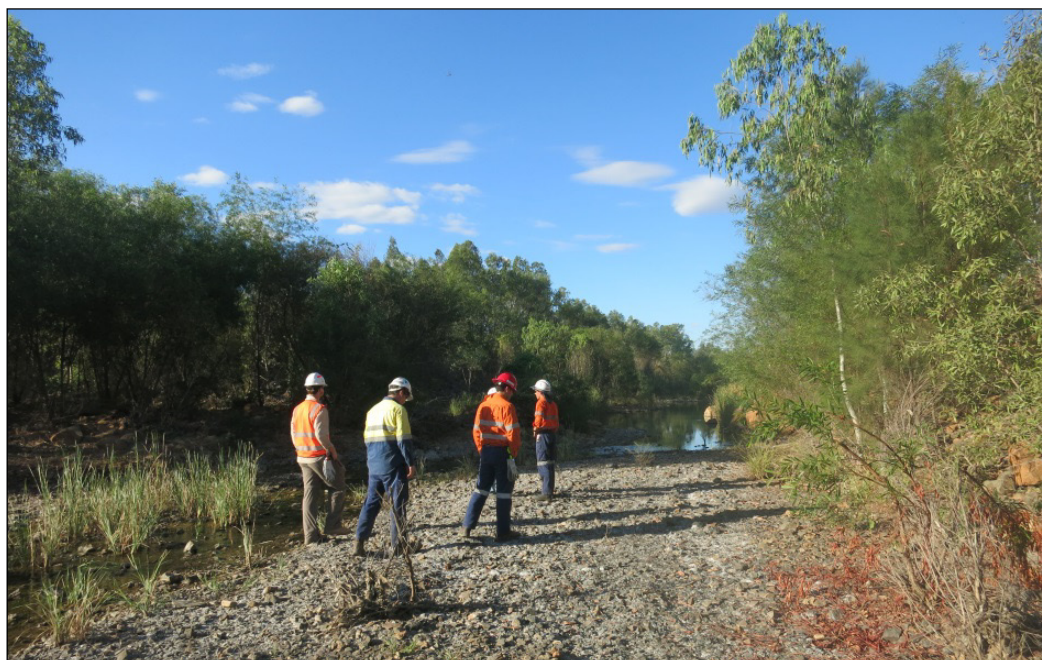
Plate 4.10 – Barney Creek Diversion at the Barney/Surprise Creeks Confluence Facing Downstream in June 2015

A visit to the Barney Creek diversion/Surprise Creek confluence during the June 2015 site visit showed that revegetation along the Barney Creek diversion channel is still improving, with a range of native flora species present and trees up to 8 m in height (Plates 4.10 and 4.11). The Barney Creek diversion channel is now at a stage where minimal revegetation is required.

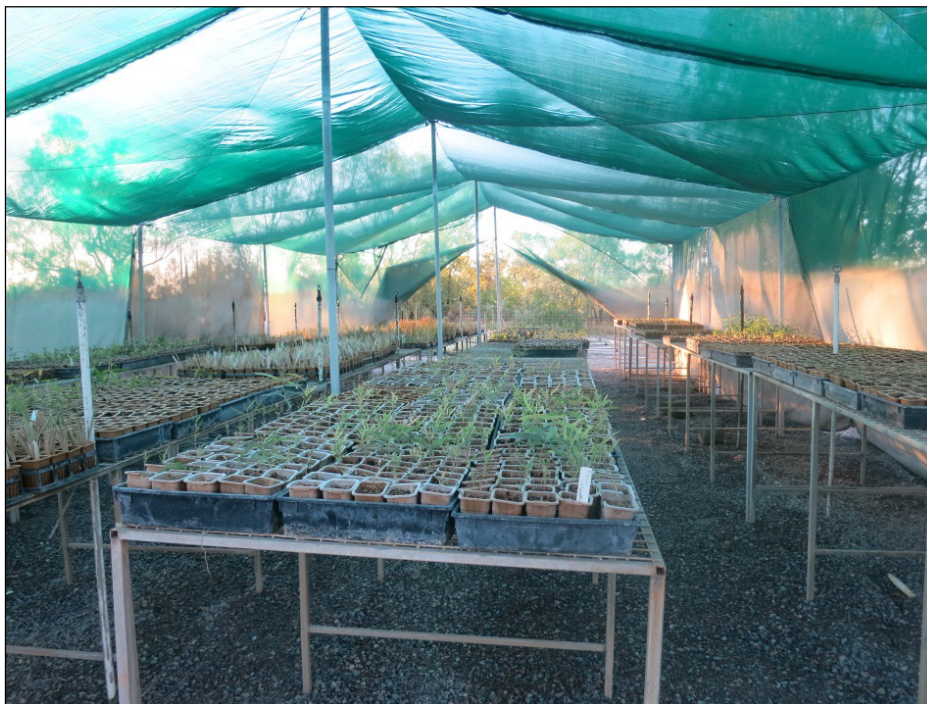
Plate 4.13 – MRM Nursery Greenhouse During the June 2015 IM Site Visit

The majority of tubestock (85%) used in revegetation works during the operational period was grown in the MRM on-site nursery, with only the species *Barringtonia acutangula* sourced from an outside supplier. This is an improvement from the previous operational period. MRM now employ full-time staff to ensure the nursery provides sufficient tubestock for revegetation works. Plates 4.12 and 4.13 show the outdoor area where plants 'harden up' and a greenhouse which contains small seedlings.

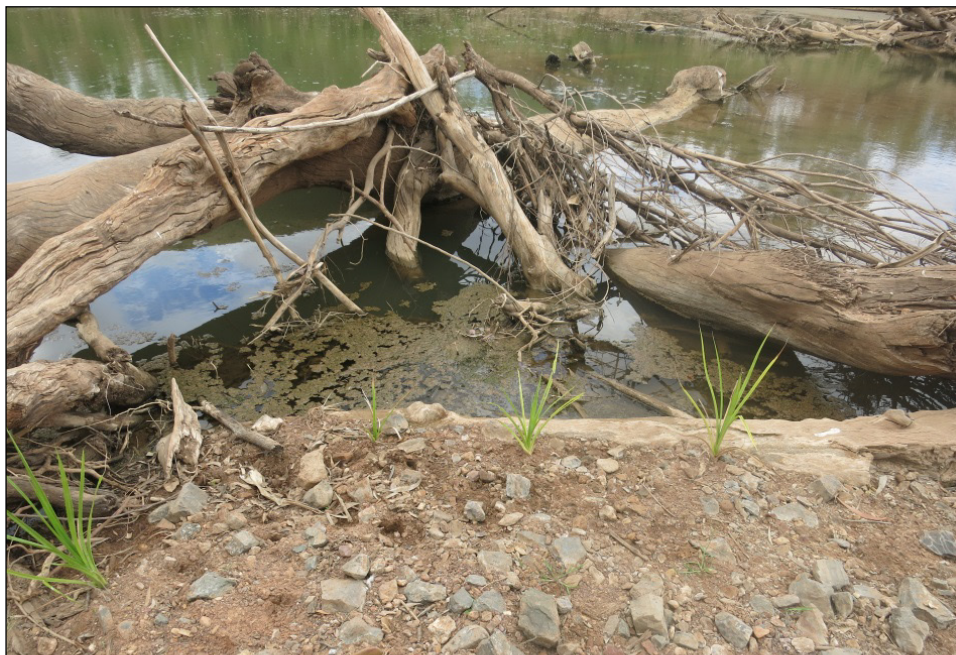
Plate 4.14 – Targeted Planting of Tubestock Along the McArthur River Diversion Channel

As highlighted in the 2014 revegetation monitoring report, it is possible that tubestock planting is occurring in the monitoring sites each year prior to monitoring events, resulting in data being skewed and giving an incorrect measure of abundance, richness and survival (EcOz, 2014a). It should be ensured either that monitoring occurs prior to tubestock planting, or that key and primary species abundance and possibly species richness are treated carefully as completion criteria. An alternative option is that MRM could monitor how many tubestock and what species they are planting within a monitoring plot, the total could then be subtracted from total abundances.

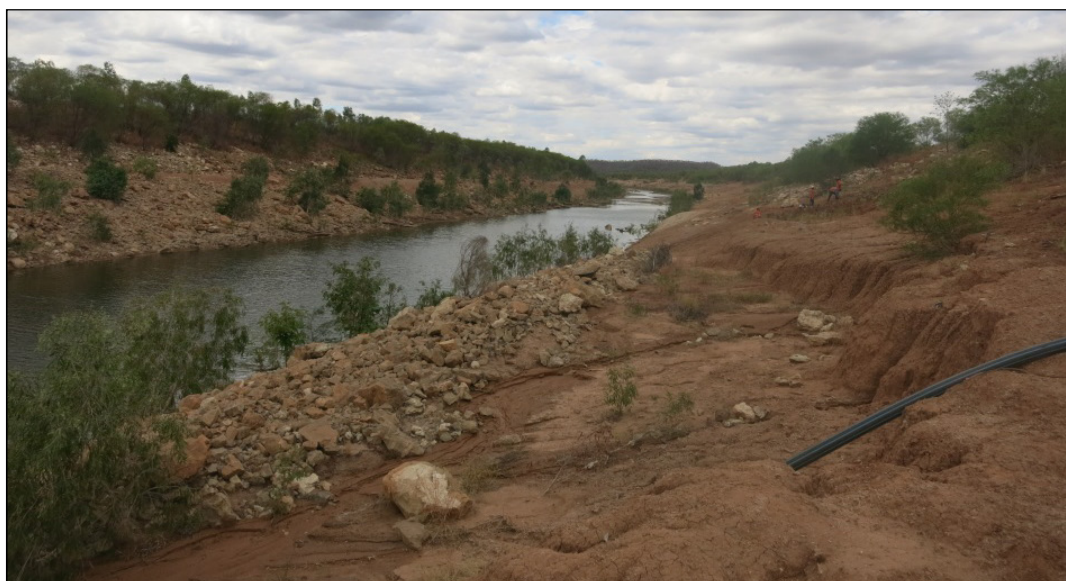
Slow revegetation of the McArthur River diversion channel is occurring due to issues with the original design of the channel, which causes high velocity flows of water in the wet season and in turn causes removal of soil and vegetation, and subsequent erosion (Plate 4.15). MRM originally predicted that the revegetation of the diversion channel would be more advanced at this stage than is the current condition. This completion time was unrealistic and the IM recommends that a revised completion time is determined. It is important for MRM to recognise that the revegetation of the channel is a long-term project and is likely to take at least 25 years before it can be considered a fully functioning ecosystem. This planning is important for the success of the rehabilitation program.

Plate 4.15 – Terracing and Soil Removal Occurring on the Upper Banks of the McArthur River Diversion Channel

It would be advantageous for MRM to assess a more reasonable completion time based on current progress and to have achievable annual milestones against which MRM can assess their progress, allowing for plans to be reassessed regularly. Milestones could include targets such as number of sites meeting a percentage of completion criteria by a nominated year, percentage of slope covered by vegetation by a nominated year, number of sites with plant diversity matching that of analogue sites by a nominated year. Milestones should be regular with at least one per year and could be refined after each year’s monitoring as data is collected. Projected completion date and milestones should be expressed as commitments in future MMPs.

It may be appropriate for MRM to establish back eddy areas and diversions in the hard rock walls by explosives or heavy earth moving equipment, which would facilitate soil deposition in pockets with resulting vegetation establishment.

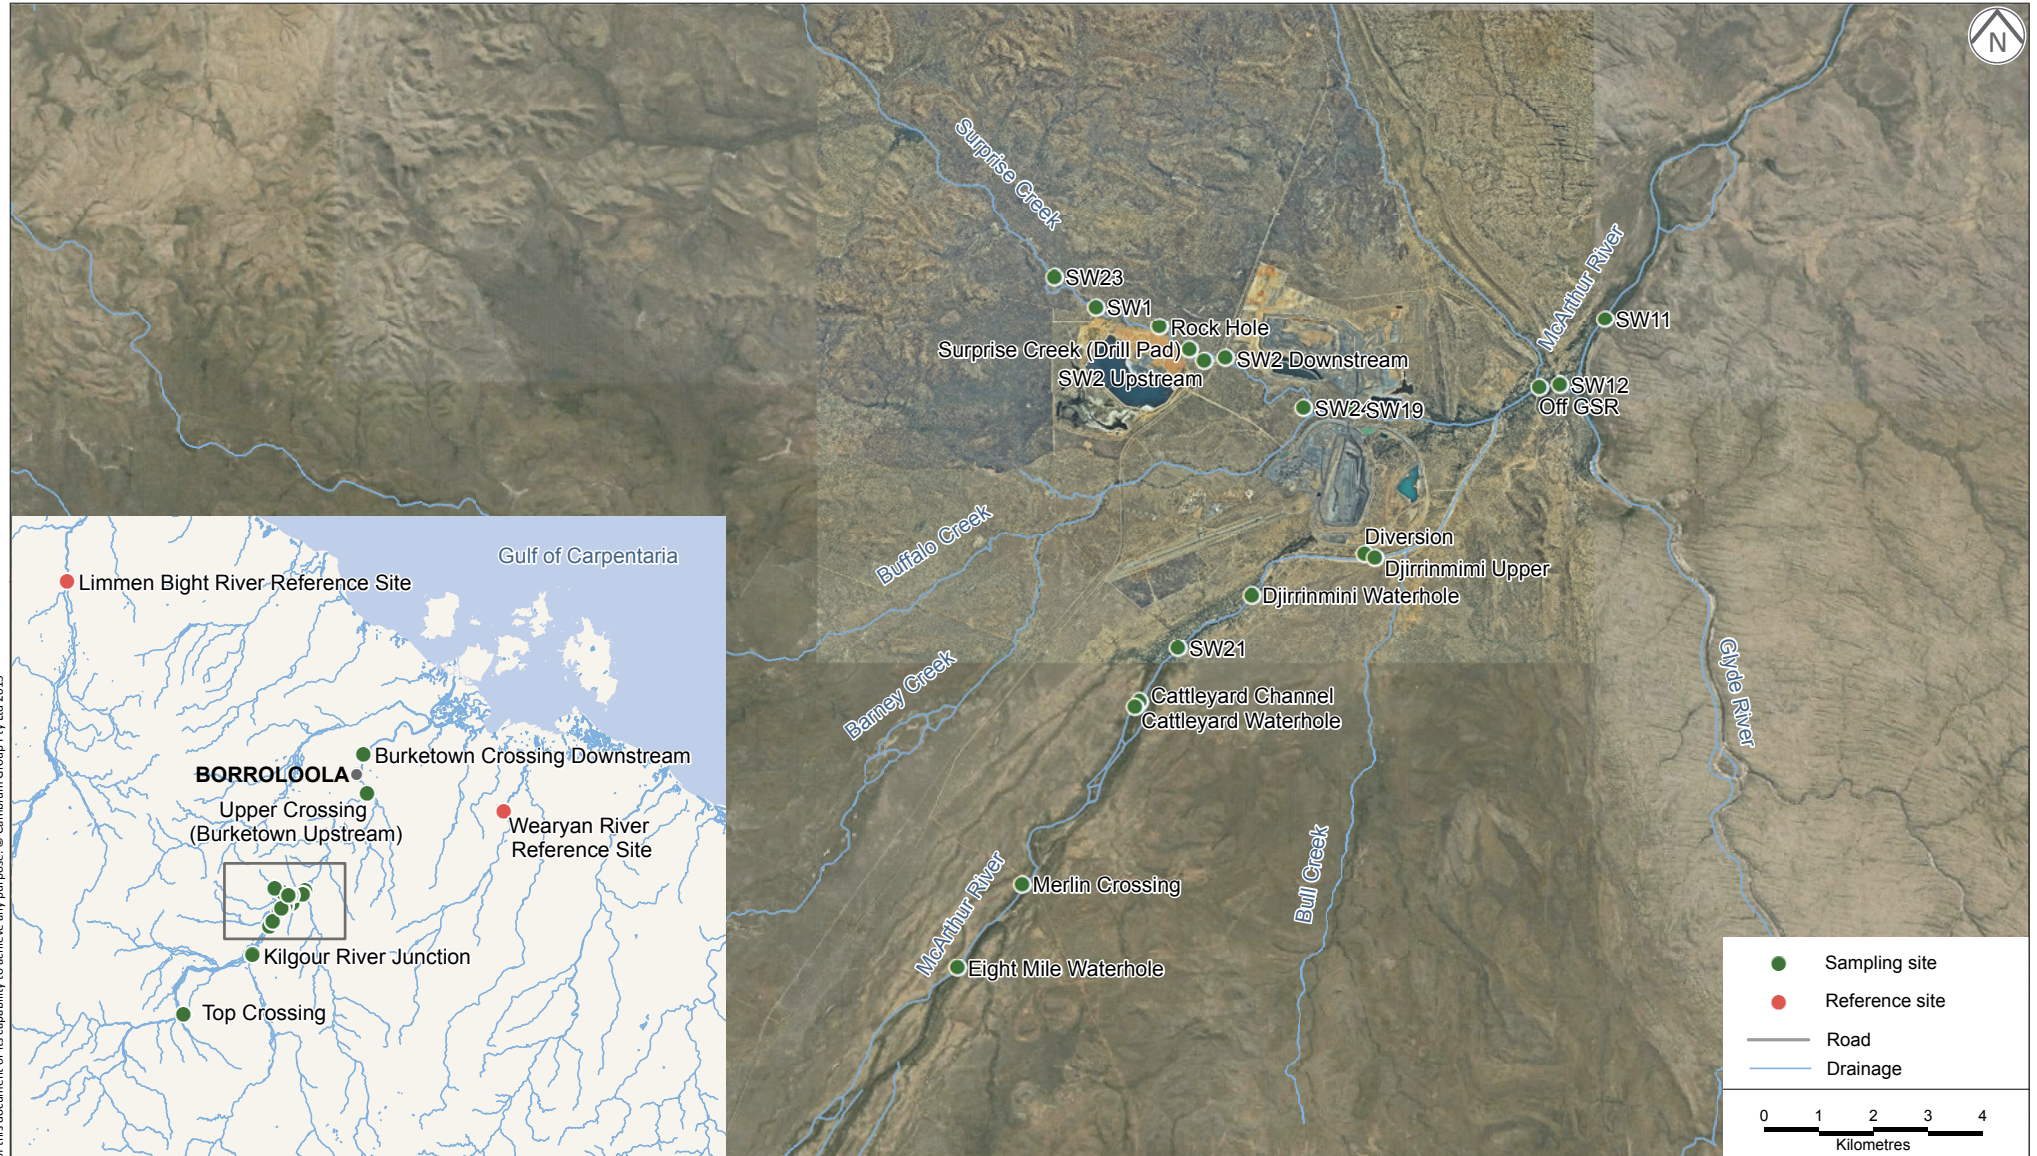
FIGURE 4.21

Results of the aquatic surveys are outlined in Table 4.45 and survey locations are shown in Figure 4.21.

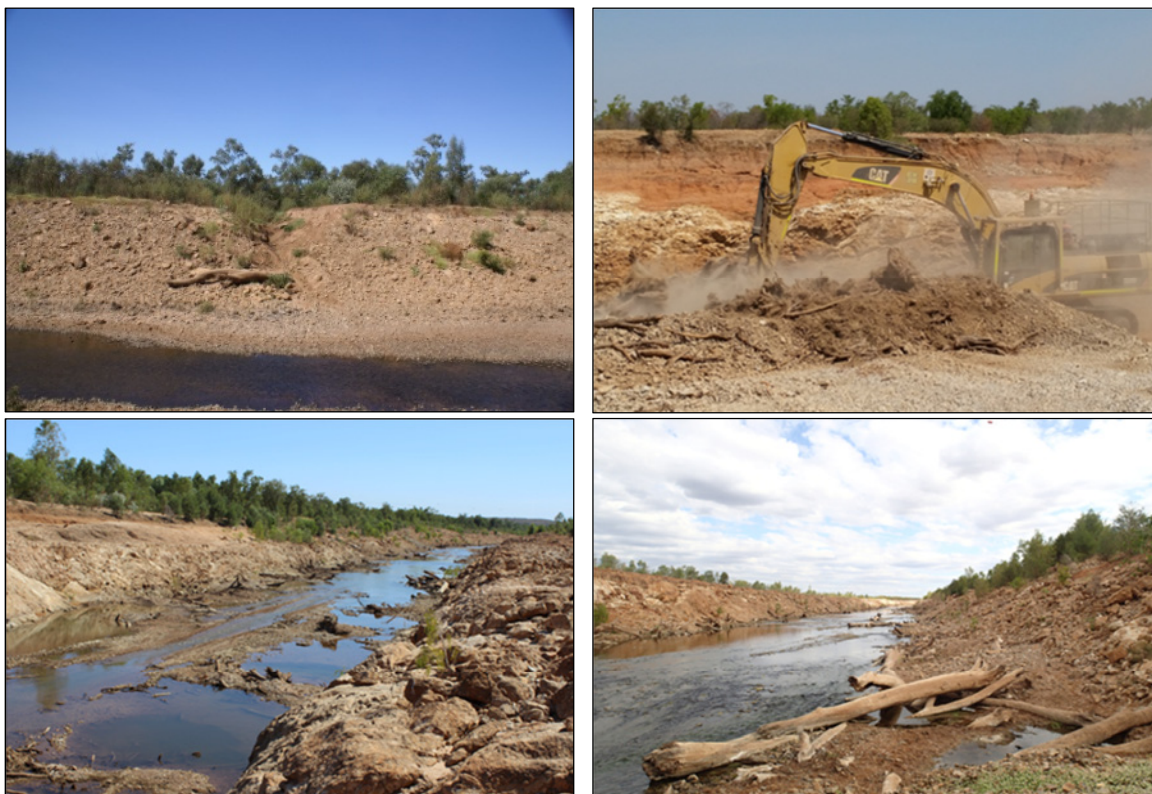
Clockwise from top left: 1) Typical lower diversion river bank in 2013. 2) Burying LWD. 3) and 4) Lower diversion during on-site visit by IM in June 2015. Note the captured sediment, which has tubestock planted in it; and the diversion immediately post-LWD installation.
