Independent Monitor
ENVIRONMENTAL
PERFORMANCE
ANNUAL REPORT
2014

McARTHUR RIVER MINE

OCTOBER 2015
Report No. 01164A_3_v2

**Independent Monitor
Environmental Performance Annual Report
2014**

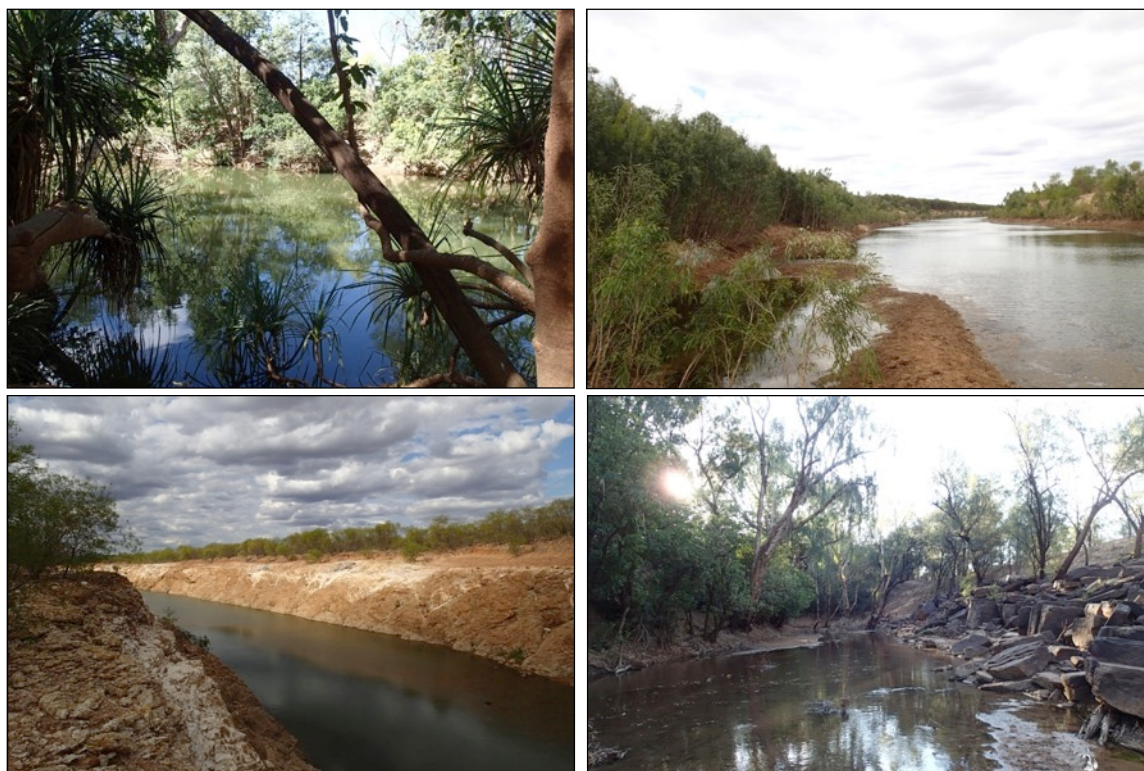
Clockwise from top left: 1) Djirrinmini Waterhole upstream of the McArthur River diversion. 2) Good revegetation a few hundred metres downstream of the start of the McArthur River diversion channel. 3) SW12, near the confluence of Barney Creek and the McArthur River. 4) Poor rehabilitation along the diversion channel, where most soil has been eroded.

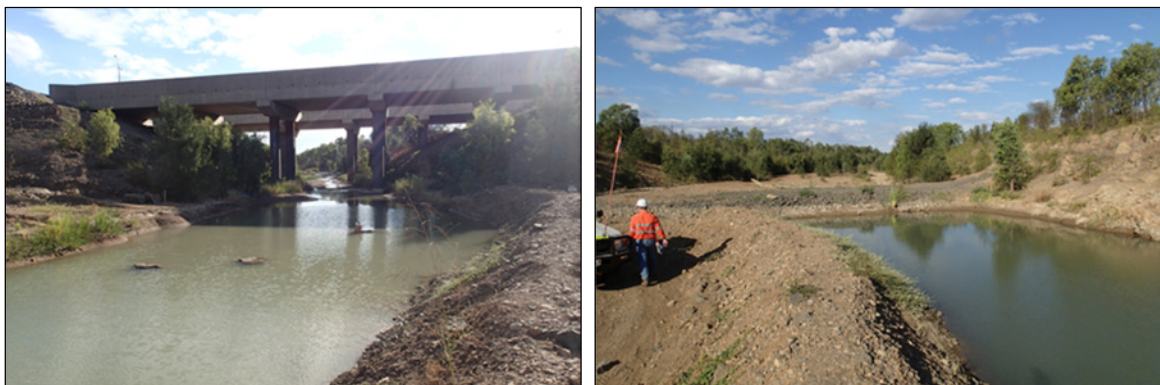
As a result of this new dam, no water was flowing to the downstream end of the Barney Creek diversion channel. This dam will deprive water to aquatic organisms living downstream of SW19. Aquatic organisms living in the channel and shallow waterholes along the diversion will likely perish as the diversion dries, and deeper waterholes are more likely to dry up over the dry season. It also reduces overall flow into McArthur River. The dam may act as a barrier to fish migration travelling up and downstream, even during periods of higher flow.

Plate 4.18 – Dam on Barney Creek Diversion Channel Downstream of the Haul Road

Rather than extracting potentially contaminated water, MRM needs to identify and quantify potential sources of contamination. Some of the sources will be legacy issues, such as seepage from SPROD, and contamination from sediment washed off the haul road, which should now be collected in the new sumps. However, evidence suggests that there are other potential sources of contamination, including dust contamination from traffic on the haul road and the processing plant and associated stockpiles and seepage from the ROM pad sump. The IM recommends that MRM uses the current monitoring programs to identify additional sources of contamination and implementing control measures at these sites. If the dam remains at SW19, MRM needs to investigate the dam's effect on downstream sections of Barney Creek diversion channel and McArthur River and consider potential mitigation techniques, such as pumping water out of the water management dam into Barney Creek diversion channel below the dam at SW19³⁰.

In addition, the IM recommends that additional surveys take place upstream and downstream from SW19 along Barney Creek diversion channel, and to a lesser extent Surprise Creek, to assess the extent of metal contamination in aquatic fauna. Specifically SW4, SW22, SW3, SW18 and SW28 should be added to the monitoring program. Following conversations with Dean Thorburn from Indo-Pacific Environmental (Thorburn, pers. com., 2015), surveying these sites

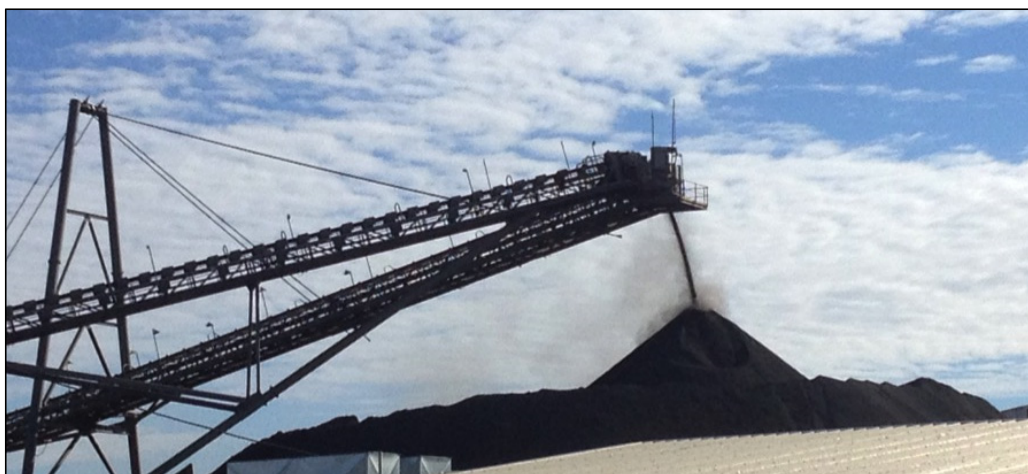
Plate 4.20 – Dust Emissions from the Conveyor System at the ROM Pad Near SW03

A brief review of other monitoring programs carried out by MRM, including surface water, fluvial sediments, soil, dust and ground water, indicates a degree of concordance in their results and highlights some of the above areas as potential sources of contamination (MRM, 2015). The IM recommends a full analysis and synthesis of all monitoring programs on site, including surface water, fluvial sediments, soil, dust and ground water to identify any additional sources of contamination. Where unaddressed sources of contamination are identified, control measures should be implemented. Quantifying legacy impacts against additional sources of contamination would be beneficial.

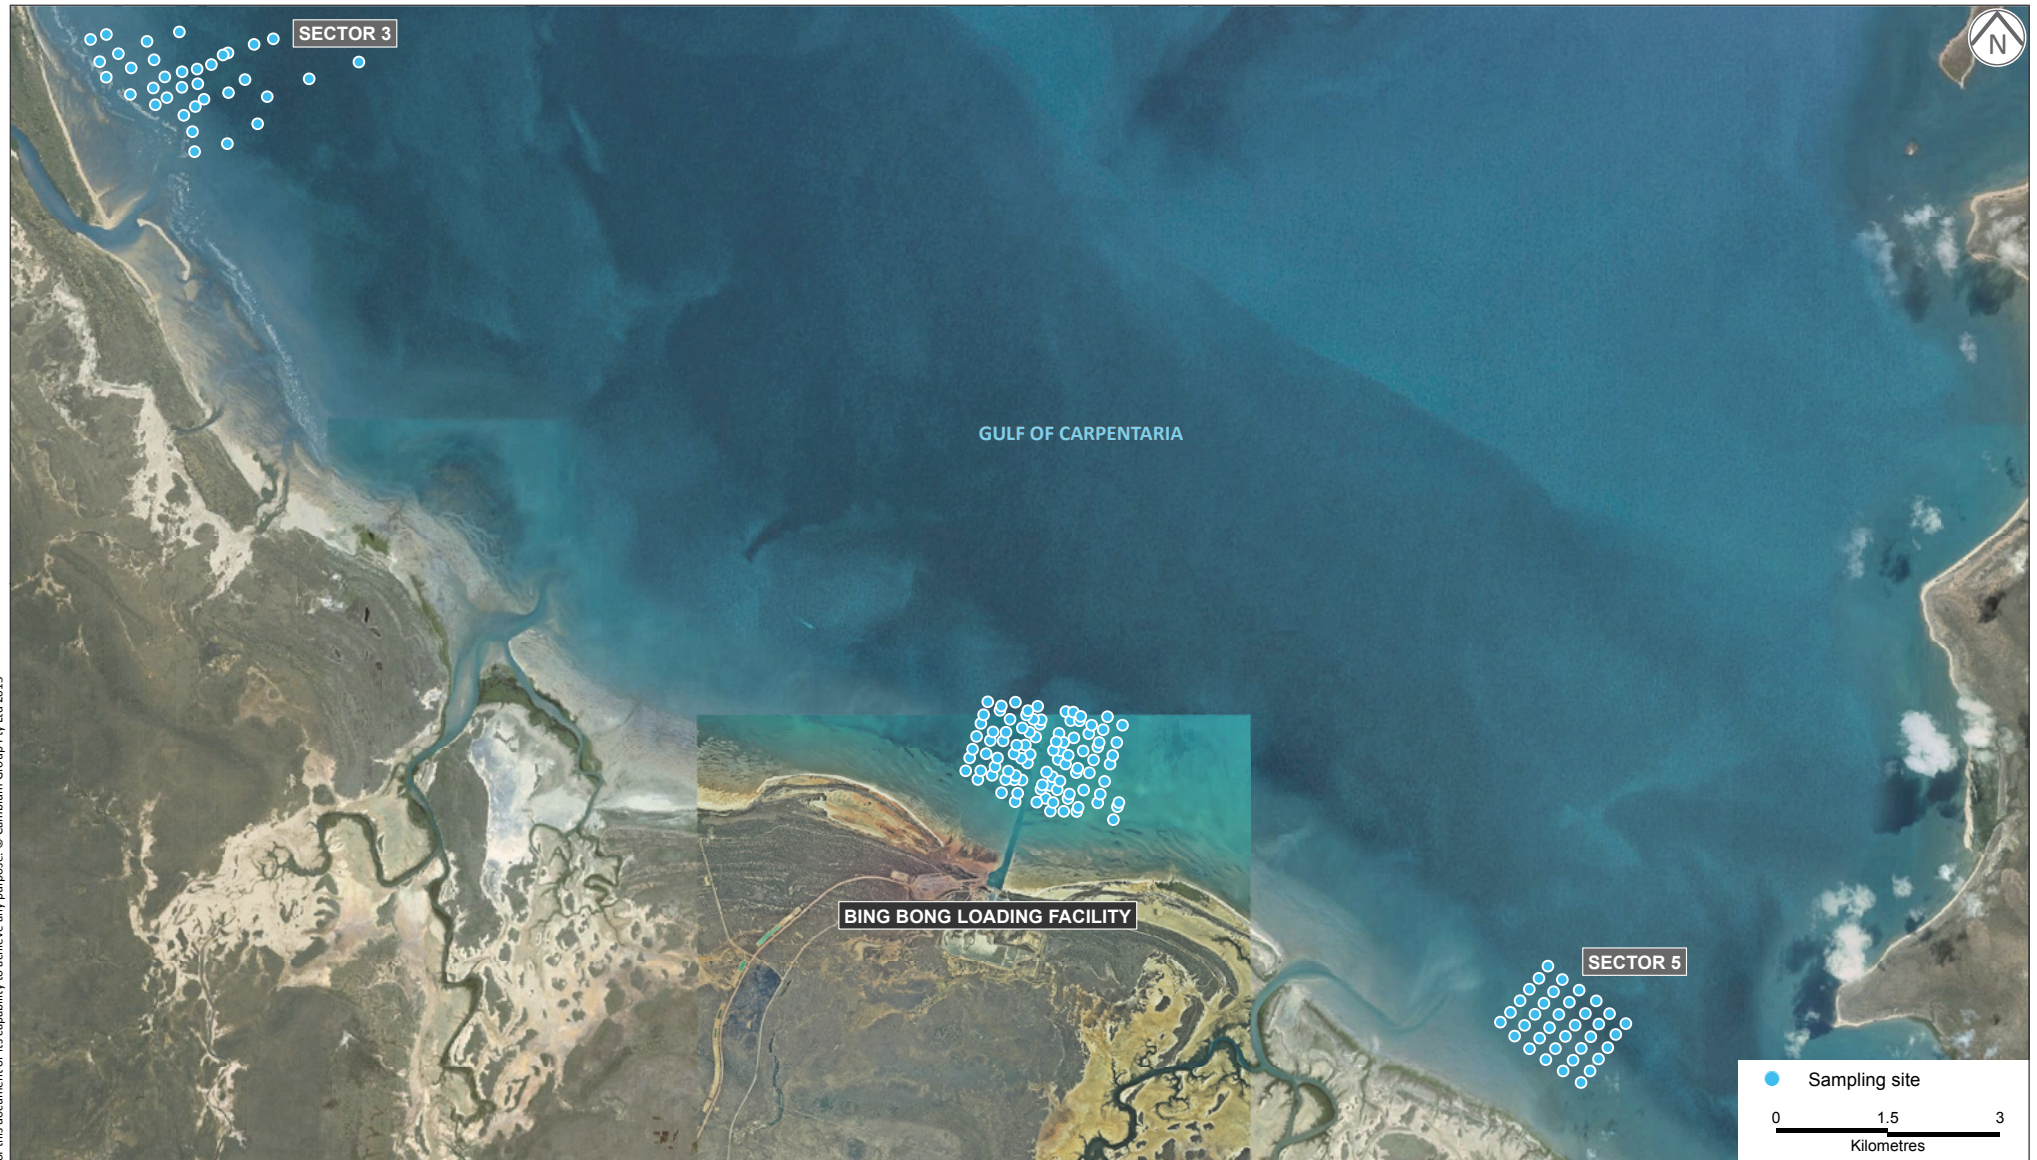
FIGURE 4.24

Since 2012, monitoring has included two control sites 12 km and 20 km northwest of Bing Bong Loading Facility (Figure 4.24), so the underlying causes of seagrass community dynamics could be better understood.

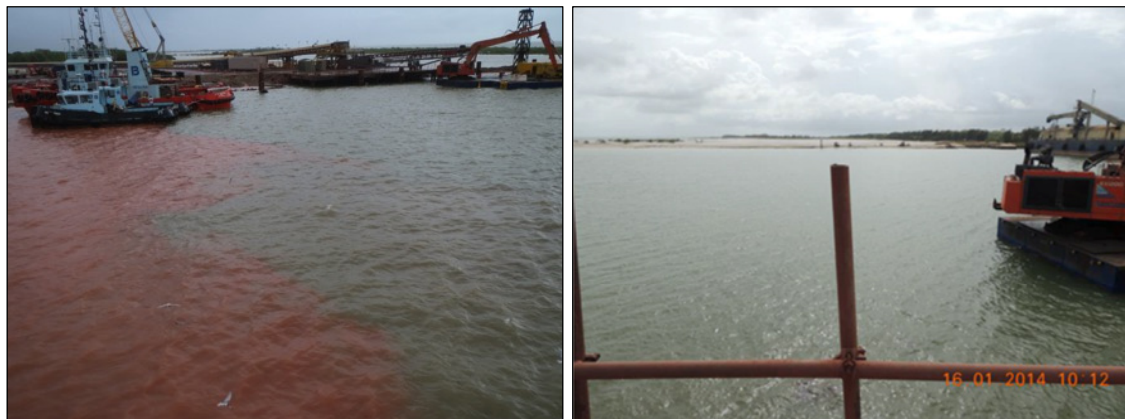
Note: Photos show the swing basin with iron-ore-infused runoff from the WDR loading facility on 14/01/2014 after heavy rain (left); and two days later (right).

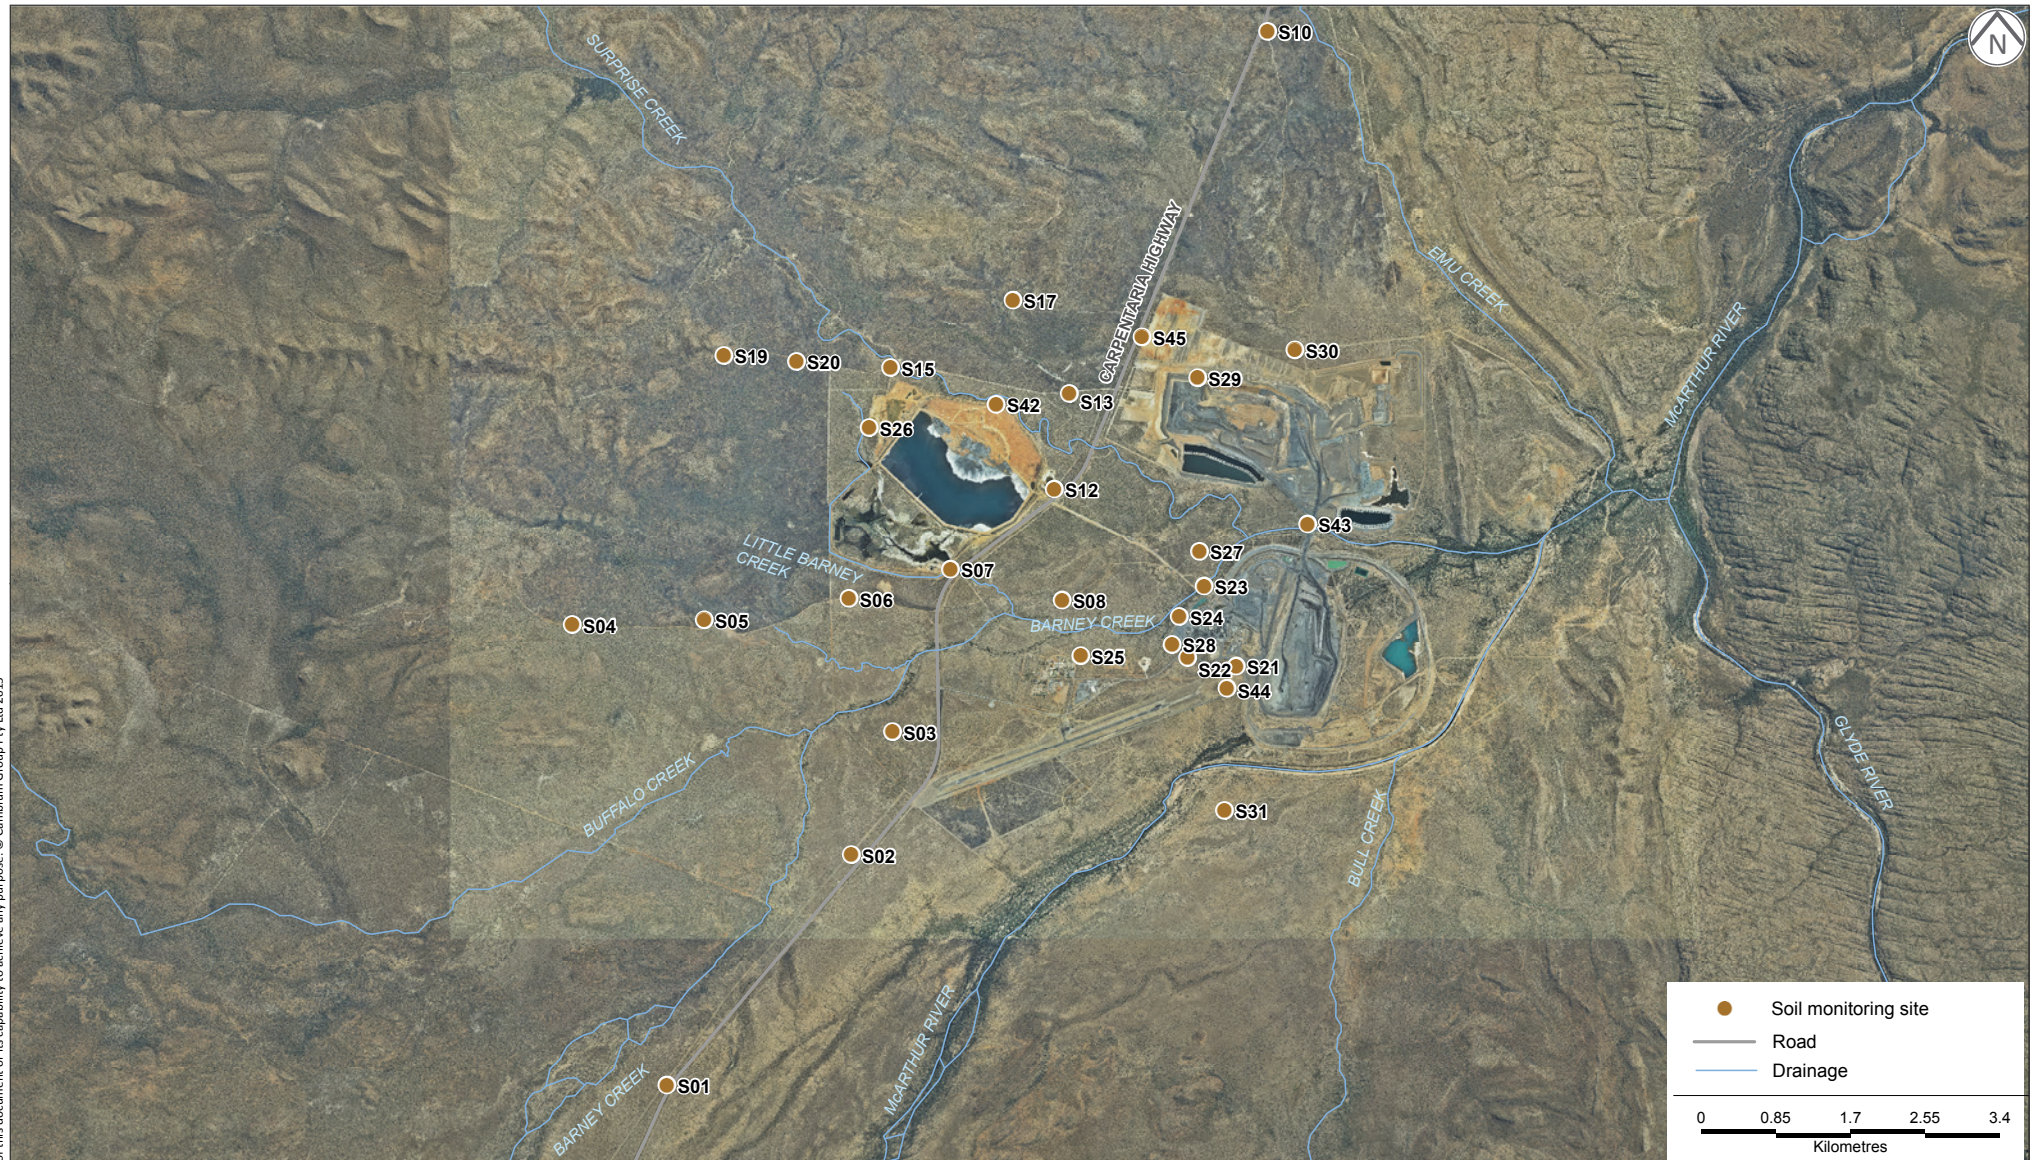
FIGURE 4.25

- ◆ Sampling sites as shown in Figure 4.25 (McArthur River Mine) and Figure 4.26 (Bing Bong Loading Facility) for the 2014 operational period. Sampling sites at the mine site were grouped according to an identified point source of potential dust generation in operation, e.g., reference sites and sites associated with each of the ore crushing plant/ROM pad, NOEF and TSF. Sampling at Bing Bong Loading Facility included sampling of surface soil from two sites (BBS03 and BBS04) in the dredge spoil emplacement area, as well as sites near the Bing Bong Loading Facility concentrate shed/loading conveyor and swing basin.

The IM has noted that a surface soil monitoring gap exists to the south and east of the mine pit – i.e., between the mine levee and the McArthur River diversion channel (see Figure 4.25). This area has potential to be contaminated by activities at the SOEF, which has been developed during the 2014 operational year. The closest existing monitoring site (S31) is approximately 1 km to the southwest of the SOEF and on the other side of the McArthur River diversion channel, and as such may not identify contamination from this facility.

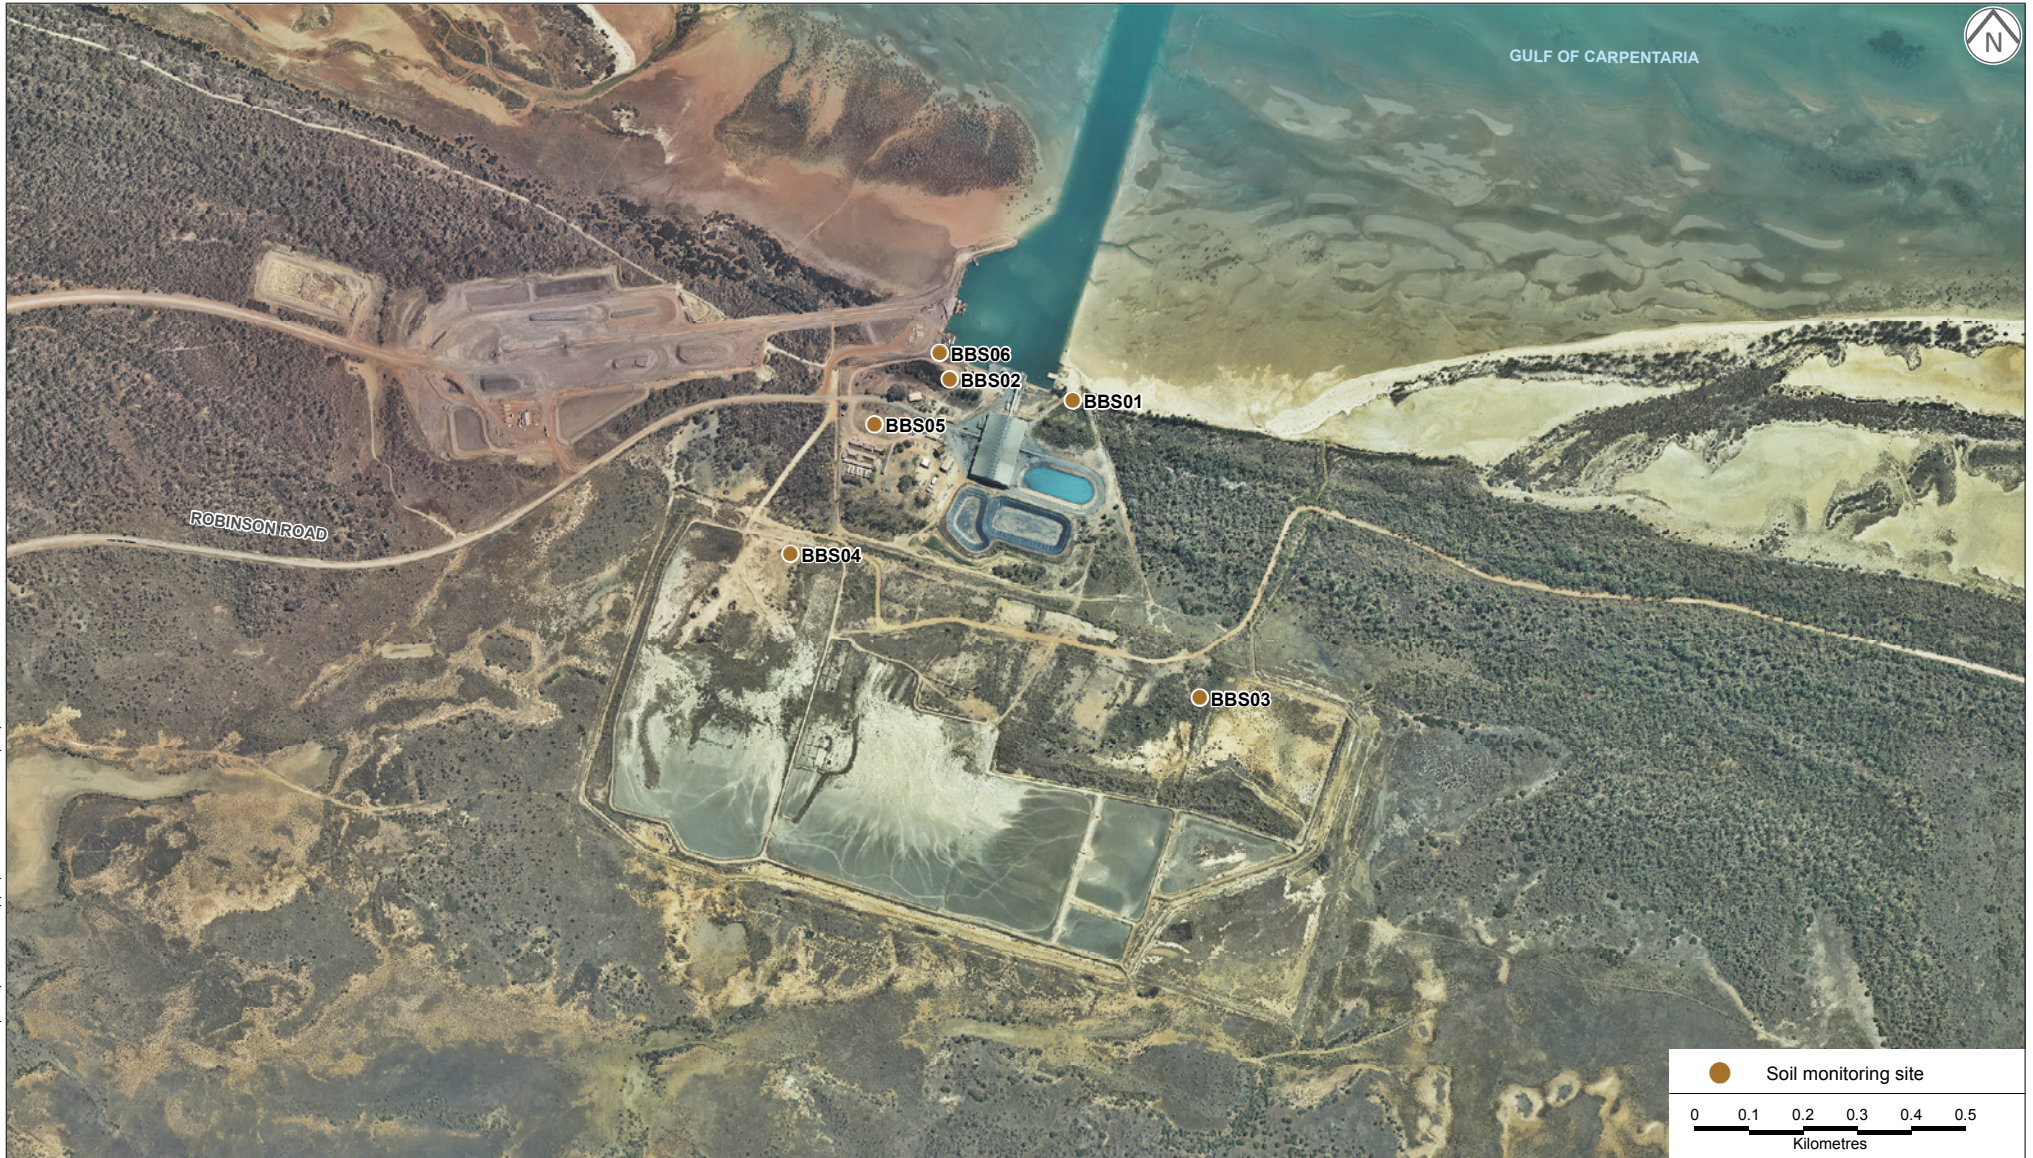
FIGURE 4.26

SOIL MONITORING SITES - BING BONG LOADING FACILITY

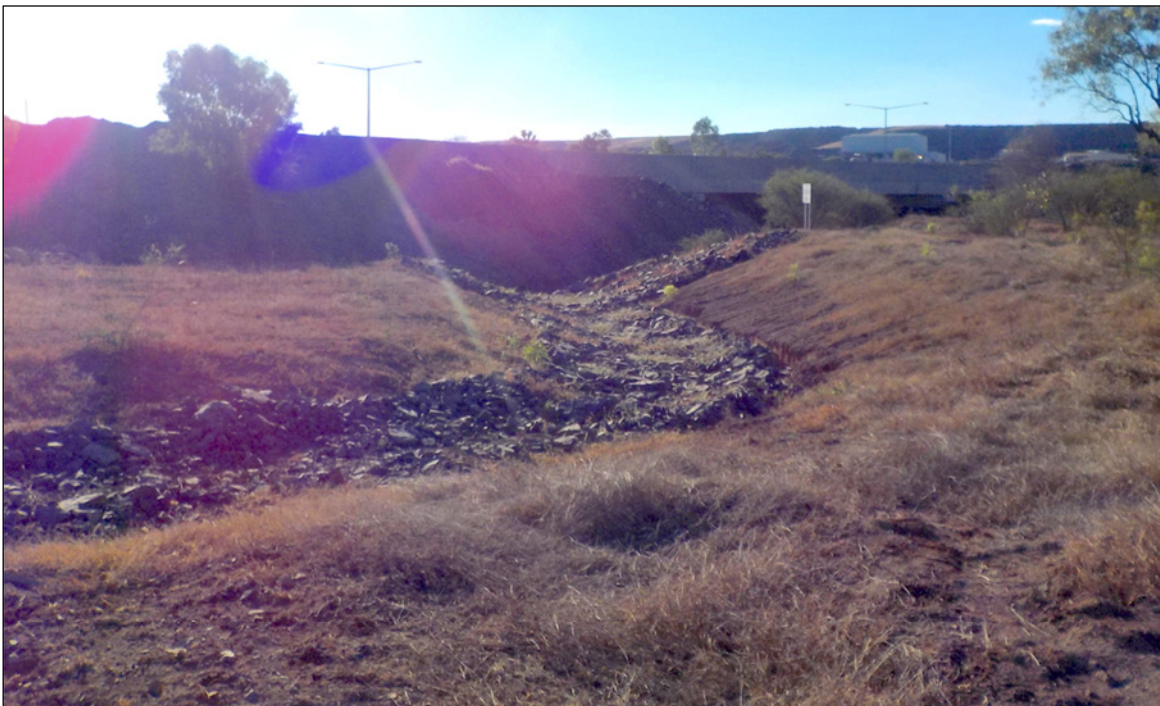
Plate 4.23 – Barney Creek Haul Road Bridge Southeast Post-Settlement Spillway

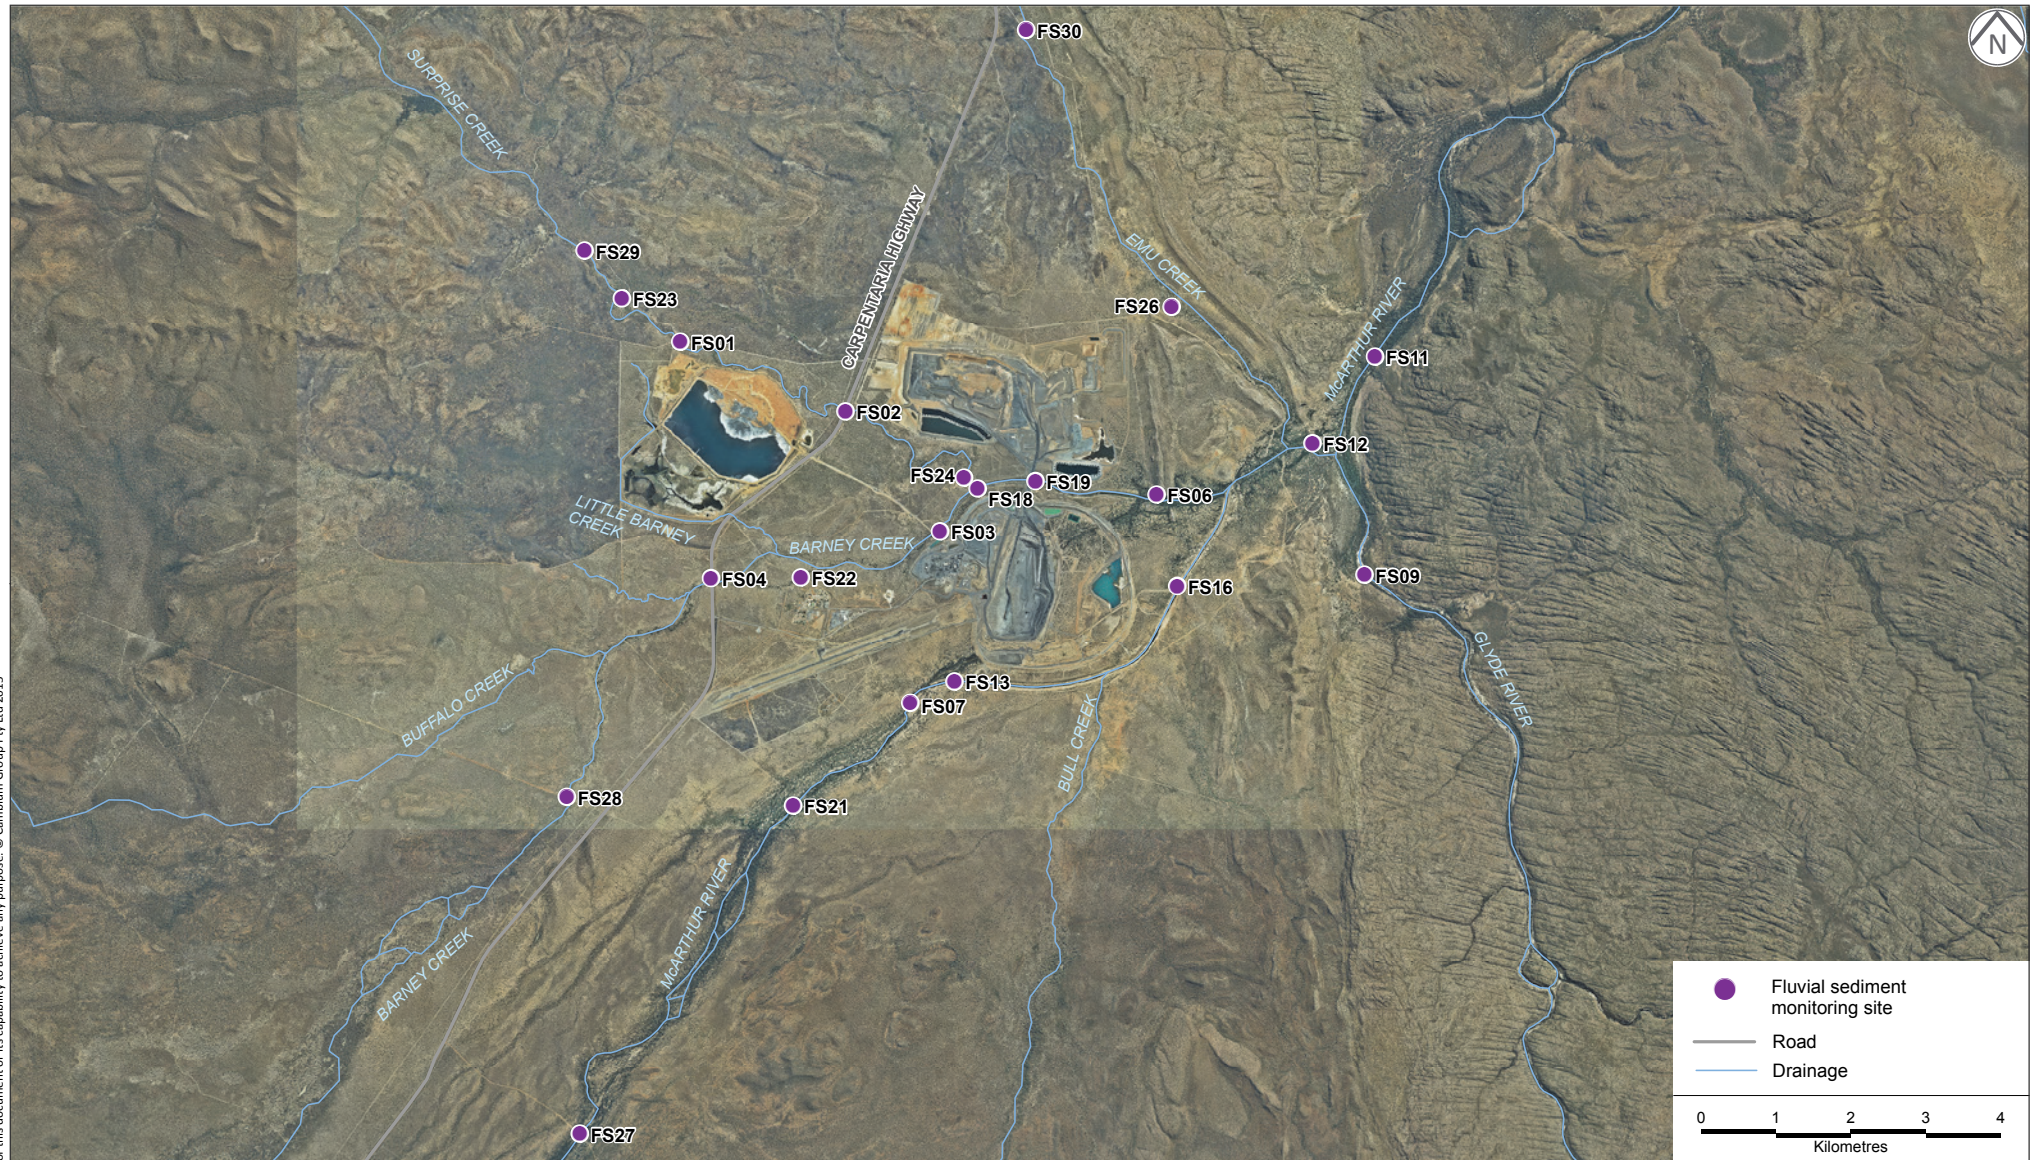
FIGURE 4.27

- ◆ Fluvial sediment sampling sites as shown in Figure 4.27 for the 2014 operational period. These are the same locations as the natural surface water sampling sites (Figure 4.1).
- ◆ Sampling annually in the middle of the dry season (in 2014, this occurred in August).
- ◆ Laboratory testing (pH (paste), conductivity (paste), particle size distribution, major ions and total and <63 µm trace metals).

Concentrations of As, Cu, Cd, Pb and Zn were well below ISQG-low values at all sites in the McArthur River, Surprise Creek, and upstream Barney Creek sites (FS28 and FS04) (Figure 4.27). Of note, FS02 in Surprise Creek (immediately downstream of the TSF) previously returned elevated sulfate, cations (particularly Ca and K), Pb and Zn levels, but 2014 results have been within the range of upstream sites, with Pb and Zn well under ISQG-low values.

Sites having elevated concentrations of metals or arsenic are shown in Table 4.55. Locations can be seen in Figure 4.27.

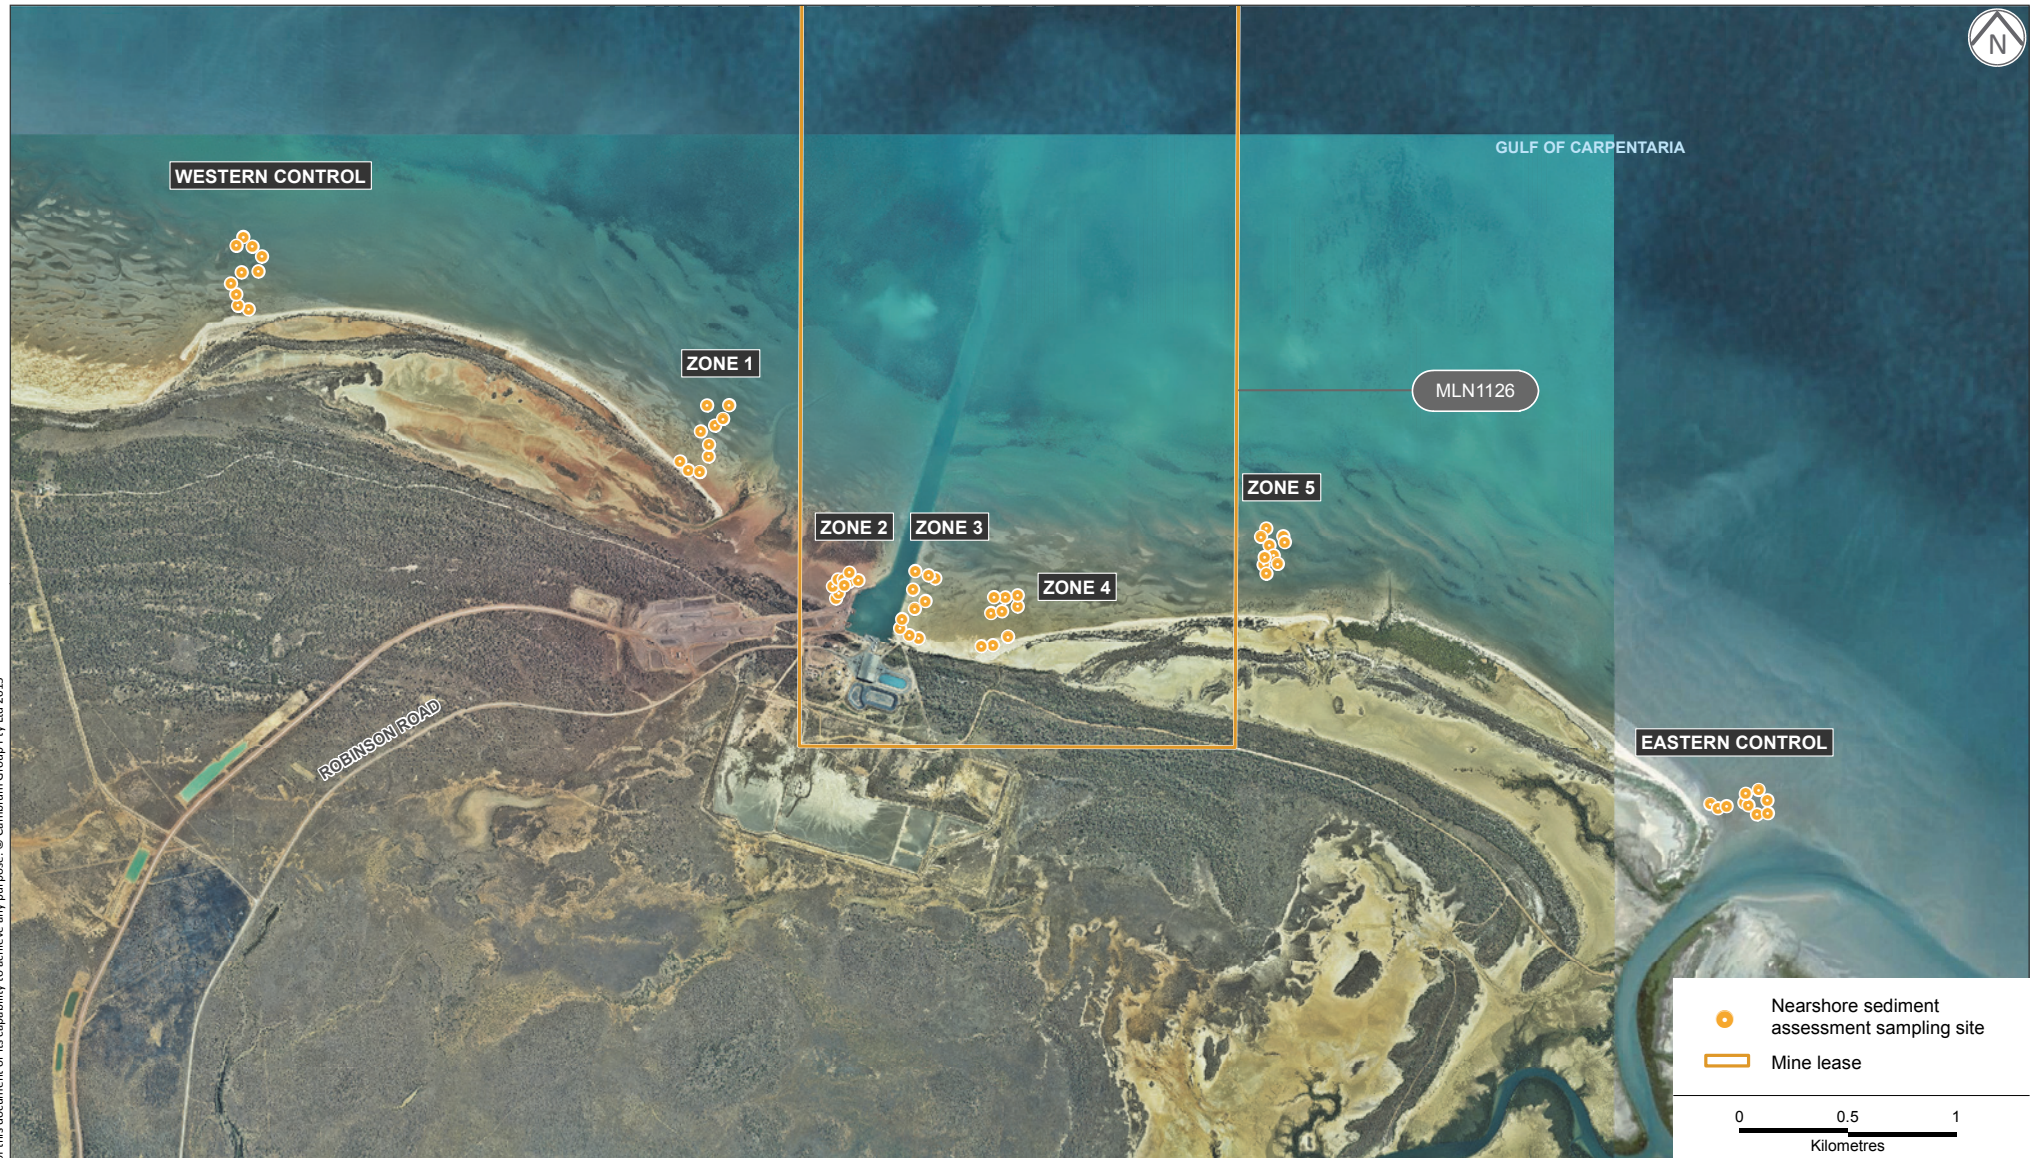
FIGURE 4.28

- ◆ Consistent with the results of the 2013 study, Zn and Pb concentrations were again highest in Zone 2 (see Figure 4.28), with mean concentrations of 37.9 mg/kg and 19.1 mg/kg, respectively. However, all nearshore Zn and Pb results remained substantially lower than their respective ISQG-low values.

As for Fe, and consistent with 2013 results, mean concentrations of As, Co and Cu were also highest in sediments collected from the Eastern Control (see Figure 4.28). On this basis, Thorburn (2013 and 2015) has reiterated that the Eastern Control site should be moved slightly to the west and away from any direct influence of Mule Creek.

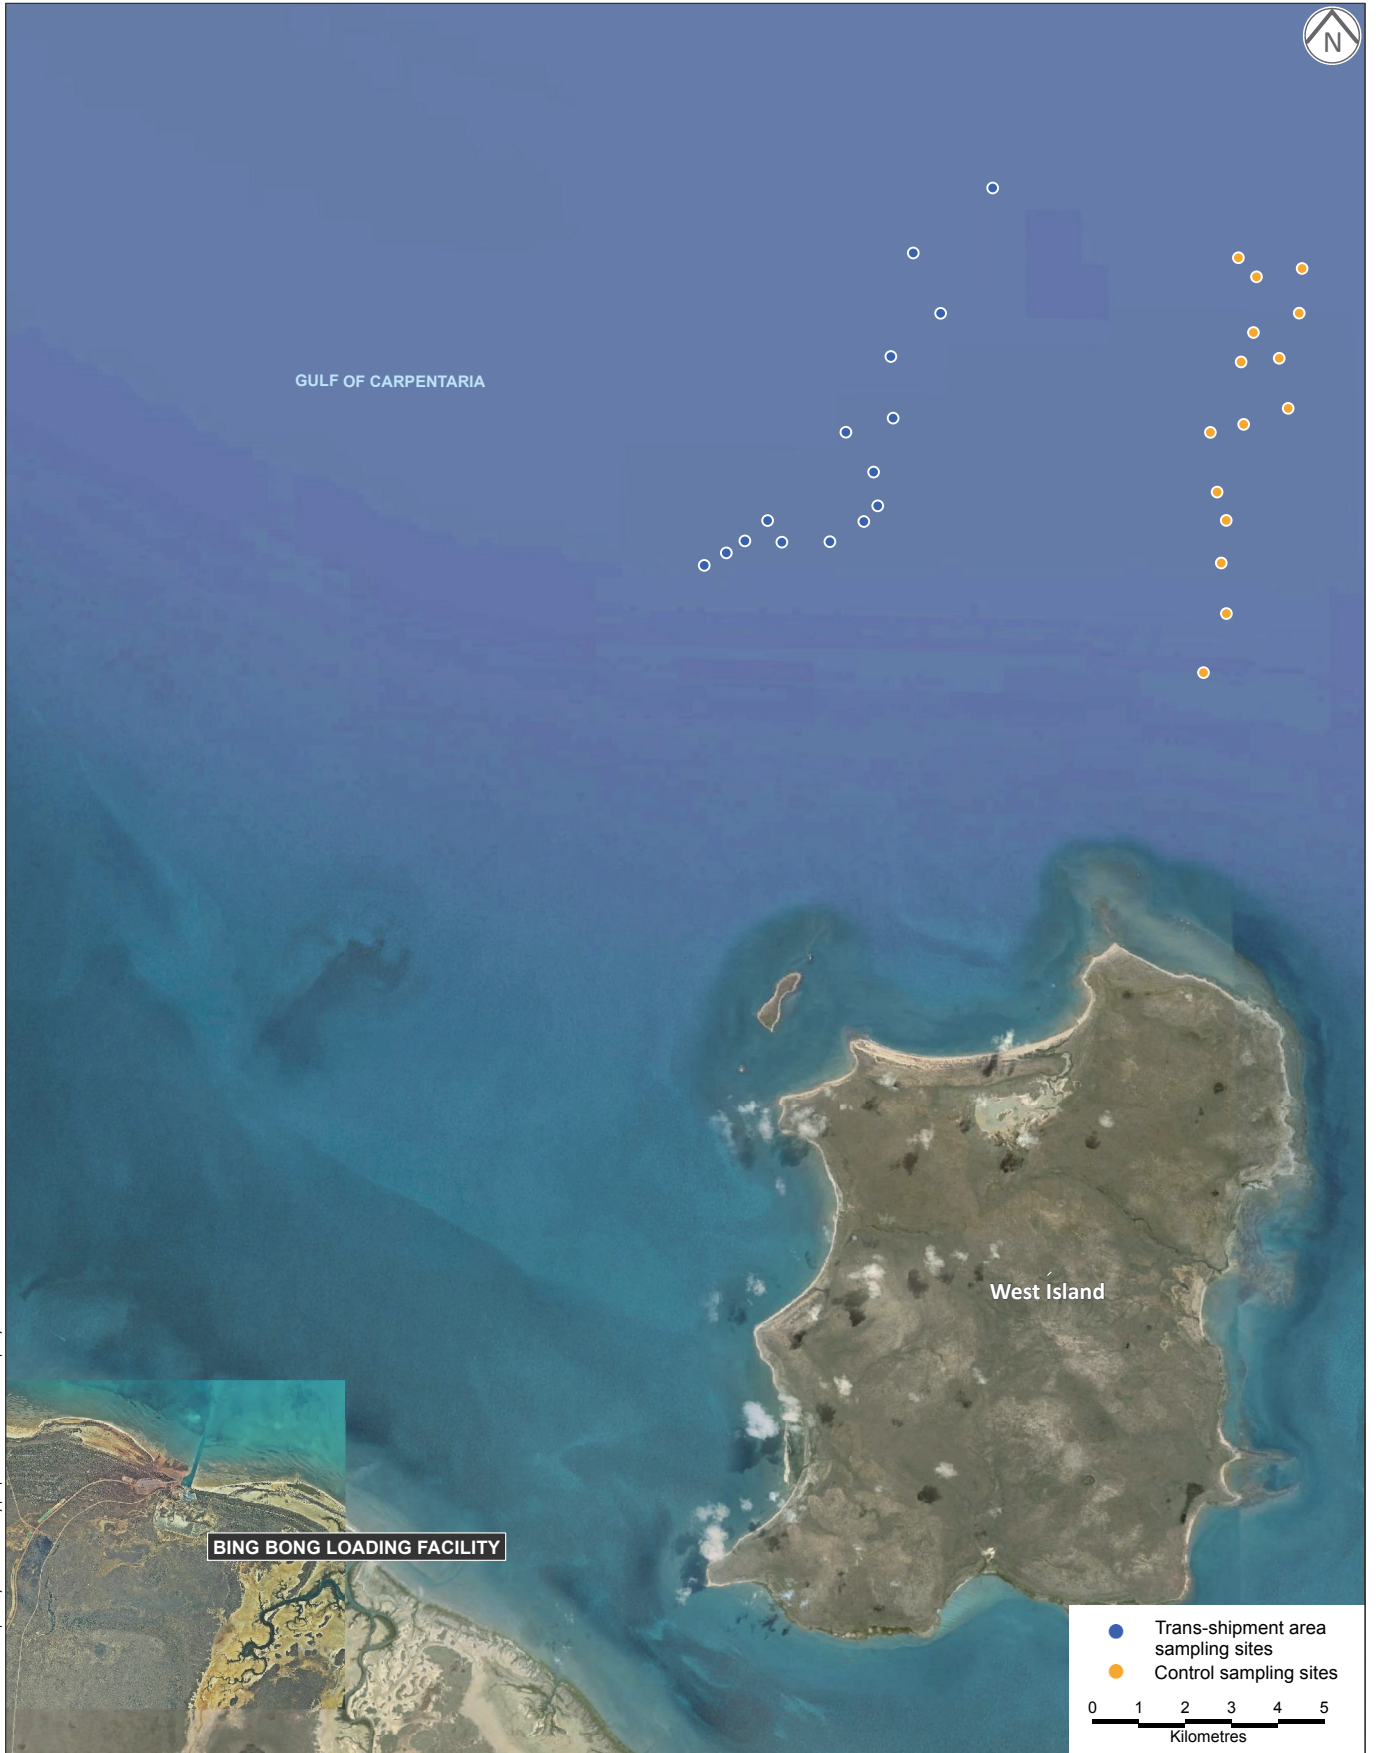
FIGURE 4.29

TRANS-SHIPMENT AREA SAMPLING SITES

Thorburn (2014a) found that metal and metalloid results for the trans-shipment area (see Figure 4.29) were comparable with those in control areas, and also consistent with the results collected in 2012:

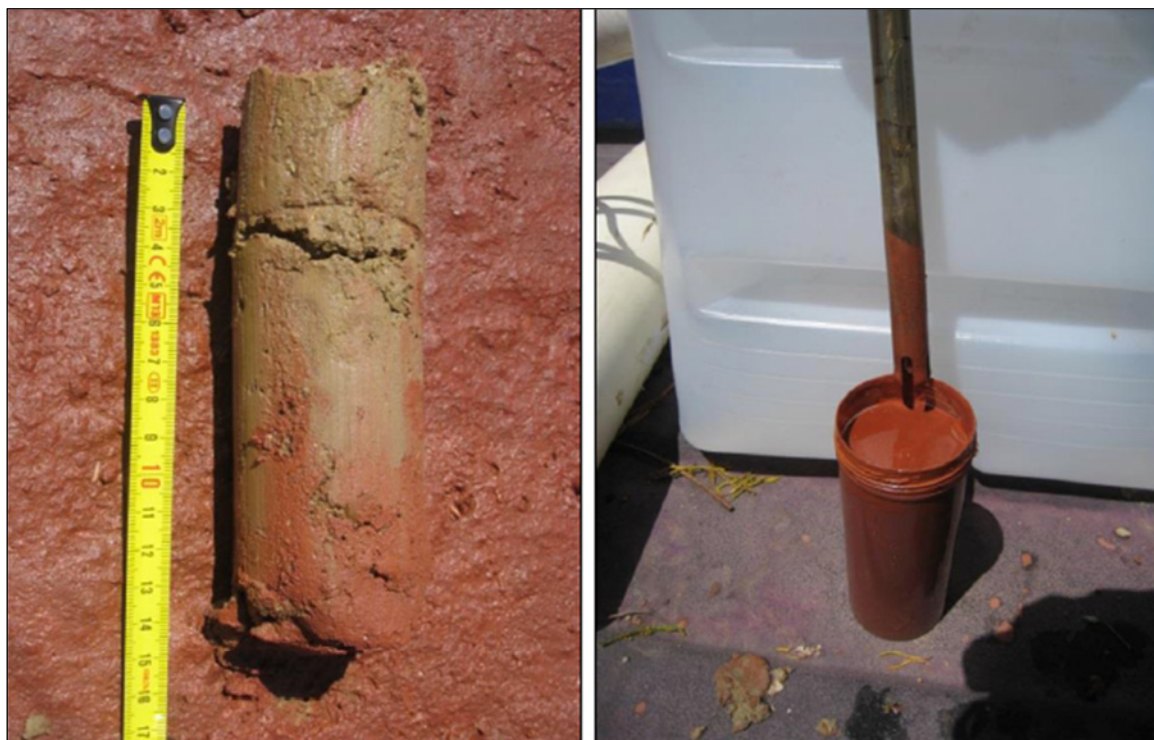
Left: sediment core showing top fraction of iron ore. Right: sediment from Zone 2 in a 1:5 ratio with deionised water.
Source: Thorburn, 2015.

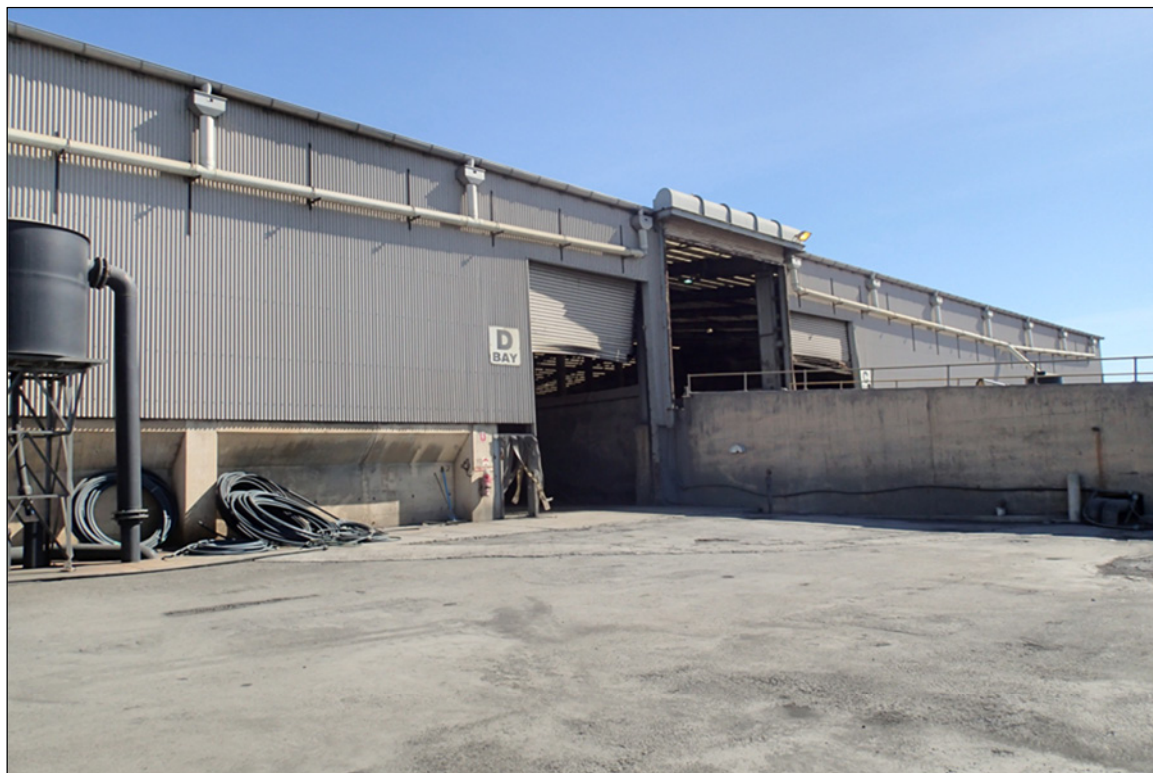
- ◆ While the loading facility was relatively clean, there was visible concentrate dust throughout the site, including some evidence of concentrate on the concrete apron (i.e., spillage from inside the concentrate shed) (see Plate 4.25). Roads around the facility were not being sprayed to control dust as they were during the IM visit in 2014 due to a drier than average wet season in 2014-2015, and subsequent low water levels in the runoff ponds.

Plate 4.25 – Open Doors on the Concentrate Shed and Visible Concentrate Dust at the Bing Bong Loading Facility

- ◆ The doors of the concentrate shed were unable to be closed, which may enable release of dust during windy conditions and/or concentrate unloading and handling. This issue should be rectified, so that concentrate shed doors can be closed except during truck access and egress.

- ◆ Similarly, the dust extractor system in the concentrate shed was not working at the time of the site visit.
- ◆ The bitumen surface surrounding the Bing Bong Loading Facility is failing in a number of areas, with formation of potholes apparent. If these are not repaired there is potential for exposed soils to be subject to wind erosion, and/or potential for the underlying road base, subsoil and/or groundwater to be contaminated by exposure to mine products (concentrate) loaded at the site. While this is primarily a soils and water issue, it is also a potential source of (contaminated) ambient dust released from the site.
