Independent Monitor Community Report

2010 Operational Period

Community Report by the Independent Monitor of the
McArthur River Mine, November 2011

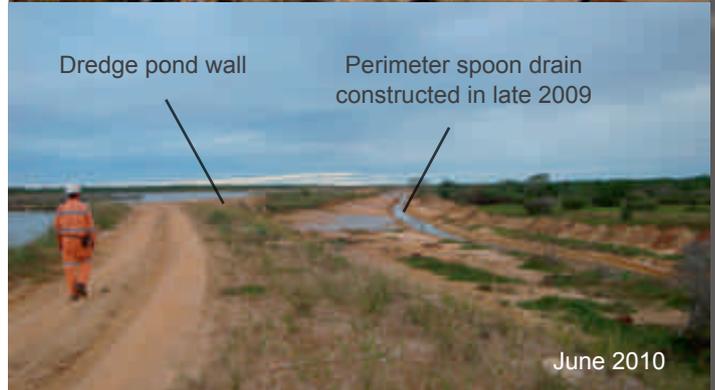
At the time of our site inspection in May 2011, the Bing Bong dredge spoil was dry, appeared to be stable and not likely to fail. However, there is still no information available regarding the geotechnical stability of the pond walls. We have recommend that MRM consider conducting a complete geotechnical review of the walls prior to the 2011/2012 wet season to determine their level of stability.

MRM have advised that further earthworks have recently been undertaken to clean out the spoon drain and repair the dredge pond walls prior to the 2011/2012 wet season.

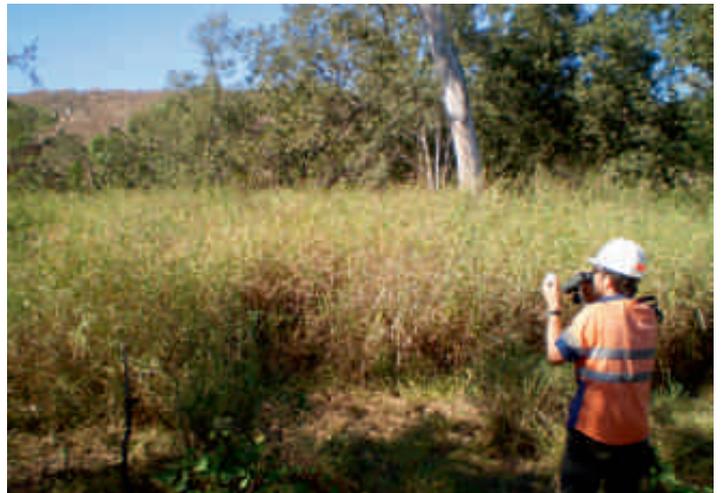
Cane grass was observed to be providing habitat for the Purple Crowned Fairy Wren during our site inspection in May 2011. This suggests that revegetation of cane grass is proving successful in these early stages (see photo below).

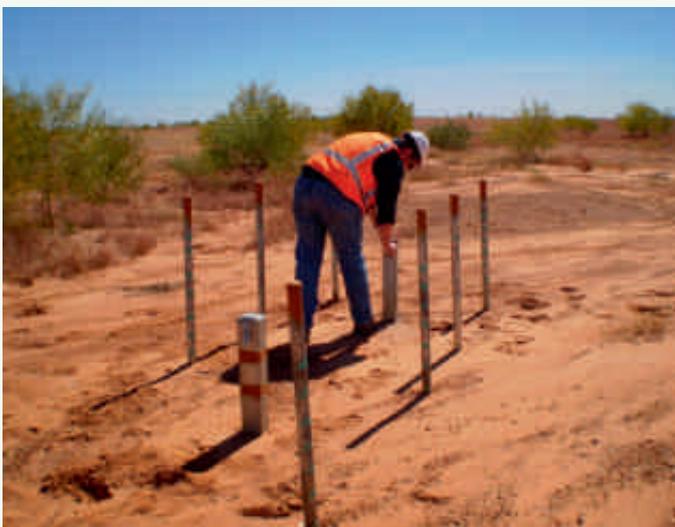
Groundwater monitoring and reporting has improved since the previous audit periods and additional groundwater bores have been added at the TSF (see photo left) and at Bing Bong. However, groundwater monitoring results prepared by both MRM and external consultants were found to be poorly discussed and inadequate to detect impacts to natural groundwater systems. We have made recurring recommendations for MRM to provide appropriate discussions of results as well as undertake quality control and quality assurance reporting. These requests have not yet been met.

Independent Monitor Hydrogeologist, Geordie McMillan inspecting two new groundwater bores installed within the TSF Cell 1.

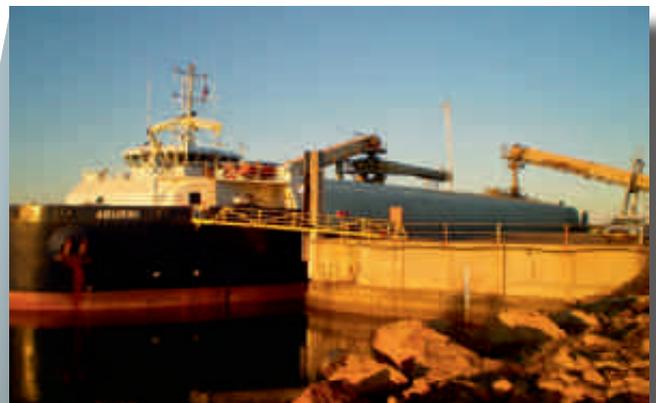
Potential concentrate spillage during loadout

In 2010, anonymous claims were made in the *Northern Territory News* (4 May 2010) that concentrate dust had been spilt and washed off the Aburri Barge during loading and cleaning. The Independent Monitor inspected the concentrate loading process this year (see photo above) and found it to be entirely closed, with no observable dust on the pavement or coming from the loading plant.
